# THE ARUP JOURNAL

JULY 1968

Vol. 3 No. 4 July 1968  
Published by  
Ove Arup & Partners Consulting Engineers  
Arup Associates Architects and Engineers  
13 Fitzroy Street, London, W.1

## York Minster

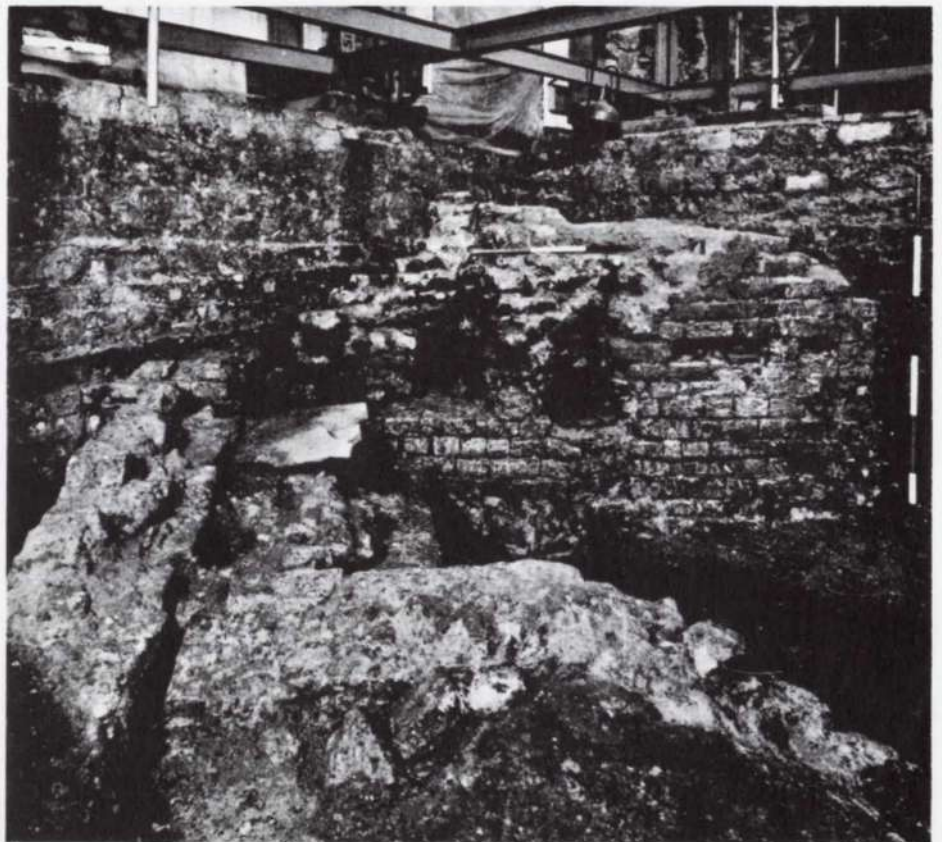
Fig. 2 above. Second century wall of the principia of the cross-hall with the flues of the hypocaust installed at a later date. The wall running into the picture is also part of later modifications. Behind this Roman work are the Norman foundations. (Published with permission of Royal Commission on Historical Monuments (England). *Crown copyright*)

After the fire of the late fourth century, there were a series of repairs and rebuilding of the Roman walls continuing after the departure of the Roman army and administration, and with a progressively deteriorating standard of mason craft. At one stage the north end of the cross-hall was partially converted to domestic occupation and a kitchen inserted on its north-west side, using a flue of a dismantled hypocaust to serve as a chimney. (Fig 2)

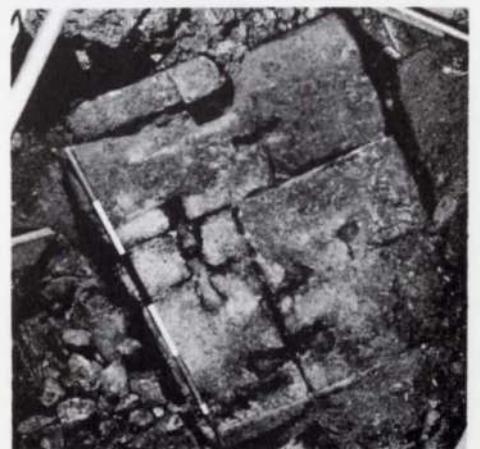
Fig. 3 right. Foundation of a pier of the cross-hall after removal of the moulded base. The incised line at the bottom of the photograph is thought to have been used in setting out the building. (Published with permission of Royal Commission on Historical Monuments (England). *Crown copyright*)

The excavations, to date, have been carried down to just below the floor level of the second century principia and just above the present level of the perched water table, standing about 15 ft. below the Minster floor. Details of the Roman foundations are therefore unknown although they are presumably mass concrete pads and footings between 3 ft. and 5 ft. deep. It is unlikely that timber piles or ground consolidation techniques were used, as it is thought that this area was comparatively dry during the Roman period, being the top of the rise above the river on which the fortress was built. The 6 ft. x 4 ft. moulded plinth of one base has been removed showing two layers of millstone grit each made up of several large blocks clamped together with large metal butterfly cramps. On one of the blocks of the upper layer, a line has been deeply incised, probably used for setting out. (Fig. 3)

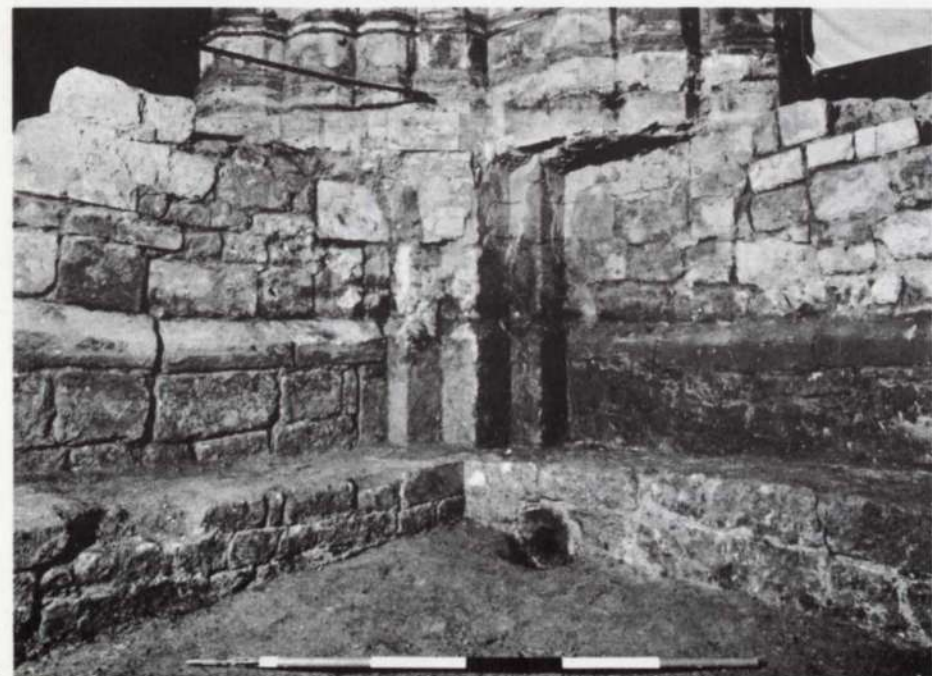
Fig. 9 below. Junction of the south wall of the Norman nave and south transept, showing the top of the foundations and the first 3 ft. of the external walls. Superimposed on these walls is the Perpendicular south-west pier of the 15th century central tower. (Published with permission of Royal Commission on Historical Monuments (England). Crown copyright)

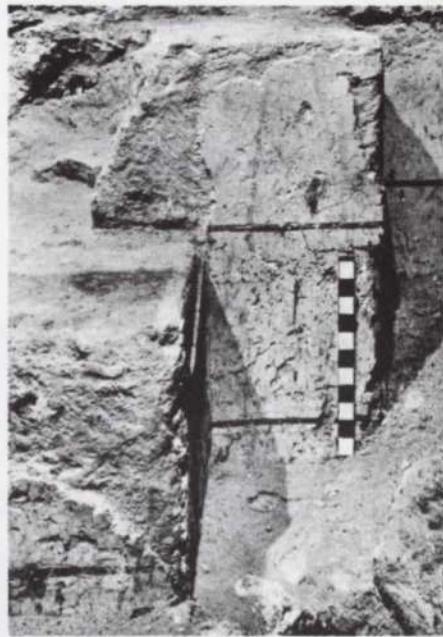
Fig. 10 above. Herringbone walling in the inside of the Norman wall at the east end of the nave, on the south side. (Published with permission of Royal Commission on Historical Monuments (England). Crown copyright)

walls of the nave (Fig. 10) where it is closely associated with Norman tooling. The same kind of walling associated with similar foundations and also of late eleventh century date occurs in the early Norman work at Richmond Castle.' (Herman Ramm).

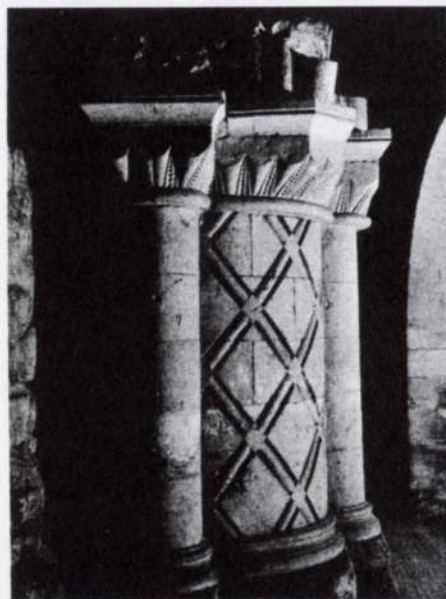
Fig. 14 right. A large transitional pier from Roger's Crypt. (Published with permission of Royal Commission on Historical Monuments (England). *Crown copyright*)

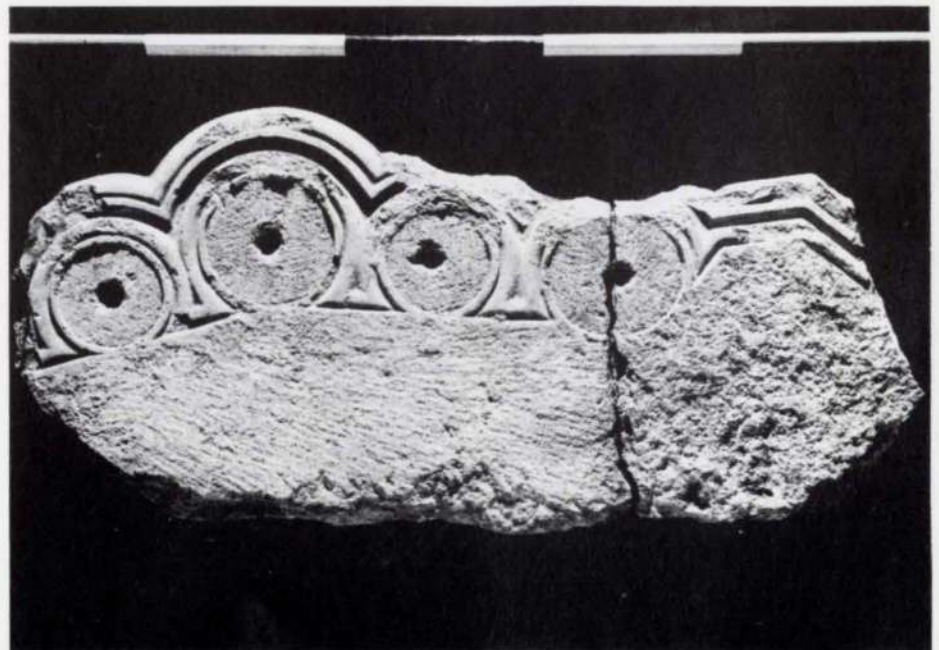
Fig. 17 below. Early English 'slab moulding' which ties together a group of clustered columns. (Published with permission of Royal Commission on Historical Monuments (England). Crown copyright)

The relationship of triforium to clerestory is conditioned by the structural demands of vaulting the roof. The height of the triforium is defined by the width of the aisle and the slope of the roof. This is typically steep due to the wet northern clime and the roofing material which would have been either tiles or flat stone slates. (Fig. 18) Thus the large span and steep slope result in a tall triforium. Its architectural treatment is stylistically similar to Whitby Choir with its single semicircular containing arch with two pointed intermediate arches and four lower arches. (Fig. 17)

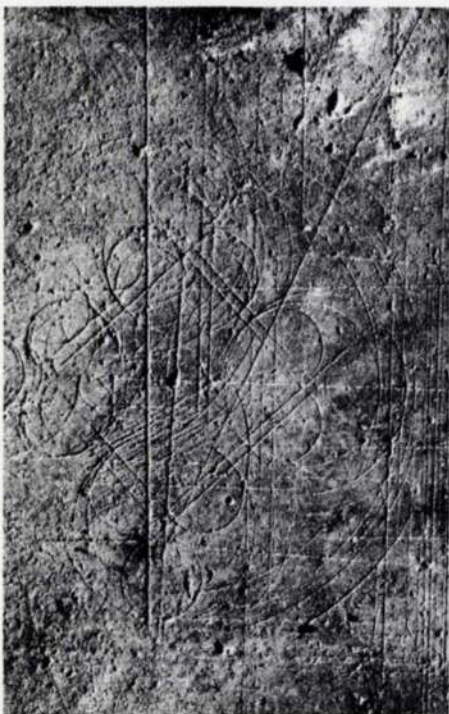
Fig. 30 The tracing floor above the chapter house vestibule. Detail (about 12 in. x 18 in.) near to the west wall. (Published with permission of Royal Commission on Historical Monuments (England). *Crown copyright*)

'Molds' or 'patterns' of the mouldings to be used in the building were made of various materials including fir boards, canvas and lead. They were produced from a drawing either drawn on vellum or paper or incised in the surface of a plaster floor. In England such floors exist at Wells and at York on top of the masonry vault of the chapter house vestibule. (Fig. 30) The templates were either given or sent to the masons on site or at the quarry. 'Roughing out' was often done at the quarry as transport was so expensive. *'At York Minster the cost of carriage was particularly serious as all stone had to be carried by cart from the quarry to the river port (Tadcaster in the case of Thevesdale) thence by boat to York and finally by sled from the river to the Minster. In 1400 the wages paid to quarriers at Thevesdale amounted to £18 whilst the cost of carriage of stone to York amounted to £18.6.4.'*<sup>(15)</sup>

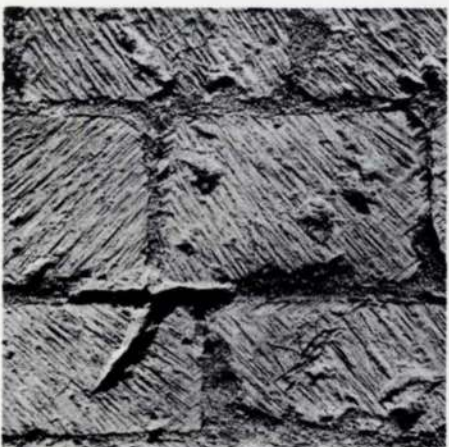
Fig. 31 Norman masonry from the remains of the newel stair at triforium level by the south-east pier of the crossing. The blocks are newly quarried magnesian limestone with diagonal axed tooling and three mason's marks; five point stars. (Published with permission of Royal Commission on Historical Monuments (England). *Crown copyright*)

Two marks were often cut on the finished stone, one to identify the mason for administrative purposes and the other to designate its position. (Fig. 31) Similar position marks were often incised on the timbers of prefabricated roof trusses and there are many on the members of the chapter house roof.

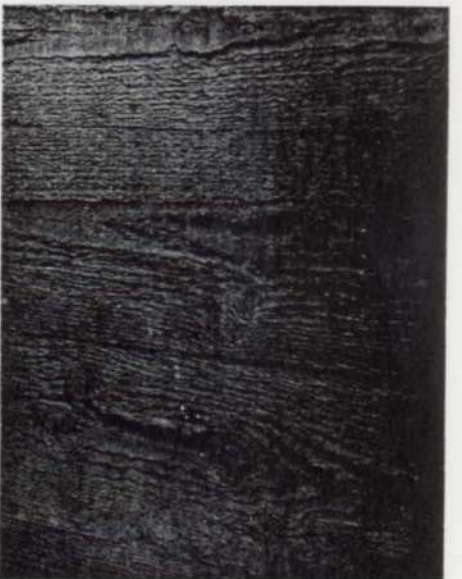
Fig. 3 University of Manchester Economics building. Finish of infill panel. Photo: Ralph Stephenson.

The dished panels of white concrete are 10 ft. x 8 ft. wide x 4 in. thick, the 2 ft. dish forming a wide window-sill cum working area. They are vertically boardmarked. A detail of part of one of these units is shown in Fig. 2. Two small samples were made, one with limestone aggregate and one with calcined flint. *Snowcrete* cement was used in both samples. As there was no difference in colour the mix made with the cheaper limestone was chosen. The horizontally boardmarked infill panels are of dark grey concrete made from high alumina cement and grey river sand and gravel. No additives were used. Fig. 3 shows the type of finish achieved on these small units.

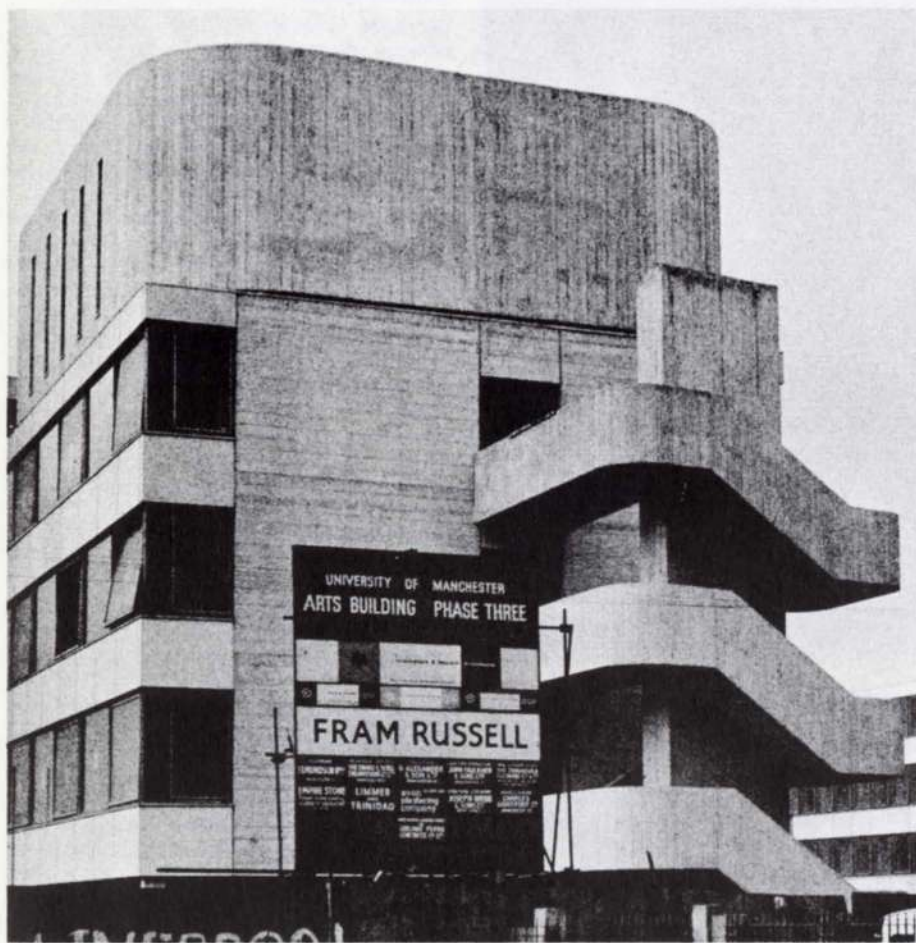
Fig. 6 University of Manchester Arts Building. South wing fire escape staircase. Photo: Ralph Stephenson.

Fig. 6 shows the fire escape. This is in a prominent position and its construction was made difficult by the fact that the architect did not want to see any construction joints. The vertically boardmarked column was cast in two halves, each half being taken up progressively to the soffit line of the stair flight on one

side or the other. The stairs and landings which are boardmarked on their soffits cantilever off the column. The balustrades were cast on to and over the edge of the flights so that the vertical boardmarking was not interrupted by a construction joint at the flight level. The soffits were slightly discoloured by rust from the reinforcement which had dropped on to the shuttering. Fortunately this was easily brushed off. In small units like this staircase, this can be prevented by suspending the reinforcement from above and covering the soffit shutters with polythene sheet, the sheet being removed just before concreting.

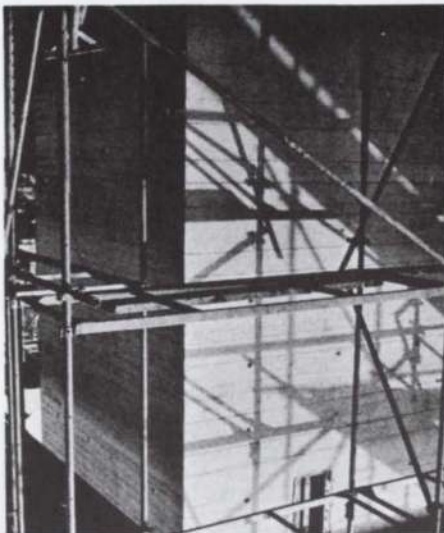
Fig. 12 University of Manchester Institute of Science and Technology Mathematics Building. Walls to north staircase. Photo: Stan Parkinson.

Fig. 11 shows the shutter detail at an 'external' corner and Fig. 12 shows the corner produced from that detail. It worked very well.

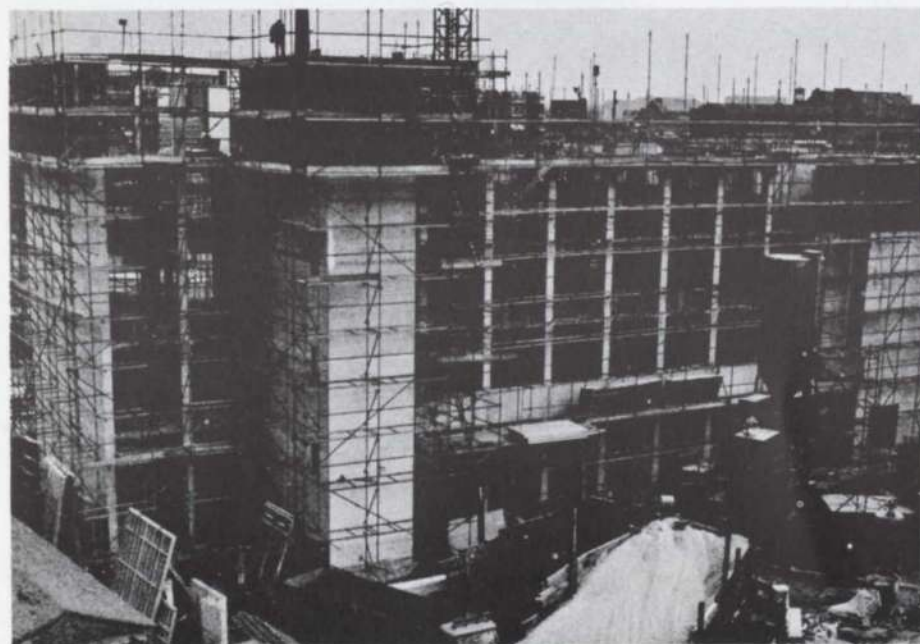
Fig. 13 University of Manchester Institute of Science and Technology. Mathematics Building—general view. Fourth floor under construction, the spandrel beams following on three floors behind the frame. Photo: Stan Parkinson.
