# THE ARUP JOURNAL

Vol. 1. No. 5 July 1967 Published by  
Ove Arup & Partners Consulting Engineers  
Arup Associates Architects and Engineers  
13 Fitzroy Street, London W1

## Scotstoun House

# Bush and pick-hammered concrete on the Barbican scheme

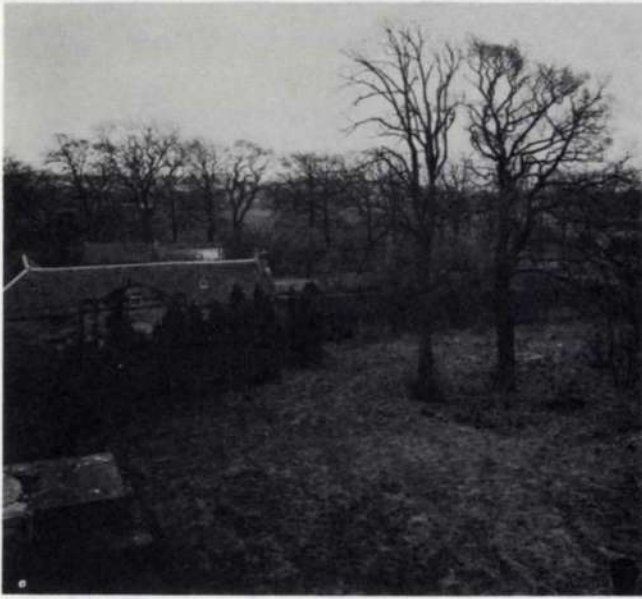
Fig. 2  
View looking east from the old house  
towards the walled garden and the stables  
(Photo: Norris, Edinburgh)

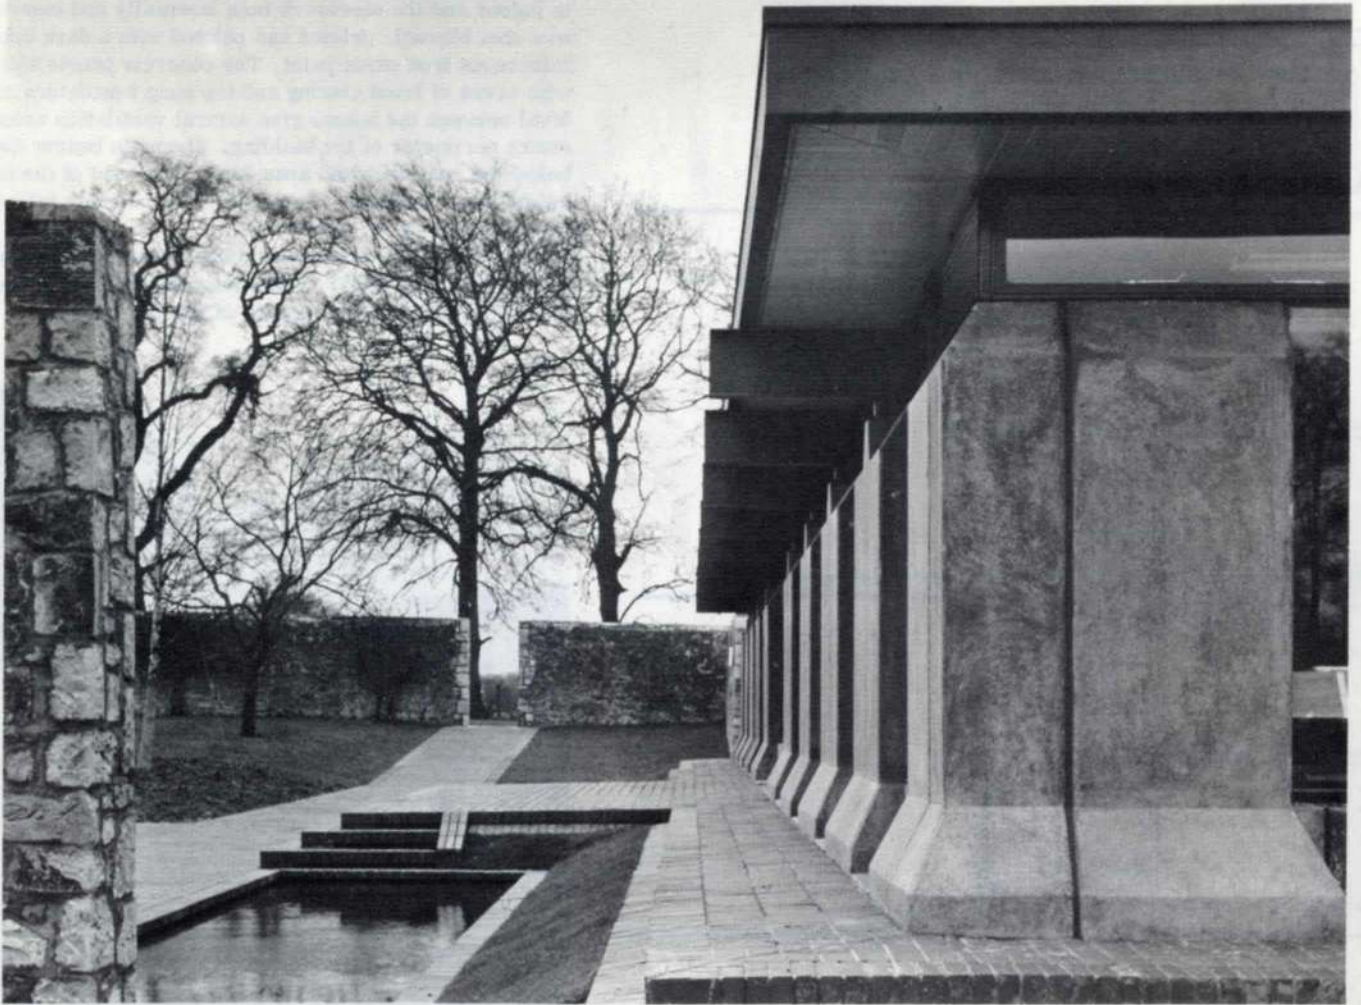
Fig. 12 right  
 The ground floor slab is built on a low plinth which provides  
 a level platform on the slightly sloping site and which raises  
 the ground floor level sufficiently to allow a short flight of  
 steps to mark the entrance.  
 (Photo: Reg Rigby)

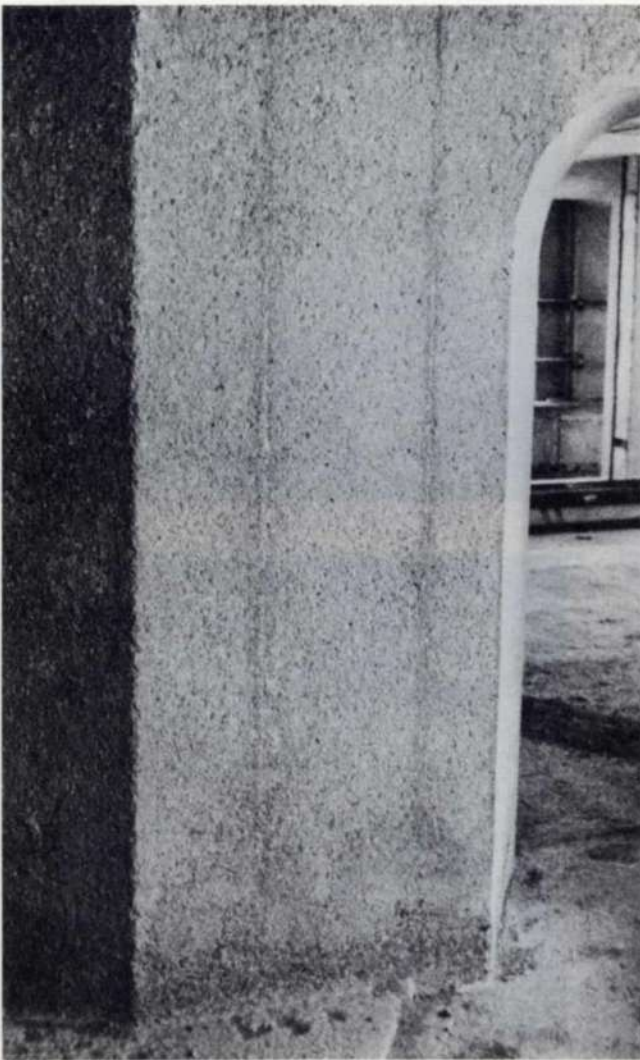
Fig. 3 above  
Tower Block 1.  
Lobby walls after bush-hammering;  
shuttering joints still show.

The biggest single factor in achieving good quality tooled concrete surfaces is the shuttering. Every joint in the shuttering will show through the finished treatment as tooling does not mask the joints. Even a joint between two sheets of ply within one shutter panel will tend to show as a dark line (Figs. 3, 4, 5 and 6). It is therefore essential that the shutter panels should be set out to a predetermined pattern which takes into account the features of the building. It is desirable to introduce a feature, such as a recess, along the horizontal joints. This masks any slight irregularities and helps to conceal the fact that generally the concrete is a slightly different colour above and below a joint (Fig. 7). At Barbican there were only a few places where this device could be used. The actual quality of surface finish is not critical, although in the case of bush-hammered work similar absorbency is necessary to maintain constant colour. The real key to success is simply the fact that the shutters must be absolutely watertight. This is easier said than done! Where shutters have to be clamped against existing concrete, grout loss will produce a 'hungry' joint which will often look worse after tooling than it did before. Polyurethane foam and various rubber seals (e.g. TRETOL 1 in. x 1 in. neoprene rubber foam) have been used successfully providing the seal is firmly secured to the shutter and tightly clamped to the existing work. These remarks apply equally to joints between one shutter panel and another and again it is essential that the joint is clamped up tightly. Nailing is insufficient, bolts at close centres are essential.

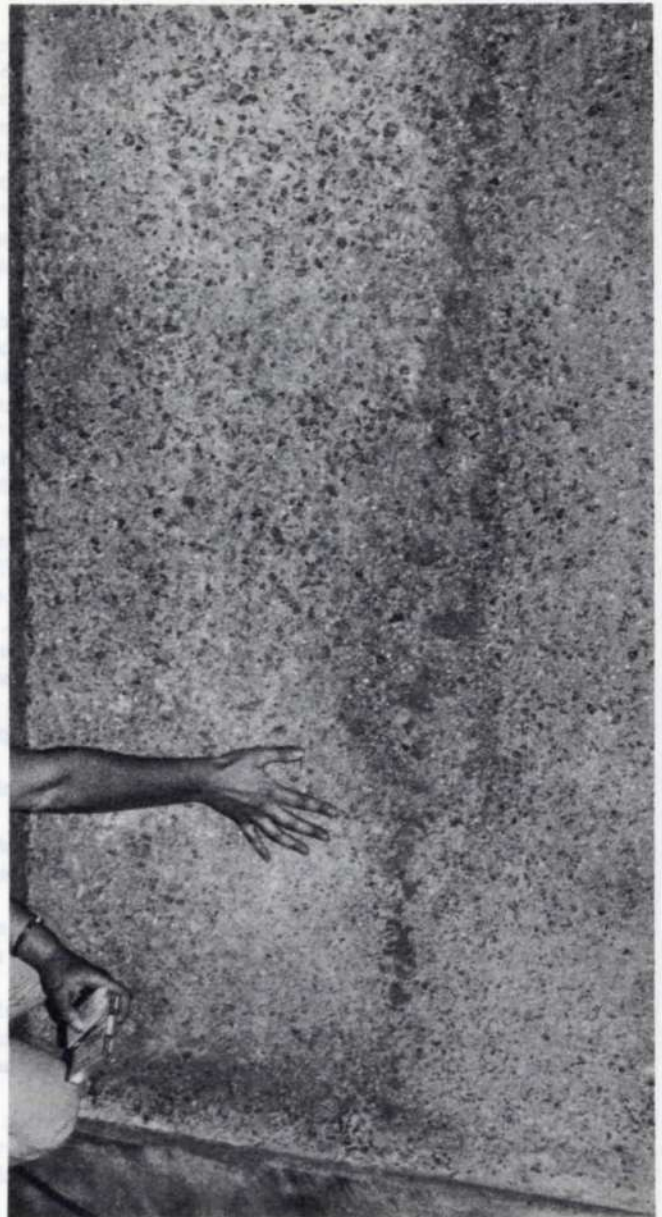
Fig. 5 above  
Block 11.  
Typical mark left by shutter joint  
after bush-hammering

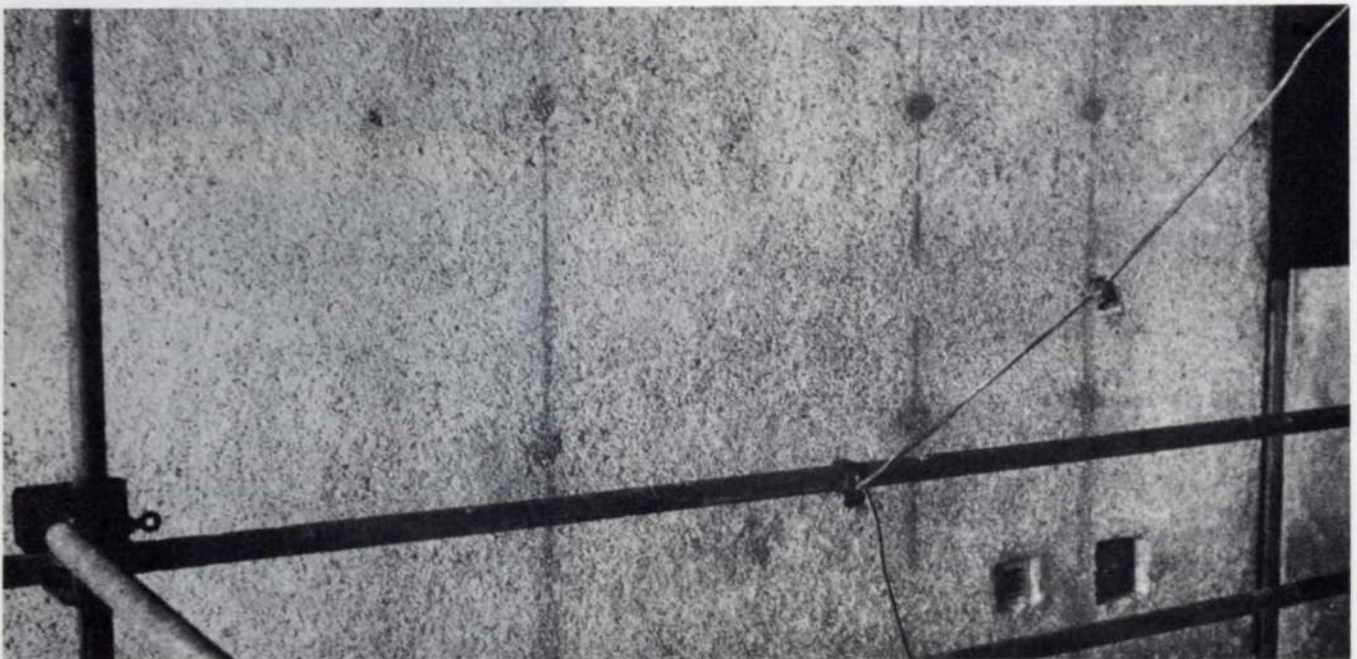
Fig. 4 below  
Tower Block 1.  
Staircase wall after bush-hammering;  
shutter joints and bolt holes still show

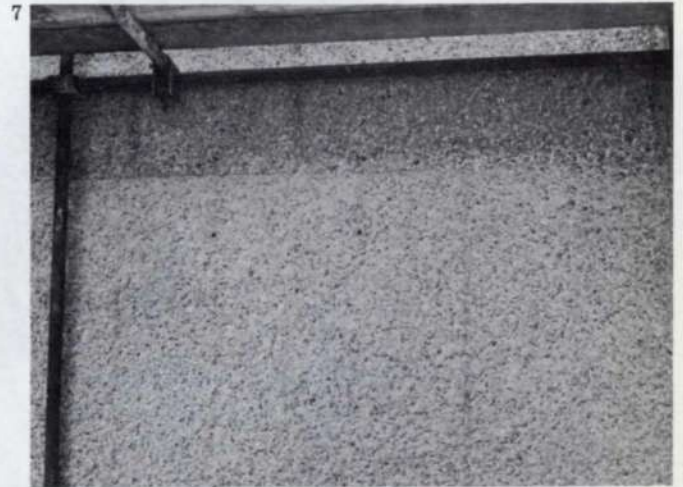
Fig. 7  
Block 8.  
Colour change at horizontal joint  
in pick-hammered cross-wall.  
Vertical shutter joints also visible

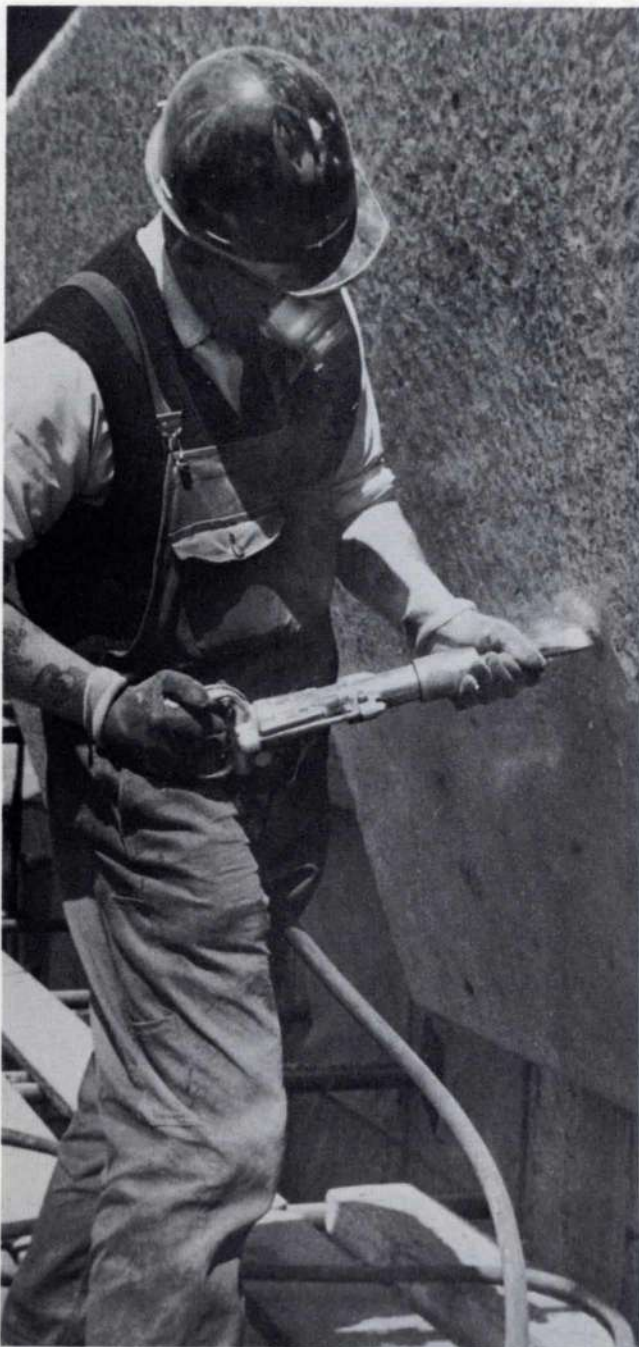
Fig. 12  
Block 6.  
Pick-hammering with a chisel bit

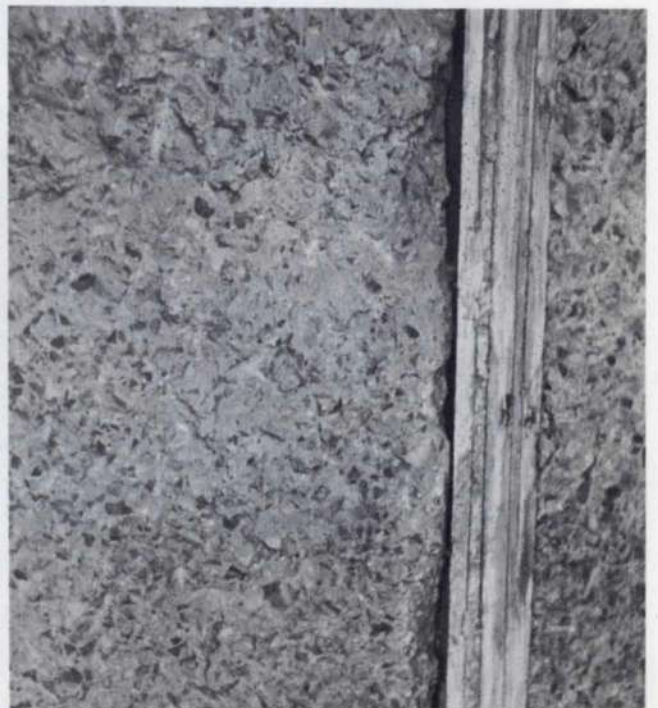
Fig. 15  
Block 11.  
Expansion joint in a split column;  
difficulty in keeping a clean edge  
in pick-hammered work

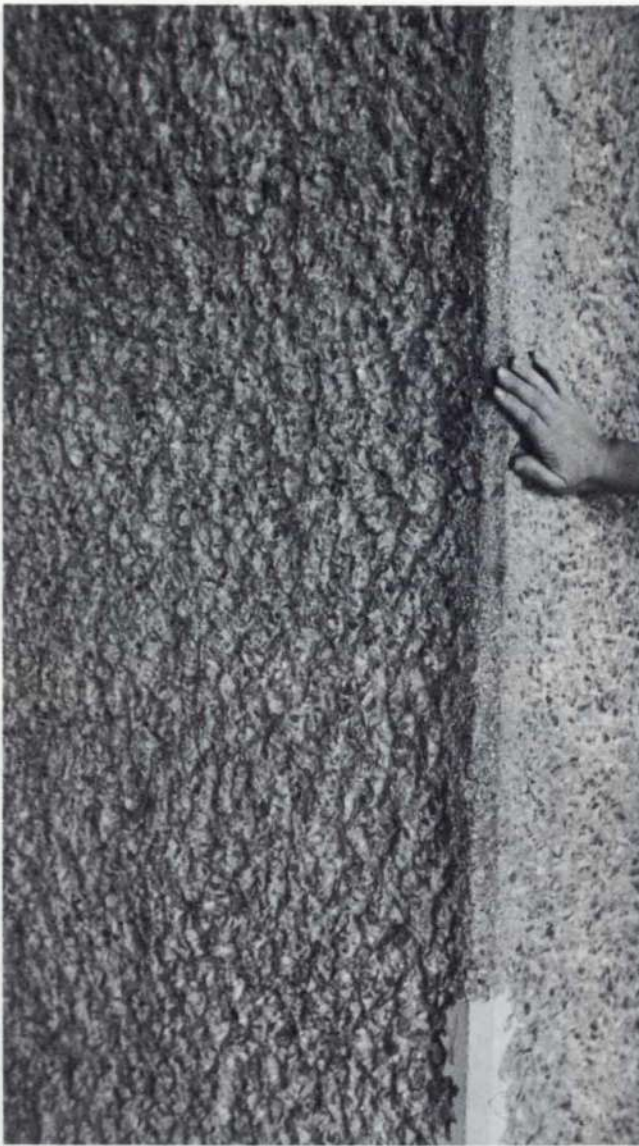
Fig. 16  
Block 11.  
Edge of a pick-hammered cross-wall

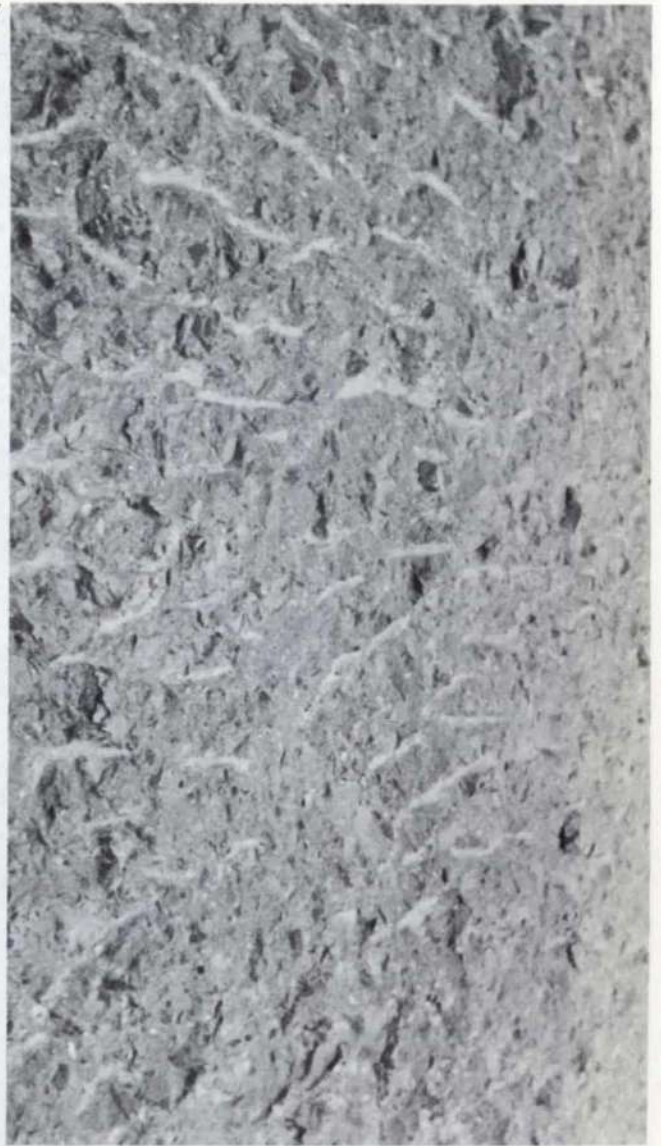
Fig. 17  
Block 11.  
Misuse of a point bit in  
pick-hammered work; tool has cut  
horizontal scores across the face

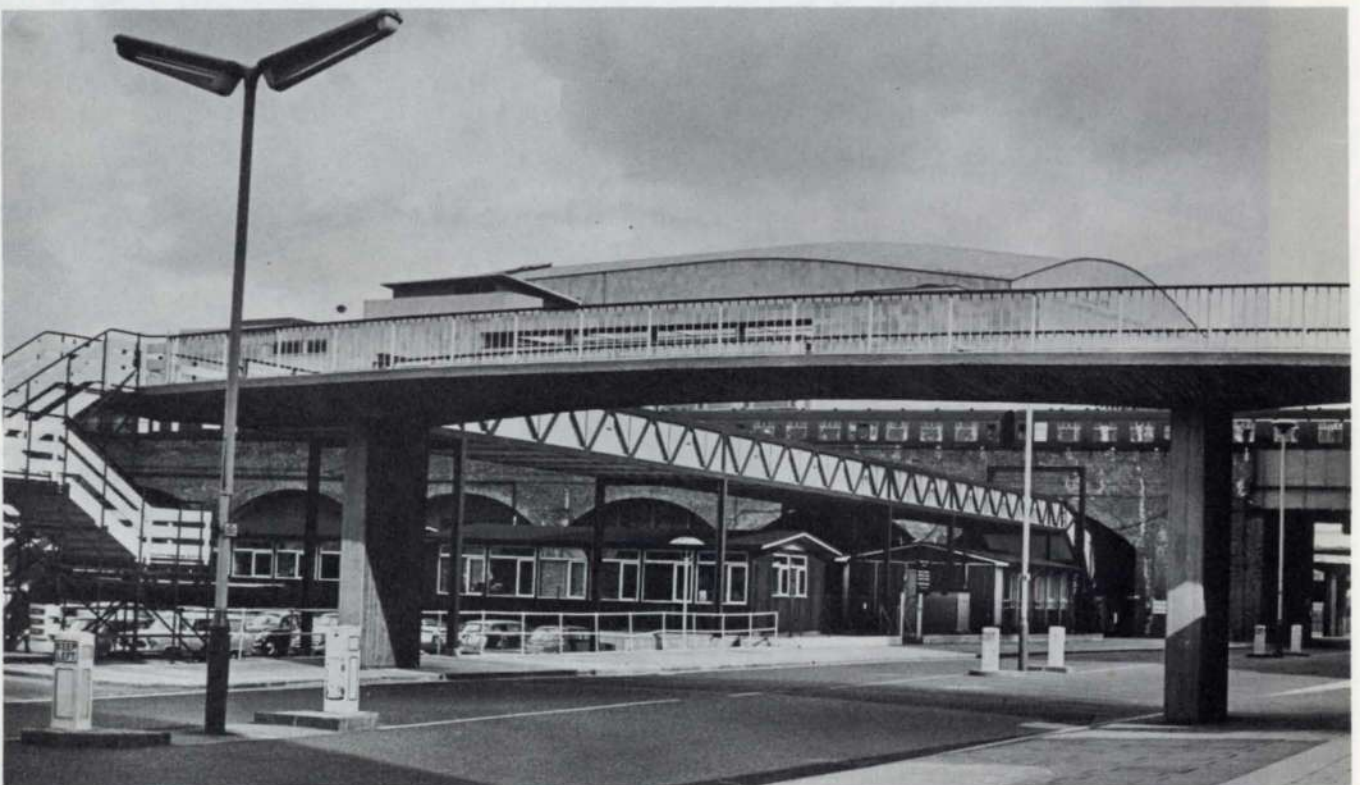
Fig. 4  
Upstream Belvedere Road footbridge and temporary walkway link
