THE ARUP JOURNAL

NOVEMBER 1967

Vol. 1 No. 7 November 1967 Published by
Ove Arup & Partners Consulting Engineers
Arup Associates Architects and Engineers
13 Fitzroy Street, London W.1

Contents

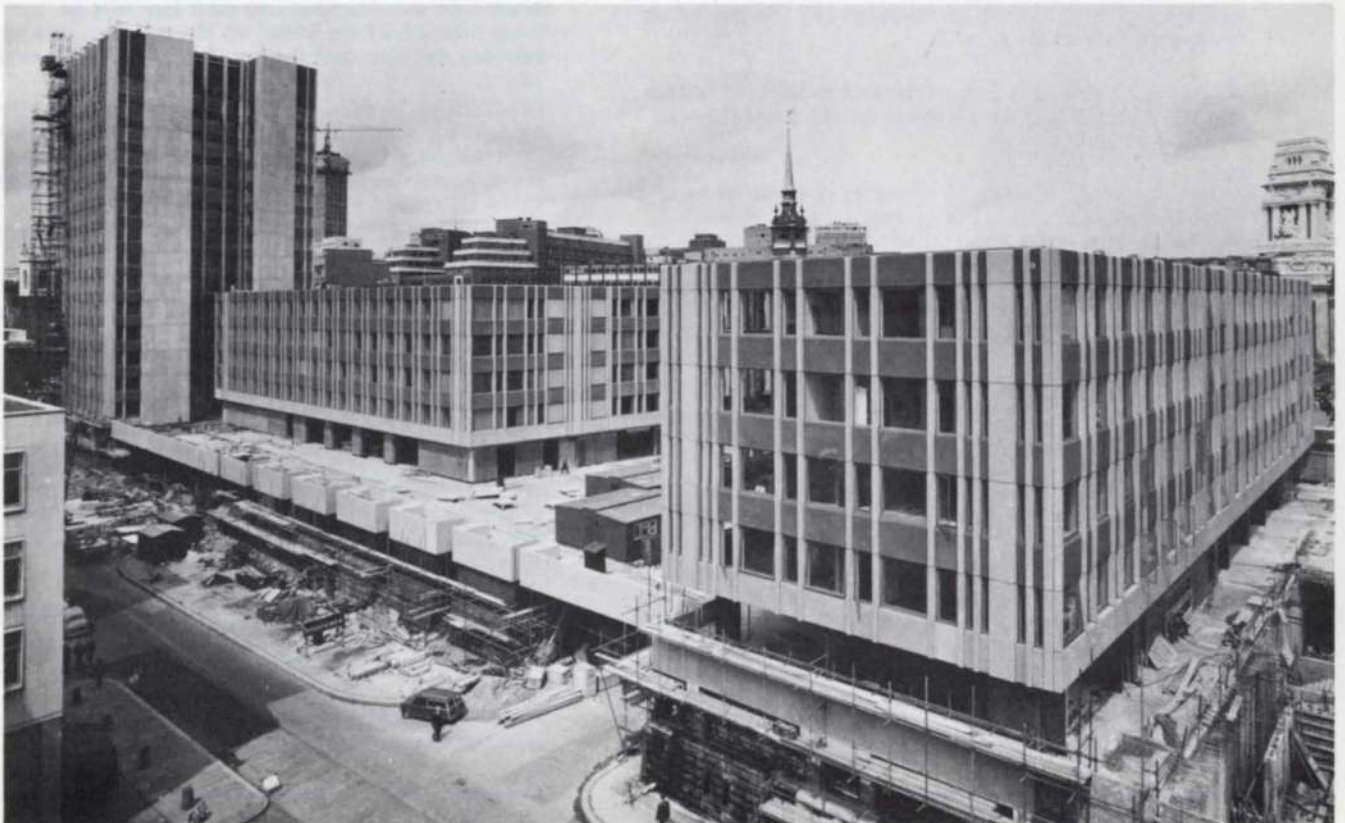
*Tower Hill Development, view looking north-west
(Photo: Edwin Lewzey & Co.)*

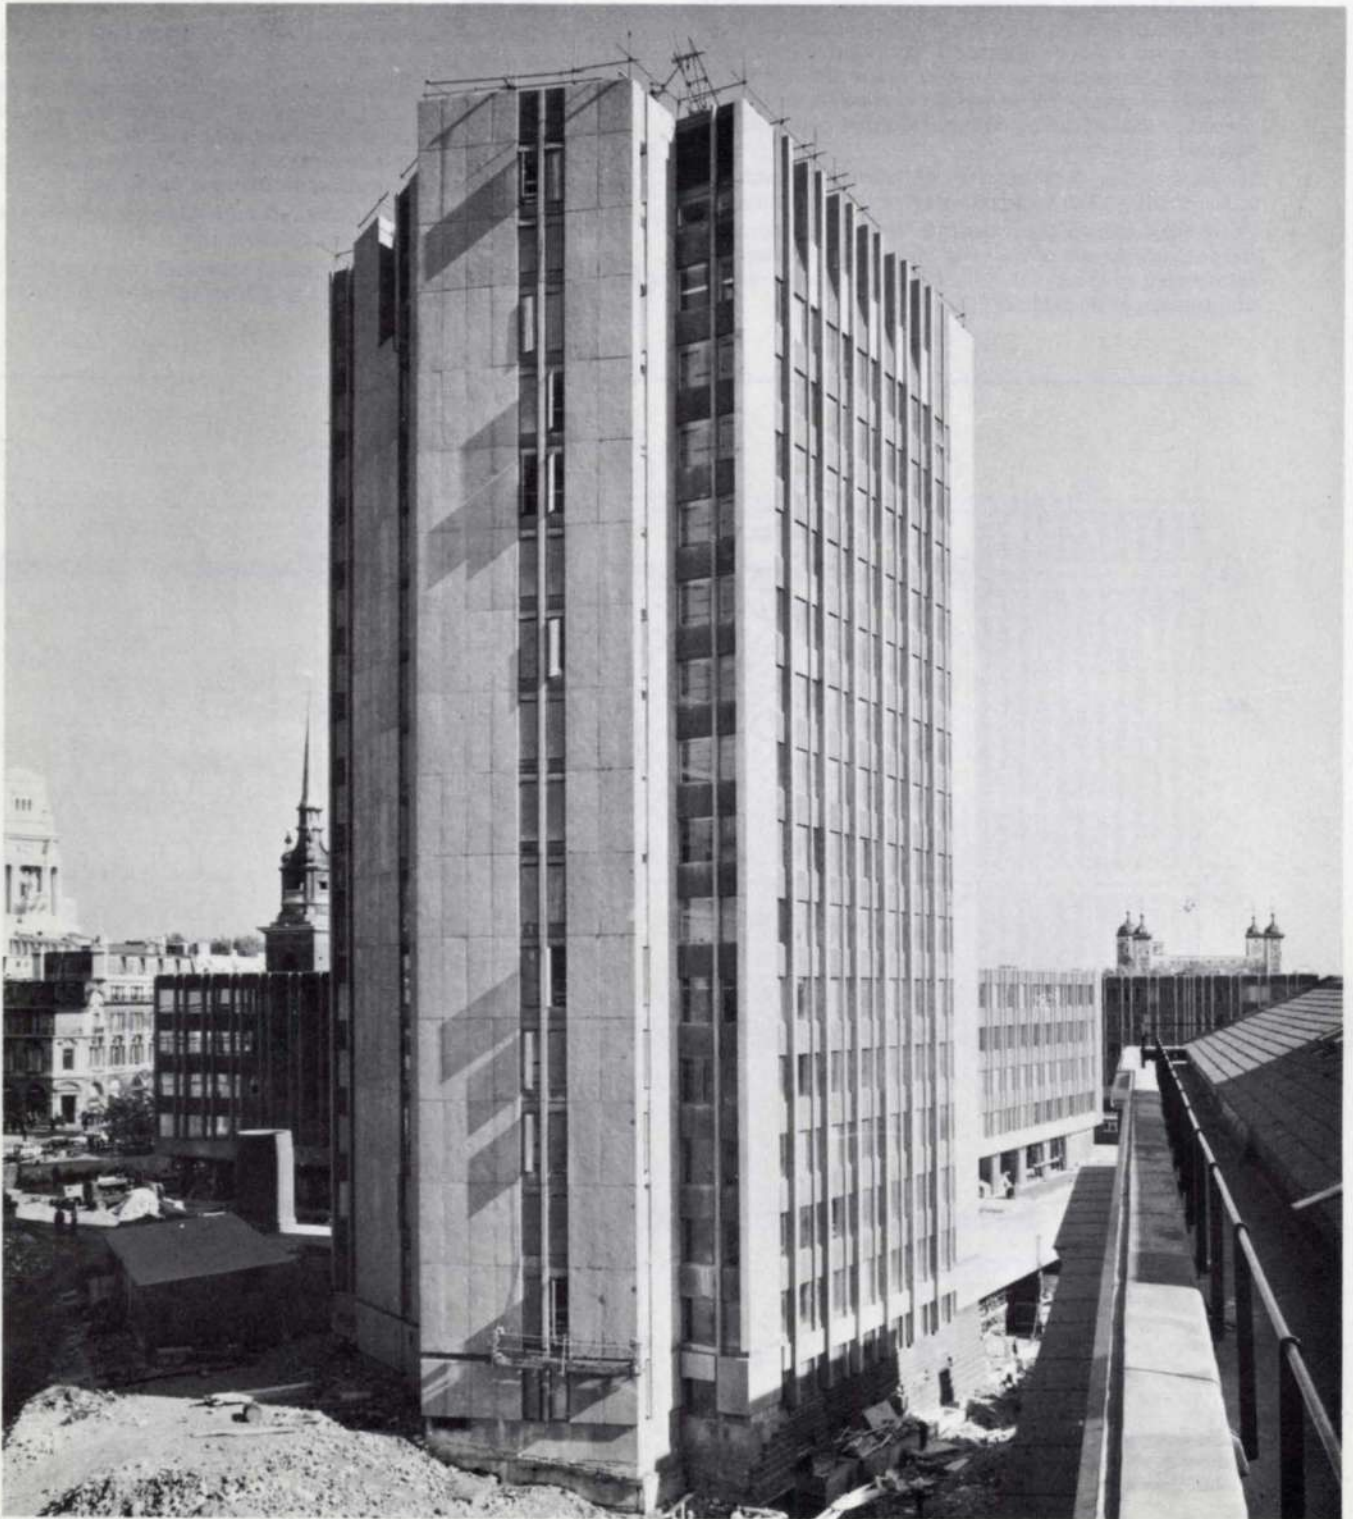
*Tower Hill Development,
view looking north-west
(Photo: Edwin Lewzey & Co.)*

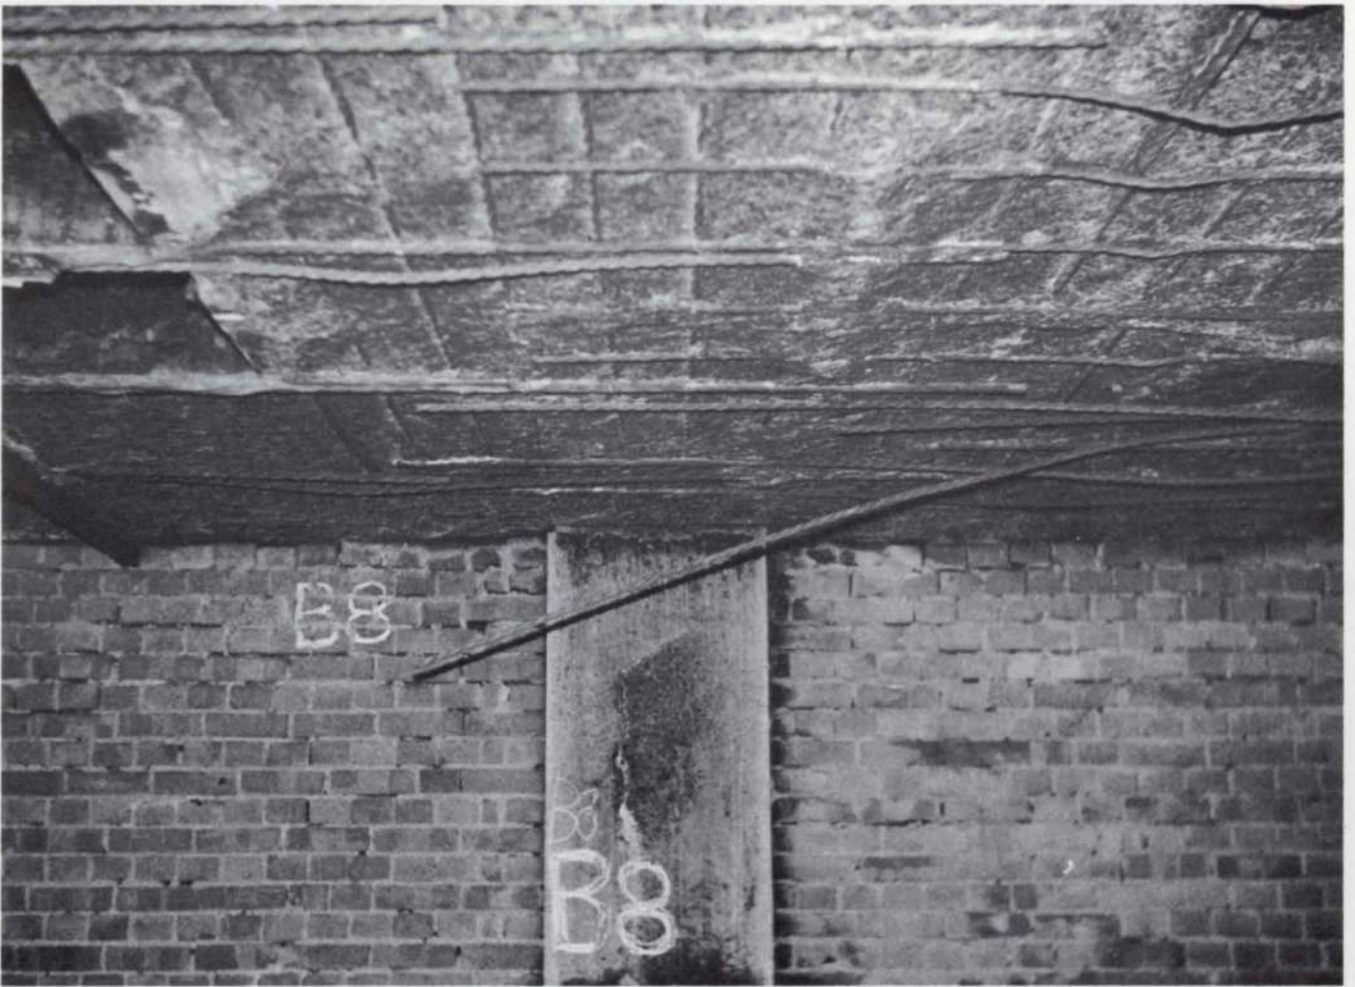
Fig. 4
Damaged soffit solid slab

The shop was completely gutted, causing extensive damage to the soffit of the first floor slab. The reinforcing steel in the underside of the slab had been exposed over extensive areas due to the concrete exploding off, Fig. 4 and Fig. 6. Evidence of calcinating of concrete was found.

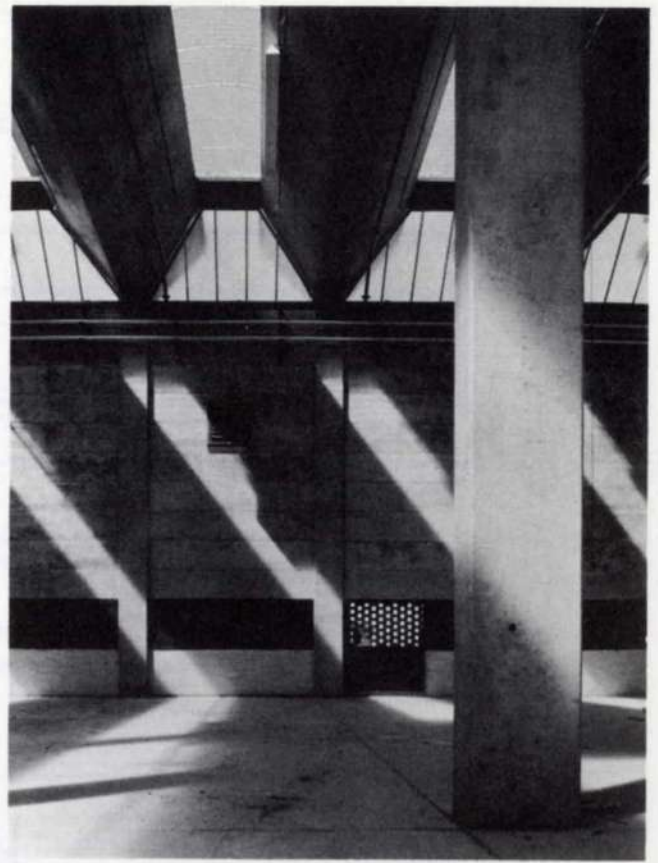
Fig. 10
Precast concrete external column (south)

Section through centre line

Elevation F

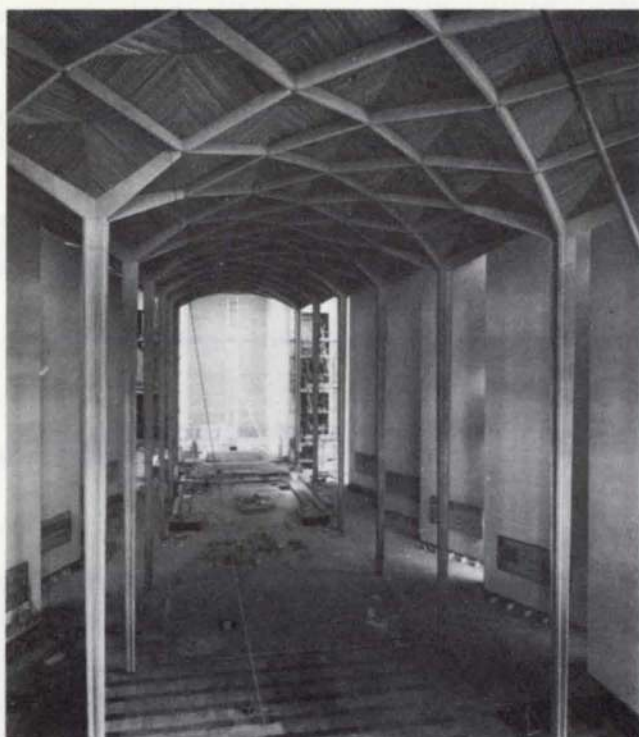
Fig. 1 above
Interior view of Coventry Cathedral nearing completion showing the columns and ceiling. The columns were precast in three sections. (Photo: John Laing & Son Ltd.)

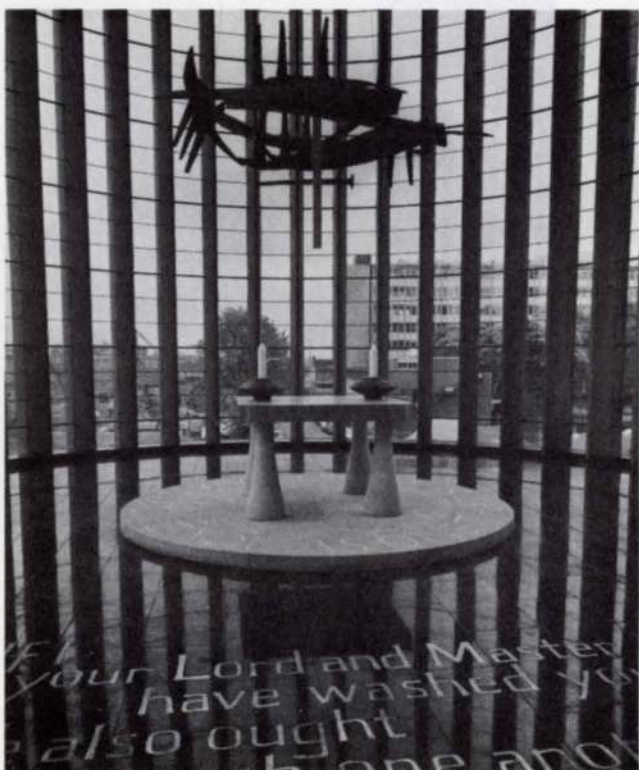
Fig. 2 below
Interior view of the Guild Chapel at Coventry Cathedral, showing the slender mullions. (Photo: John Laing & Son Ltd.)

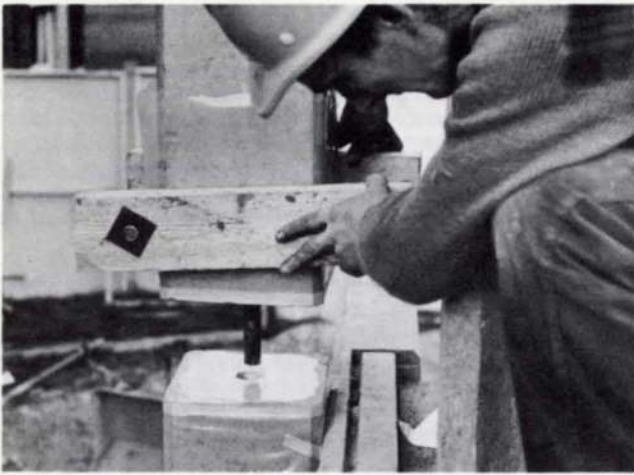
Fig. 8
Forming the joint between precast columns at Somerville College, Oxford University, Phase III. (Photo: Oliver Spence.)

The use of an in situ joint similar to the beam-to-column joint would have reduced the speed of erection, and as a self-supporting and aligning method was preferable, it was decided to use an epoxy joint. The column sections being dowelled together, it was only necessary for the epoxy joint to transfer compressive stresses. These are normally 1100 lbf/sq. in. with maximum value of 1400 lbf/sq. in. As the final finish was to be equivalent to an in situ bush-hammered surface, the epoxy joint had to be of minimum thickness. This requirement did not allow for any joint tolerance to be taken up by packing and shimming. To overcome this problem the column was cast in a 3 storey height mould with $\frac{1}{4}$ in. mild steel dividing plates at each joint. This gave smooth matching faces for glueing. The only problem during glueing was the clamping of the column sections. The resin acted as an efficient lubricant until set. CIBA's *Araldite 123B* with Hardener HV 953B was used and the result was reasonably satisfactory. A similar solution has been adopted on the phase III building at Somerville. The column-to-column joints have a dowel connector, and speed of erection was an important consideration. The adhesive used was *Nitoflor Jointing Compound* from Chemical Building Products Ltd., a material based on CIBA *Araldite* resins. This type of joint will be used again for the joints between the precast H-frame units of the Marist Technical High School, Manchester (Architects: Burles, Newton & Partners.)

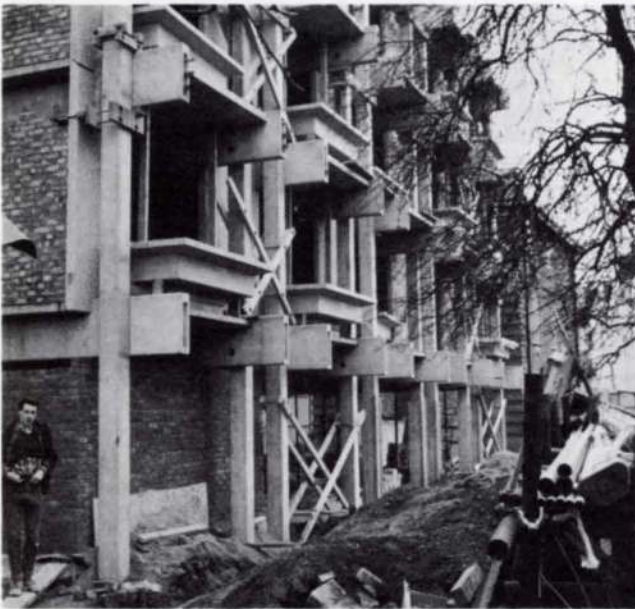
Fig. 9
View of the frame of the Phase III building at Somerville College, Oxford University. (Photo: Oliver Spence)

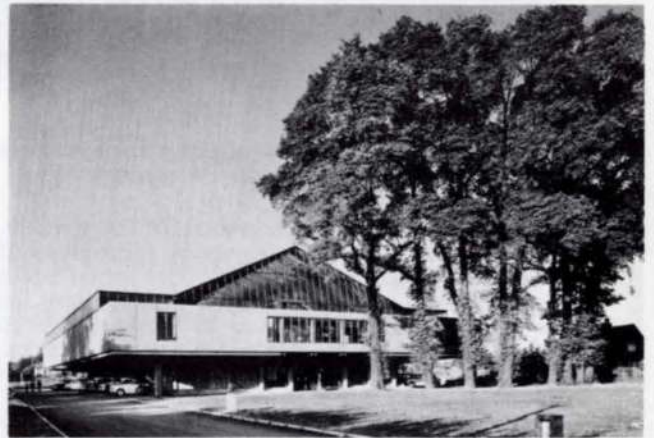
Fig. 11
Swimming Pool, Walton-upon-Thames, showing the twin beams which are bolted to the columns with glued interfaces. (Photo: Colin Westwood)

This building also incorporates bolted beam to column joints. In this case twin beams are bolted with stainless steel bolts to the columns. The contact faces were treated with an epoxy resin adhesive to give improved stress distribution. In this case there are no nibs supporting the beams and the adhesive acts in shear. The adhesive used was *Colma-Fix* from Sika Ltd. and the nominal glue-line thickness was $\frac{1}{4}$ in.

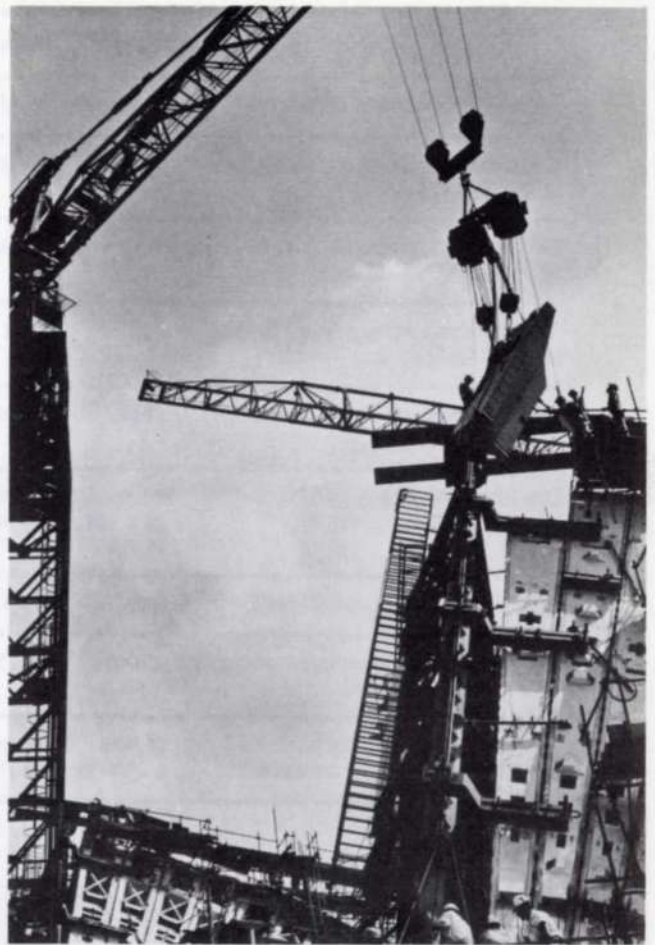
Fig. 16
Lifting a rib segment into position.
(Photo: Max Dupain)

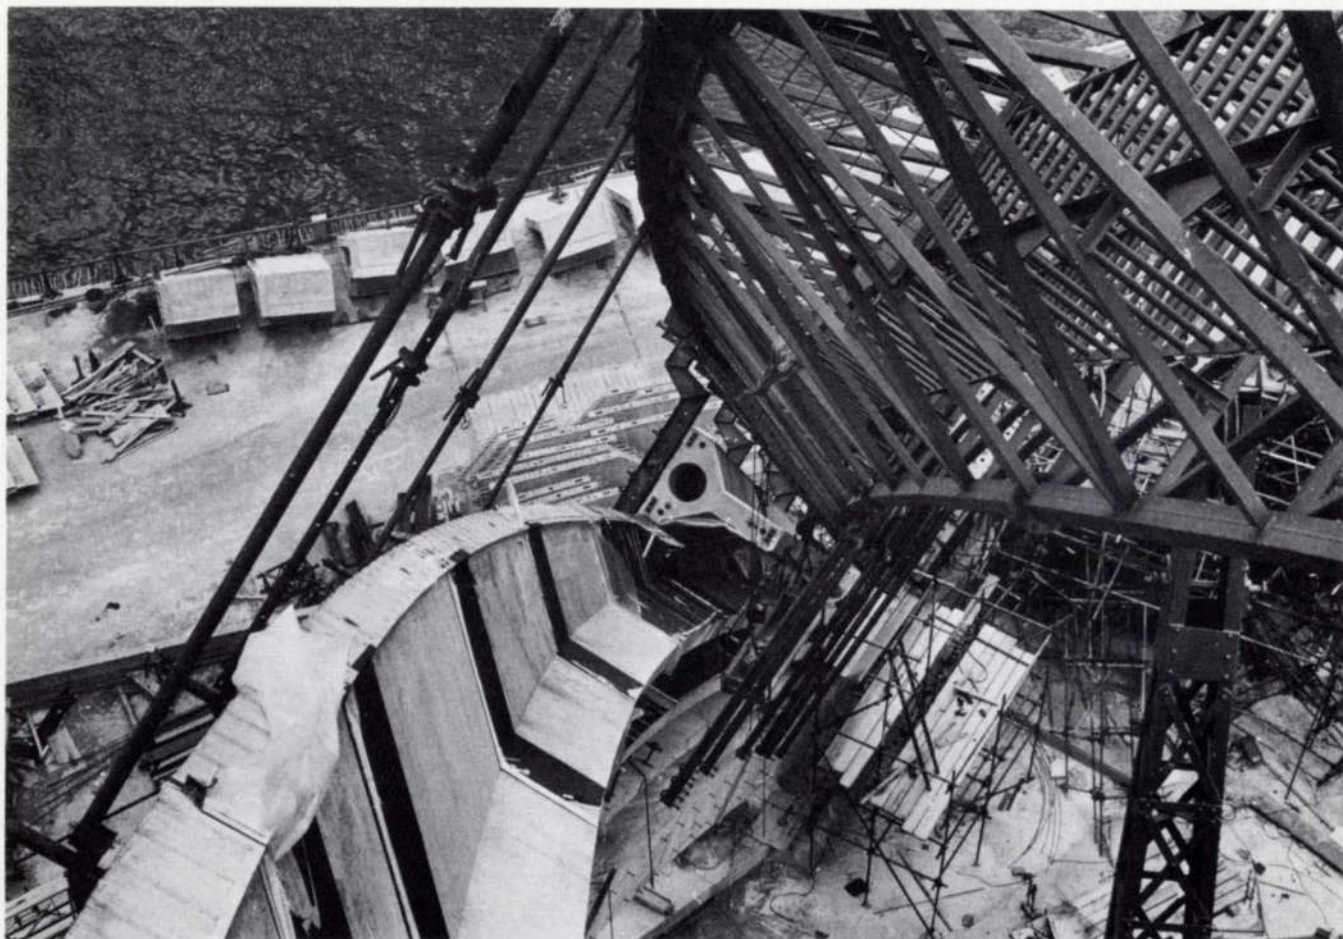
Fig. 17
View down a rib under construction.
(Photo: G. Wood)

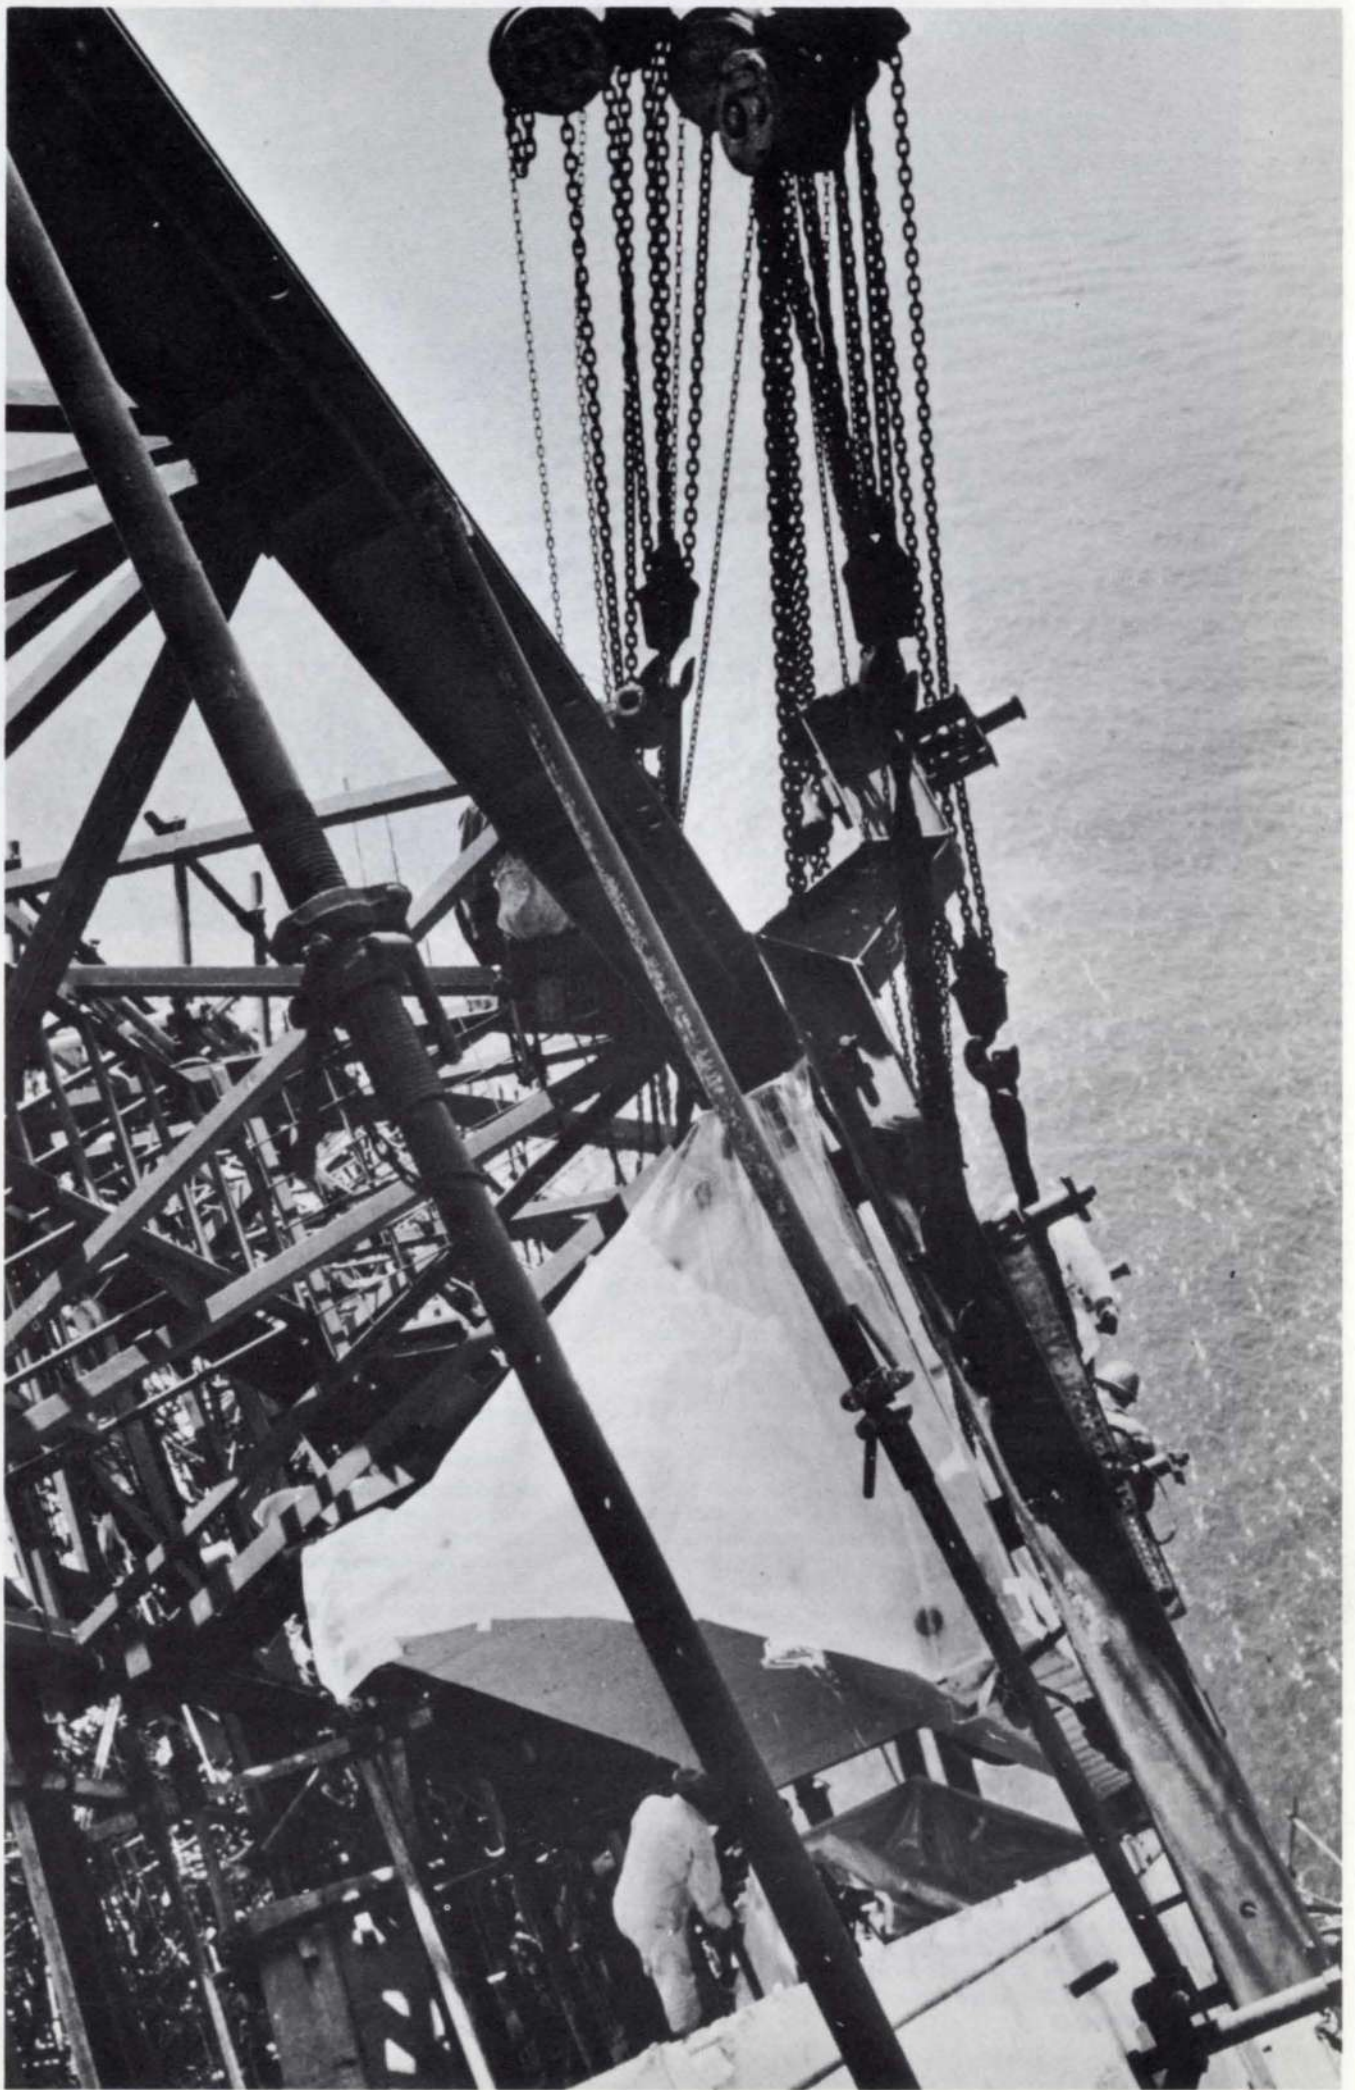
*Fig. 18 left
Holding a rib segment in place while glueing is carried out. (Photo: Max Dupain)*
