THE ARUP JOURNAL

Vol.20 No.3 Autumn 1985
Published by
Ove Arup Partnership
13 Fitzroy Street, London W1P 6BQ

Strengthening techniques

Poul Beckmann

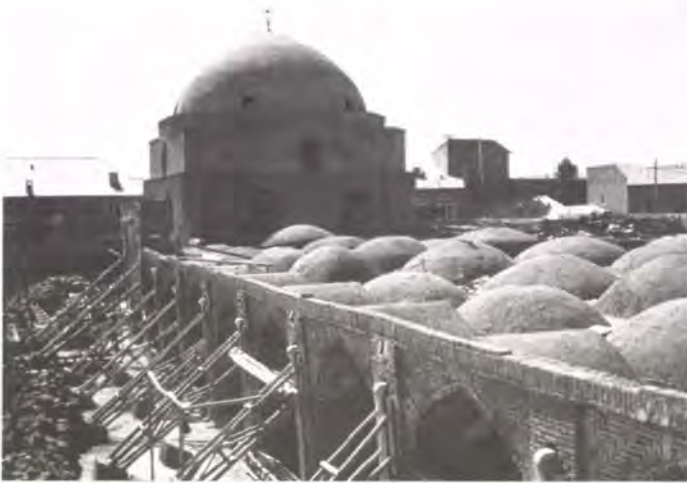
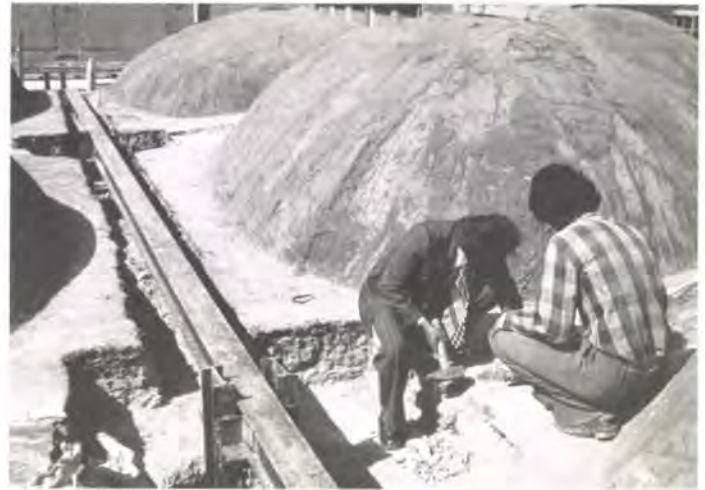
Fig. 3
Koran School in Rezaiyeh:
view from adjacent roof

Fig. 4
Koran School: new tie in the roof

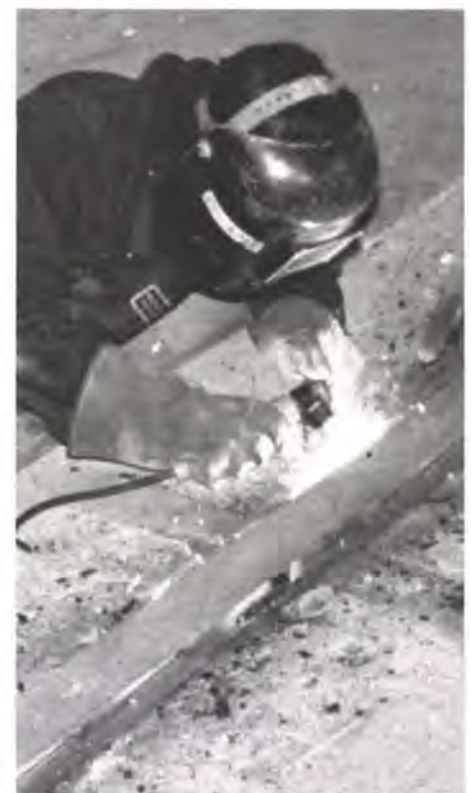
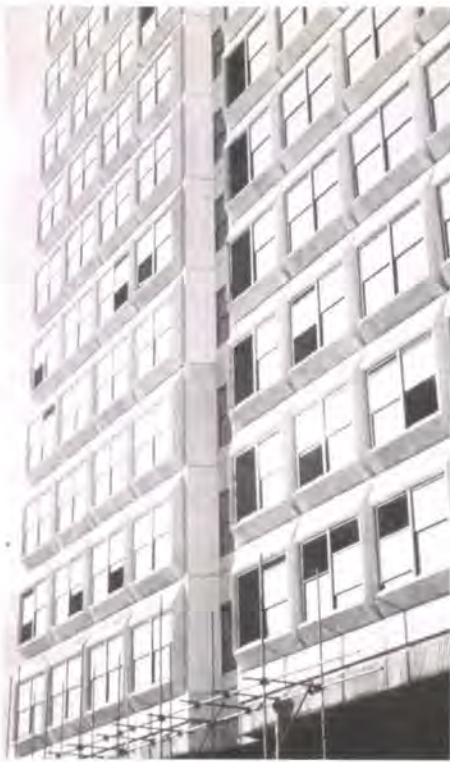
Fig. 9
Office block with loadbearing facade elements of precast concrete
(Photo: Poul Beckmann)

An example of such a by-pass structure was provided by an office block with 13 storeys of precast concrete loadbearing facade panels supported off a transfer structure at 1st floor level. The horizontal joints between the panels had been badly executed and, as a result, the loadbearing mullion parts of the panels on the lower

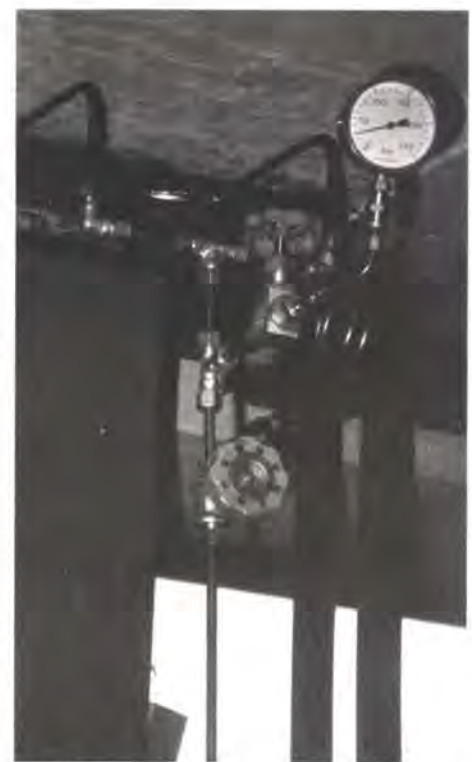
Fig. 11
Close-up of flat-jack arrangement at top of relieving stanchion
(Photo: Poul Beckmann)

floors began to split badly when construction had reached the 12th floor. As reinforcement loops from the panels interlaced with the bars in the in situ floor slabs, panel replacement was considered impractical. Structural steel stanchions were therefore inserted immediately behind the mullions and to avoid further, delayed, cracking of the concrete as the steel stanchions were gradually taking up their load, they were pre-loaded by means of flatjacks. As the floor slabs were incapable of sustaining the punching shear from the stanchions carrying 12 storeys, the stanchions on any one vertical line had to be pre-loaded simultaneously, and to avoid excessive distortion and hence cracking of the facade panels as they were relieved of their load, the stanchions adjacent to those being fully pre-loaded were partially pre-loaded at the same time!

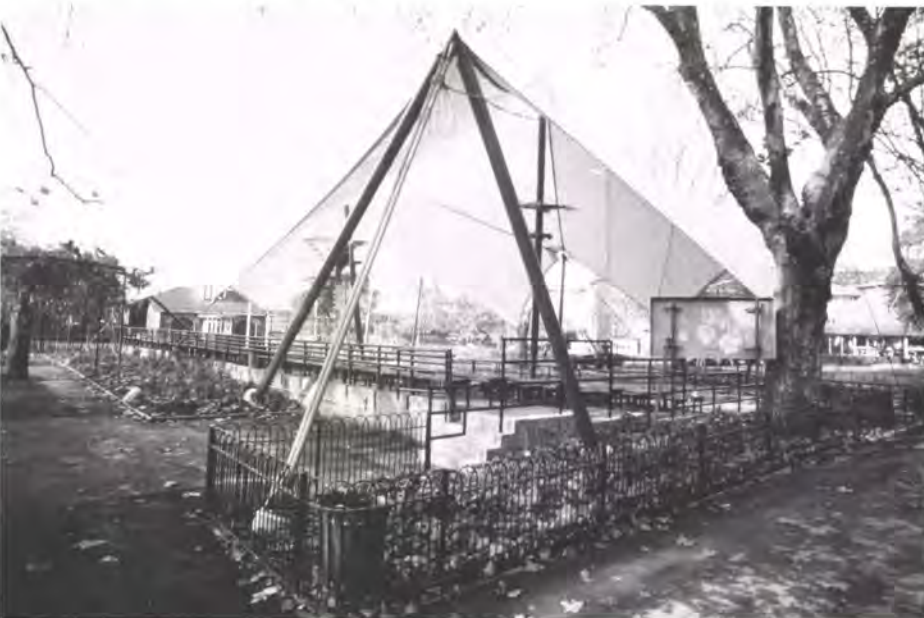
Fig. 7 London Zoo: PTFE coated glass canopy over Hummingbird Amphitheatre

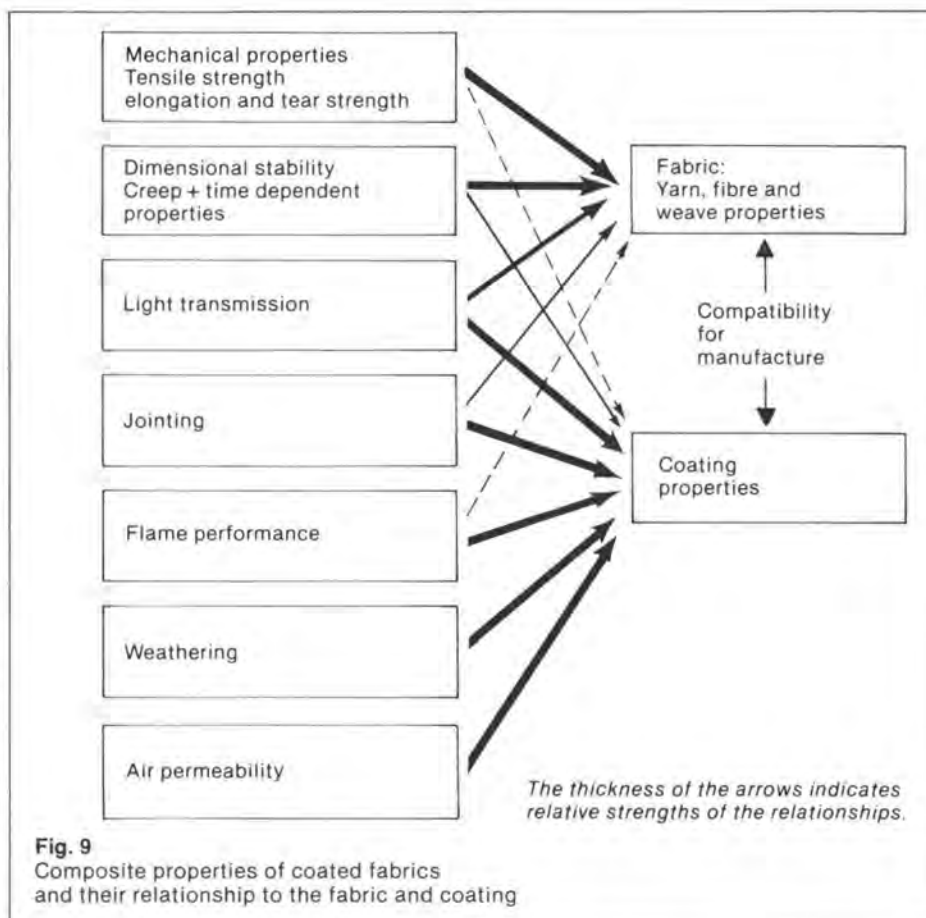
Fig. 9 Composite properties of coated fabrics and their relationship to the fabric and coating

The thickness of the arrows indicates relative strengths of the relationships.

The general properties that are important in a building application are listed in Fig. 9 which also shows the relative dependence

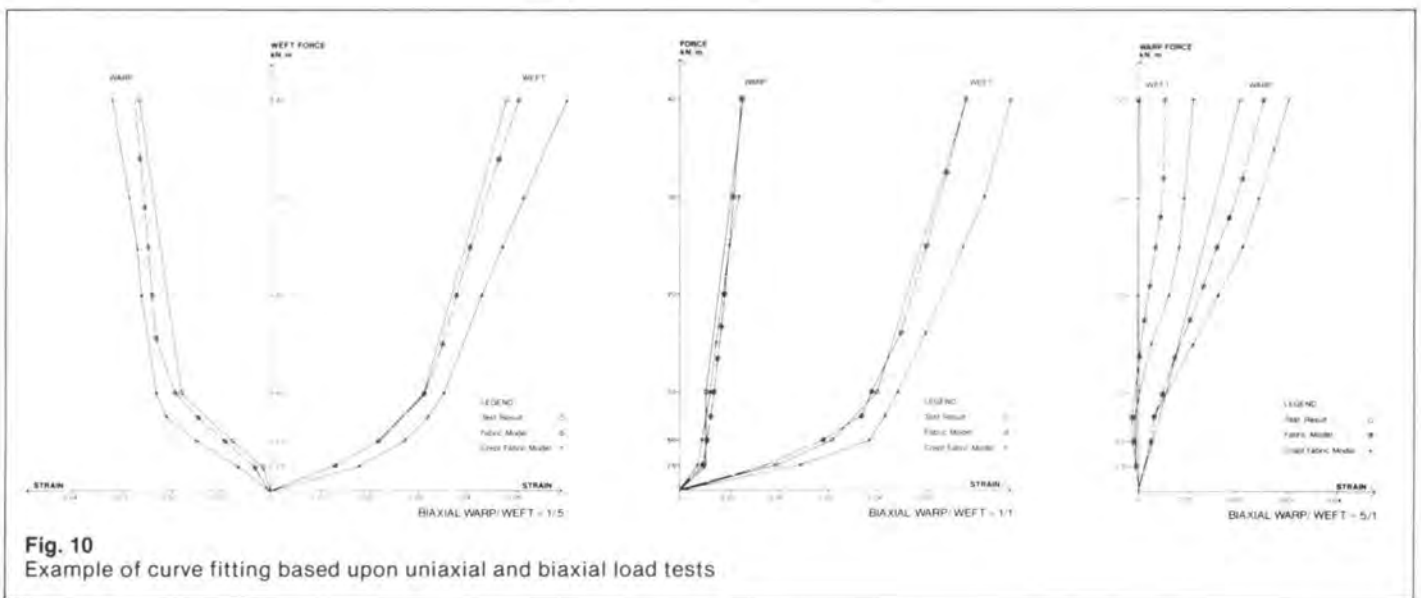
Fig. 10
Example of curve fitting based upon uniaxial and biaxial load tests

these displacements. On this basis the construction method can be developed. The computer's numerical model must cope with the non-linear, anisotropic, and creep characteristics of coated fabrics. Fig. 10 shows an example of curve fitting based upon uniaxial and biaxial load tests.
