THE ARUP JOURNAL

JUNE 1972

Structural analysis and recording of ancient buildings

Poul Beckmann

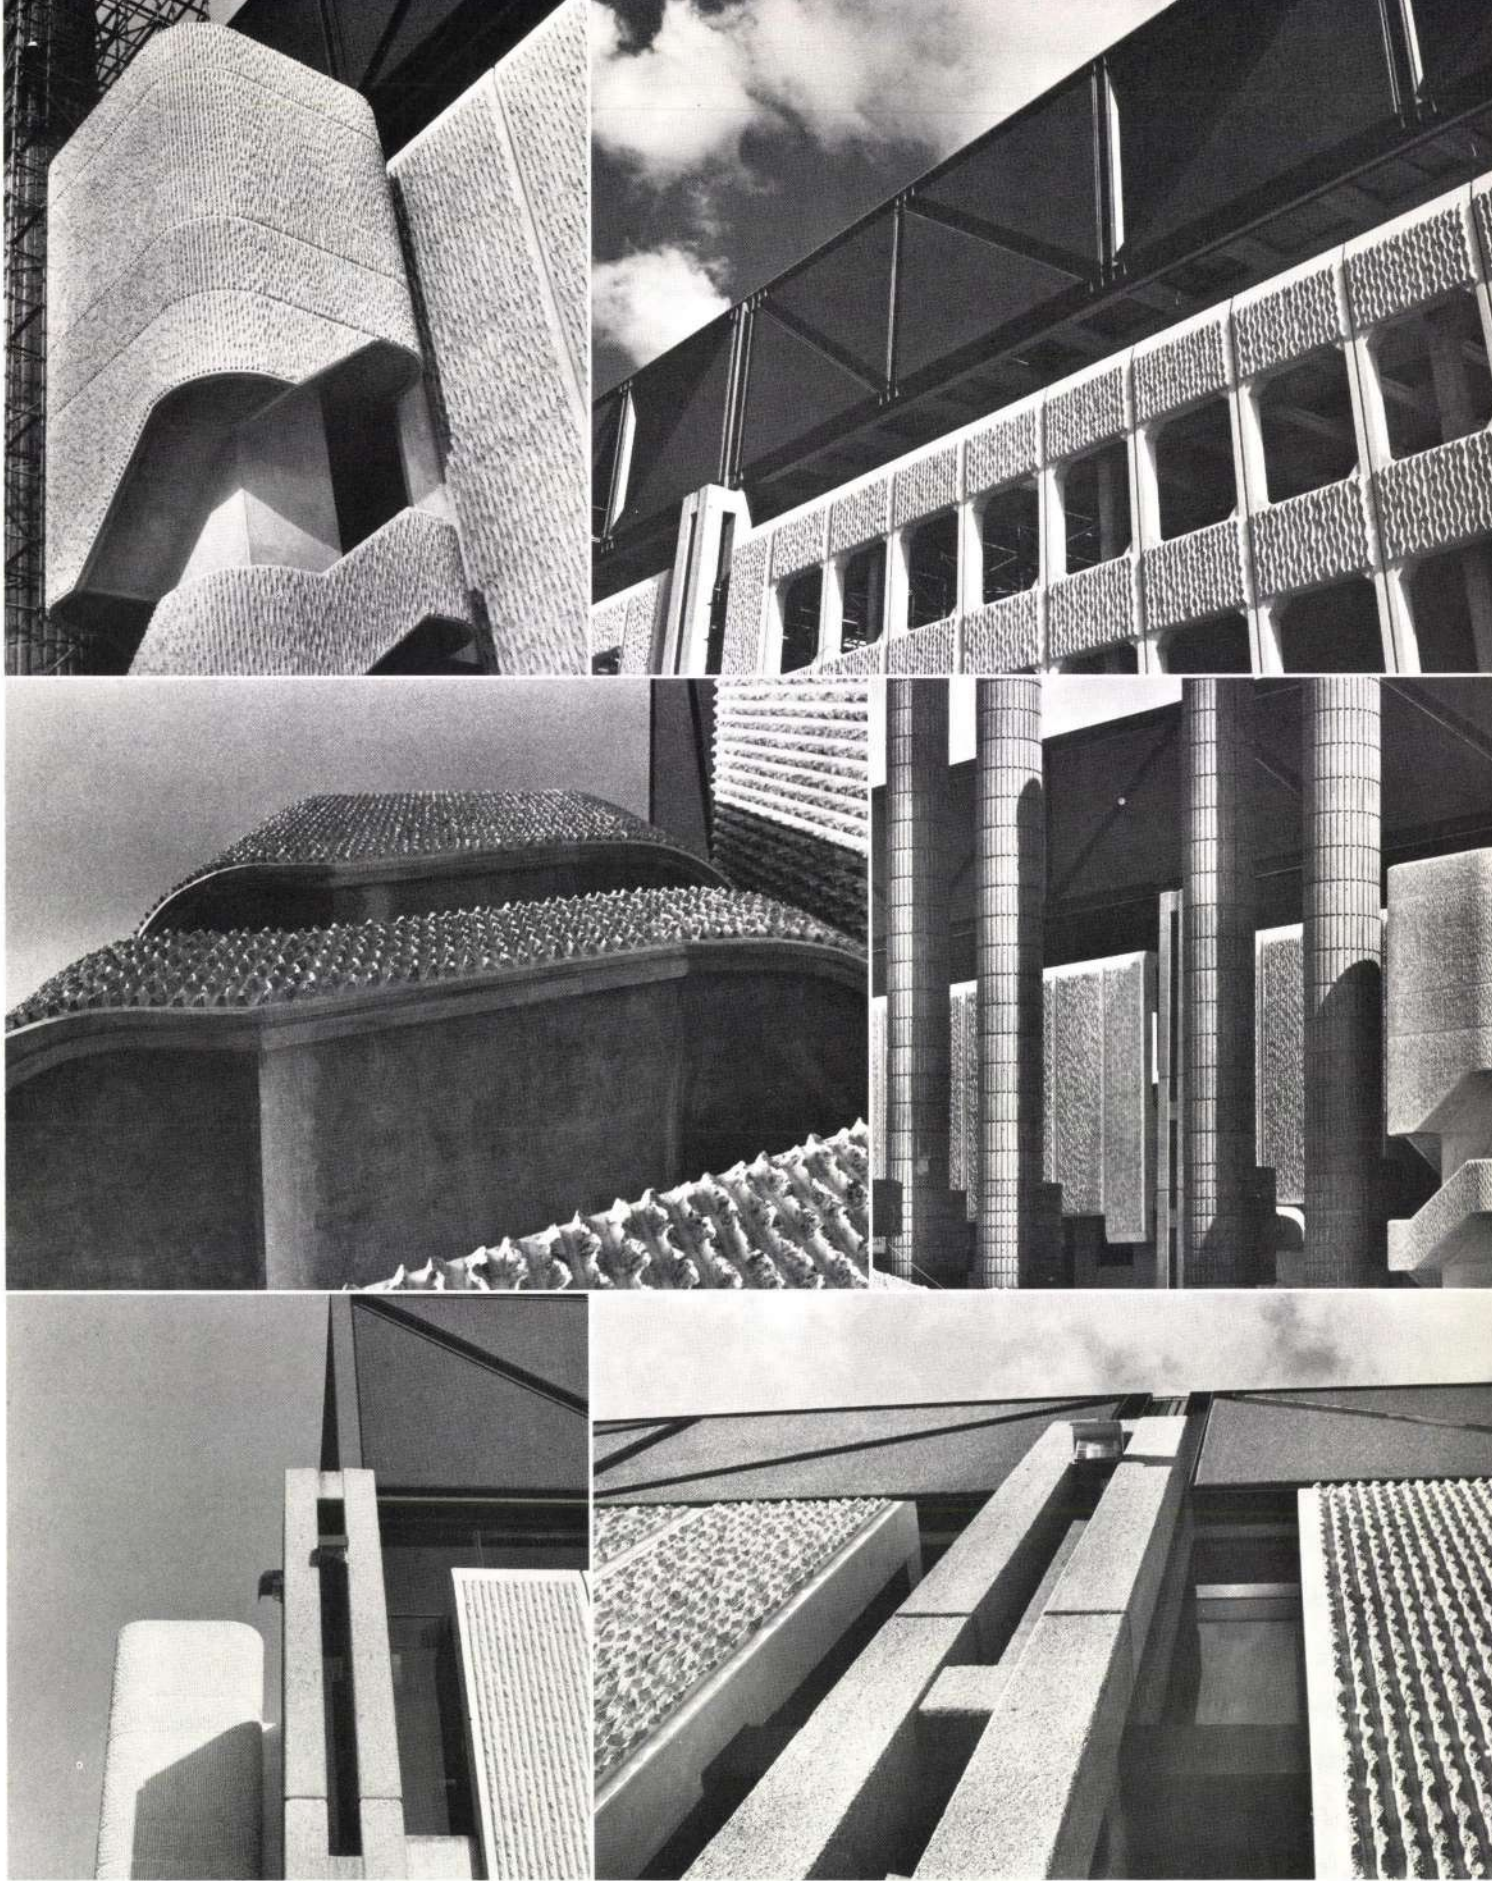
Textures and scale (the projecting ribs on the stairs are 40 mm x 35 mm, and on the cladding panels 85 mm x 80 mm)

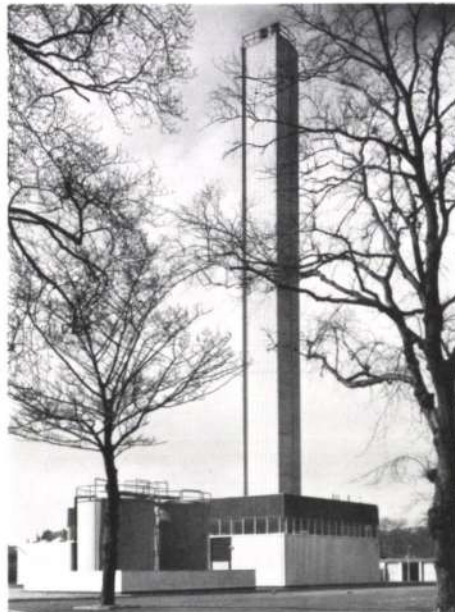
Fig. 7 left
Boiler and chimney (Photo: W. Ralston Ltd.)

The boiler plant is situated to the south of the ward block, and to avoid enveloping the wards in smoke, the chimney rises to a height of 64.5 m. It serves three boilers and there is space for three boiler flues, one incinerator flue and two future additions. (See Fig. 5).

The structural shell of the chimney is I-section in plan. Two walls and the spine are of structural concrete, and the other two are *Galbestos* cladding. The chimney is founded on a slab bearing directly onto rock.

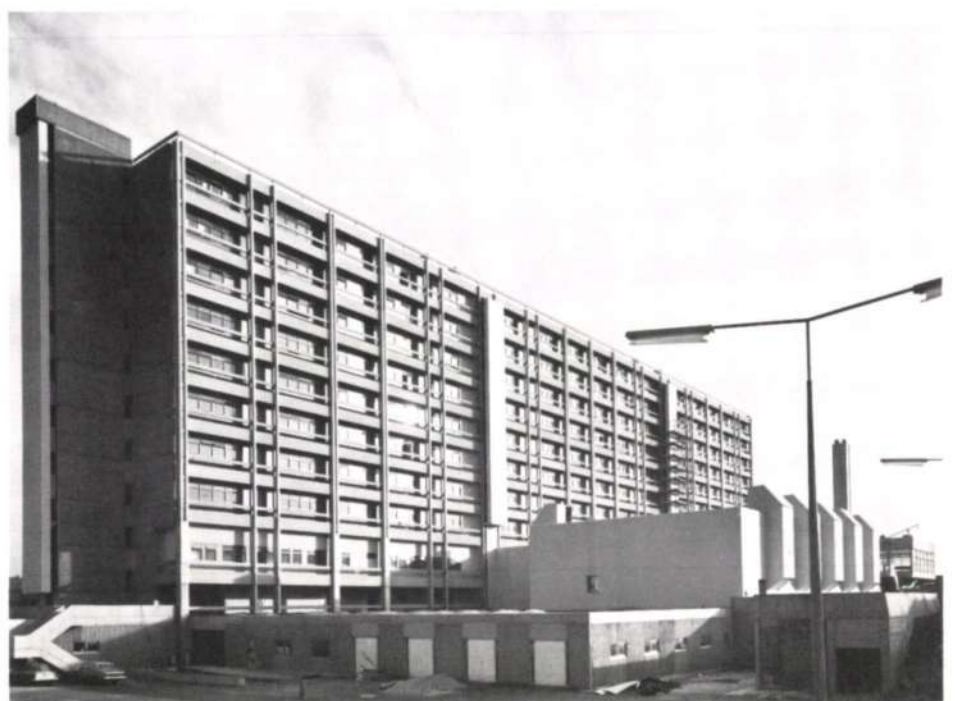
Fig. 8 below
West elevation of main hospital block
(Photo: W. Ralston Ltd.)

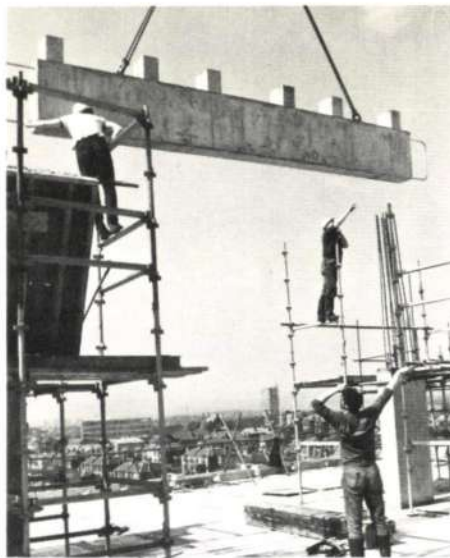
Fig. 9
Erection of precast spine beam
(Photo: Keppie Henderson & Partners)

Three lines of columns carry the floors. The outer two lines positioned outside the cladding, are of precast concrete, but the inner line, known as the spine columns, is in situ. They are at centres varying from 6.7m to 7.13m and carry a heavy precast spine beam in simply-supported sections running the full length of the building.

The spine beam carries precast ribs which span transversely to the external edge beams. The latter in turn are supported on the outer lines of precast columns mentioned above. The floor ribs are bridged by shallow slabs, and these complete the precast structure. (See Fig. 3).

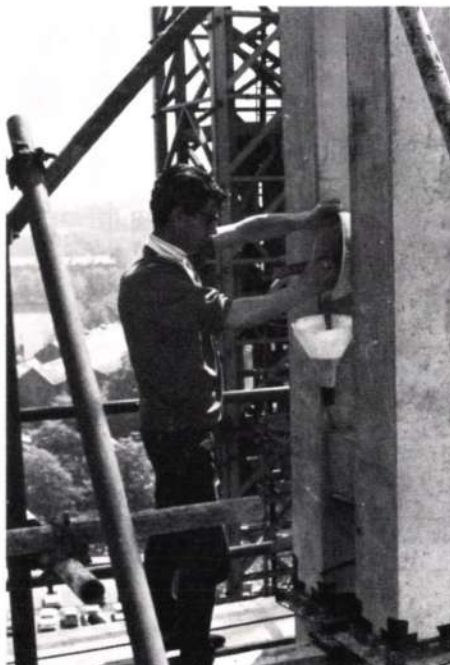
Fig. 11
Operative pouring *Certite* column joint
(Photo: Keppie Henderson & Partners)

The material finally chosen was pourable *Certite* grout in a mixture specially prepared for us by the manufacturers, SBD Construction Products Ltd., of Rickmansworth. This grout consists of a polyester resin, hardener and filler in the proportion of 1.15:1:1 by volume. The columns to be jointed were 250mm x 250mm in plan, in groups of two and four. (See Fig. 4). The material was poured from the top at A, and air was allowed to escape at B. When the grout appeared at B the hole was plugged and the reinforcing bar was finally grouted to the entrance at A.

Tests of mixing and pouring the *Certite* were carried out beforehand in a deep freeze with the object of studying joint construction under cold weather conditions. Cubes were cured at temperatures of -5°C and strengths of 105 N/mm^2 at five days were obtained.
