THE ARUP JOURNAL

OCTOBER 1982

Swire Bottlers redevelopment, Tsuen Wan

Earthquake damage and repairs to historic buildings in Montenegro

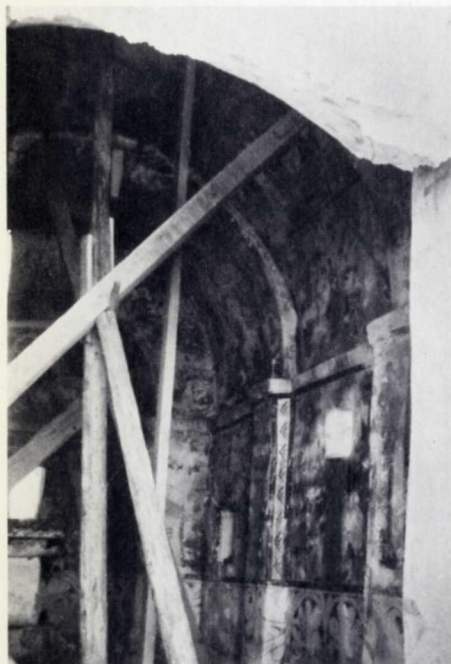
Fig. 1
The upper chapel at Praskvica

We were then taken on another drive of great scenic beauty to Budva, stopping on the way to inspect two damaged churches at Praskvica. One was only lightly cracked; the other, only 30m away up the hillside was in a state of partial collapse: stripping of the frescoes and reinstatement after rebuilding of the vault seemed the only remedy.

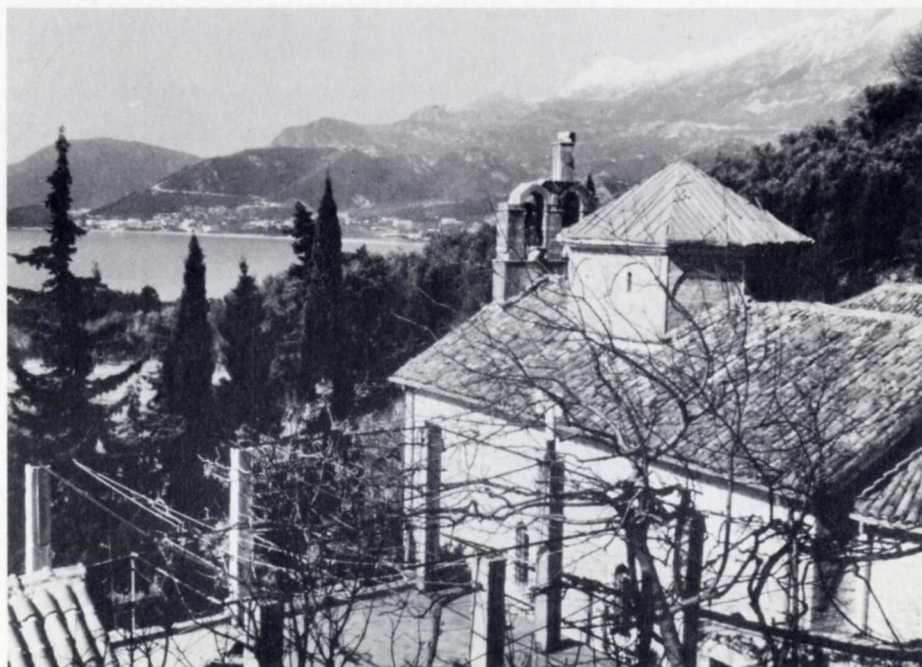
Fig. 2
The lower chapel at Praskvica

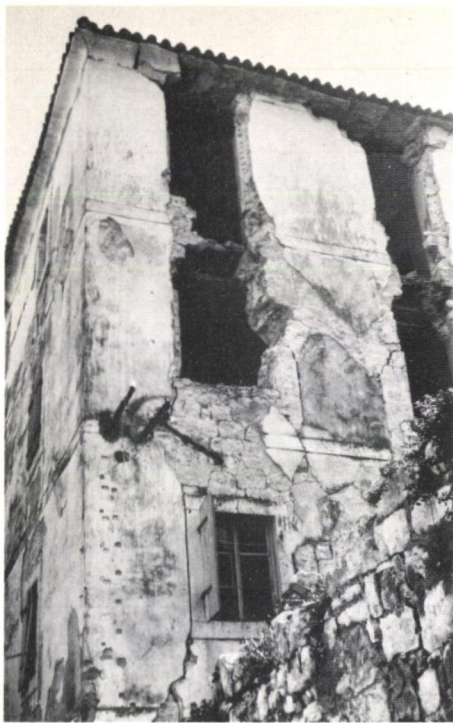
Fig. 3
House in Budva with characteristic pattern of damage

In Budva we had observed that the damage was far more severe in general. It was, however, of similar pattern to that found in

corner of window surround and sometimes here the thin undersill masonry panels had fallen out completely. In one house the whole front had fallen out between the windows nearest to the (still largely intact) corners. Here we could see that the floor timbers were spanning parallel to the front and therefore had not provided any tying in of the fallen wall. We also found a wall which had been fractured down to ground level and we could see that the mortar in the core of this masonry was brown in colour and of an earth-like crumbly consistency significantly different from the hard mortar in Kotor. In Kotor itself as well as in the villages along the road from Tivat to Kotor we found many instances where a nearly intact house would be standing immediately adjacent to a very severely damaged one and, whilst in some instances the differences could be ascribed to early repairs being undertaken by private initiative, this was not always so.

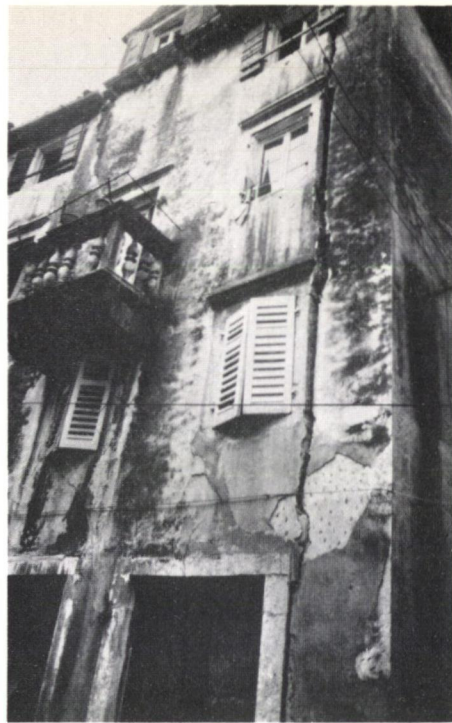
Fig. 4
Kotor: crack following straight joint between stone window surround and corner masonry

In the city centre the most widespread earthquake damage was seen to be nearly vertical cracks associated with the window openings. In most cases these would join the outer corners of the stone window surrounds and would continue along the butt-joints between these and the rest of the masonry.

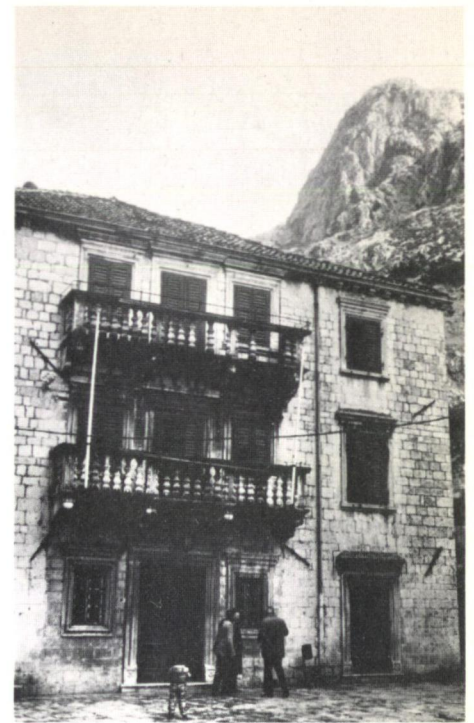
Fig. 5
Kotor: Maritime Museum Building, note tie rod anchors

The project for the museum building had included tie-rods of *Dywidag* bars in plastic sleeves along and across the walls. The drawings appeared to show the tie-rods below the ceilings. We thought that if these tie-rods were supposed to be temporary (which was not clear from the drawings, despite their detail) they would seem to be hardly necessary in view of the sound condition of the museum building; If, however, they were intended to be permanent we considered that they should have been placed in the reinforced concrete slabs shown on the drawings.

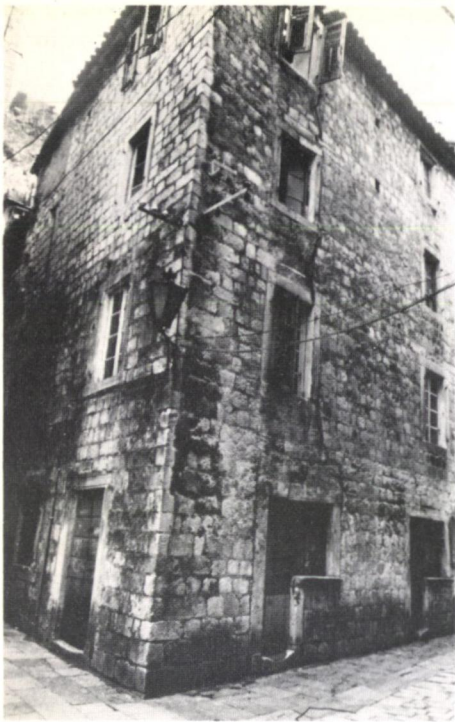
Fig. 6
Typical example of
minor damage at Kotor

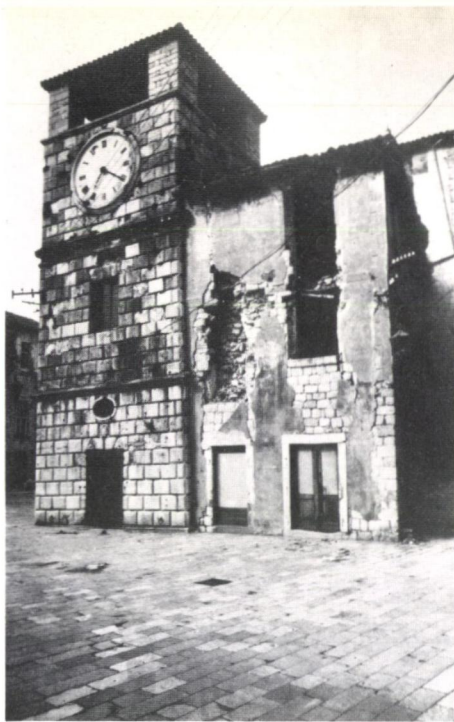
Fig. 7
Kotor: Clock tower nearly intact
adjoining building badly damaged

The striking difference in the damage sustained by buildings adjacent to each other suggested that the conditions of the soil strata under the foundation would in this case be less significant than the quality and integrity of the original construction. The sediments under the main part of the town would in theory be considered to predispose to greater damage from earthquakes but it was difficult to see how this could account for one building standing practically undamaged and an adjoining building having suffered very greatly indeed.
