THE ARUP JOURNAL

The Island Site, Addiscombe Road, Croydon, Surrey, by T. Henry and P. Ryalls	2
The design and construction of Sheffield University Concourse, by K. Ranawake, R. Gordon and K. Tune	11
Preston Bus Station and Car Park, by R. Stephenson	19
Rooms for students, by T. Sturgis	27

The Island Site, Addiscombe Road, Croydon, Surrey

Tom Henry and
Peter Ryalls

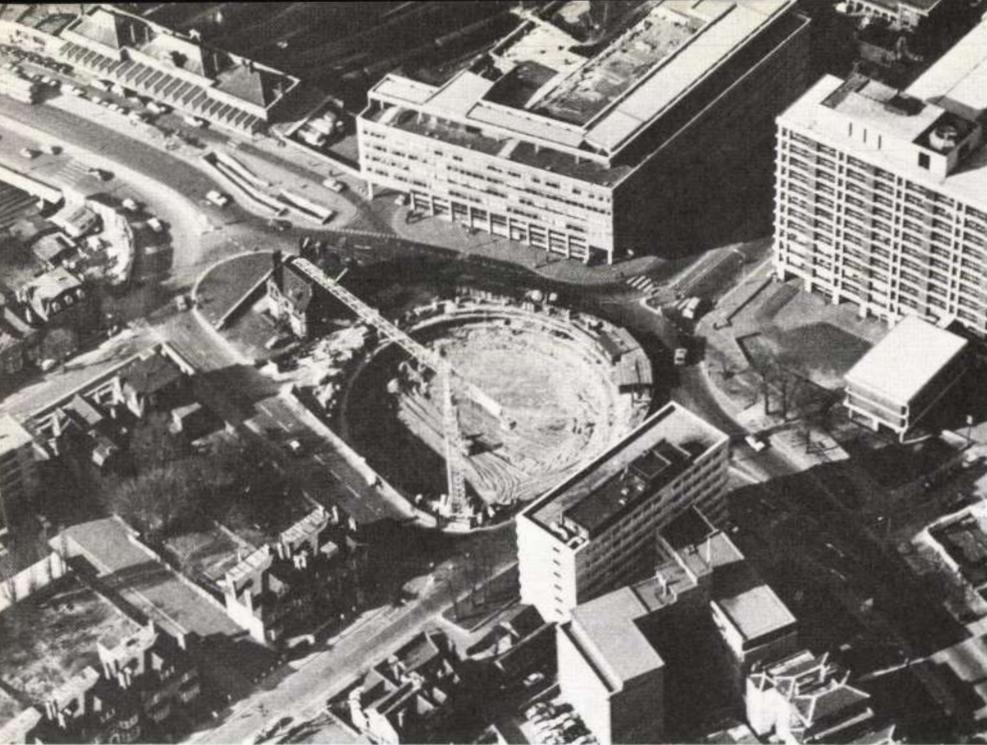
Fig. 1
Aerial view of the site
during excavations.
(Photo : Handford Photography)

The development is situated on a triangular-shaped traffic island, (Fig. 1) bounded on all three sides by a one-way, high density traffic system. There is a road junction at each corner of the triangle. It is connected by three pedestrian subways to both the railway station and adjacent office developments, thus eliminating the need for pedestrians to cross the roads at ground level.

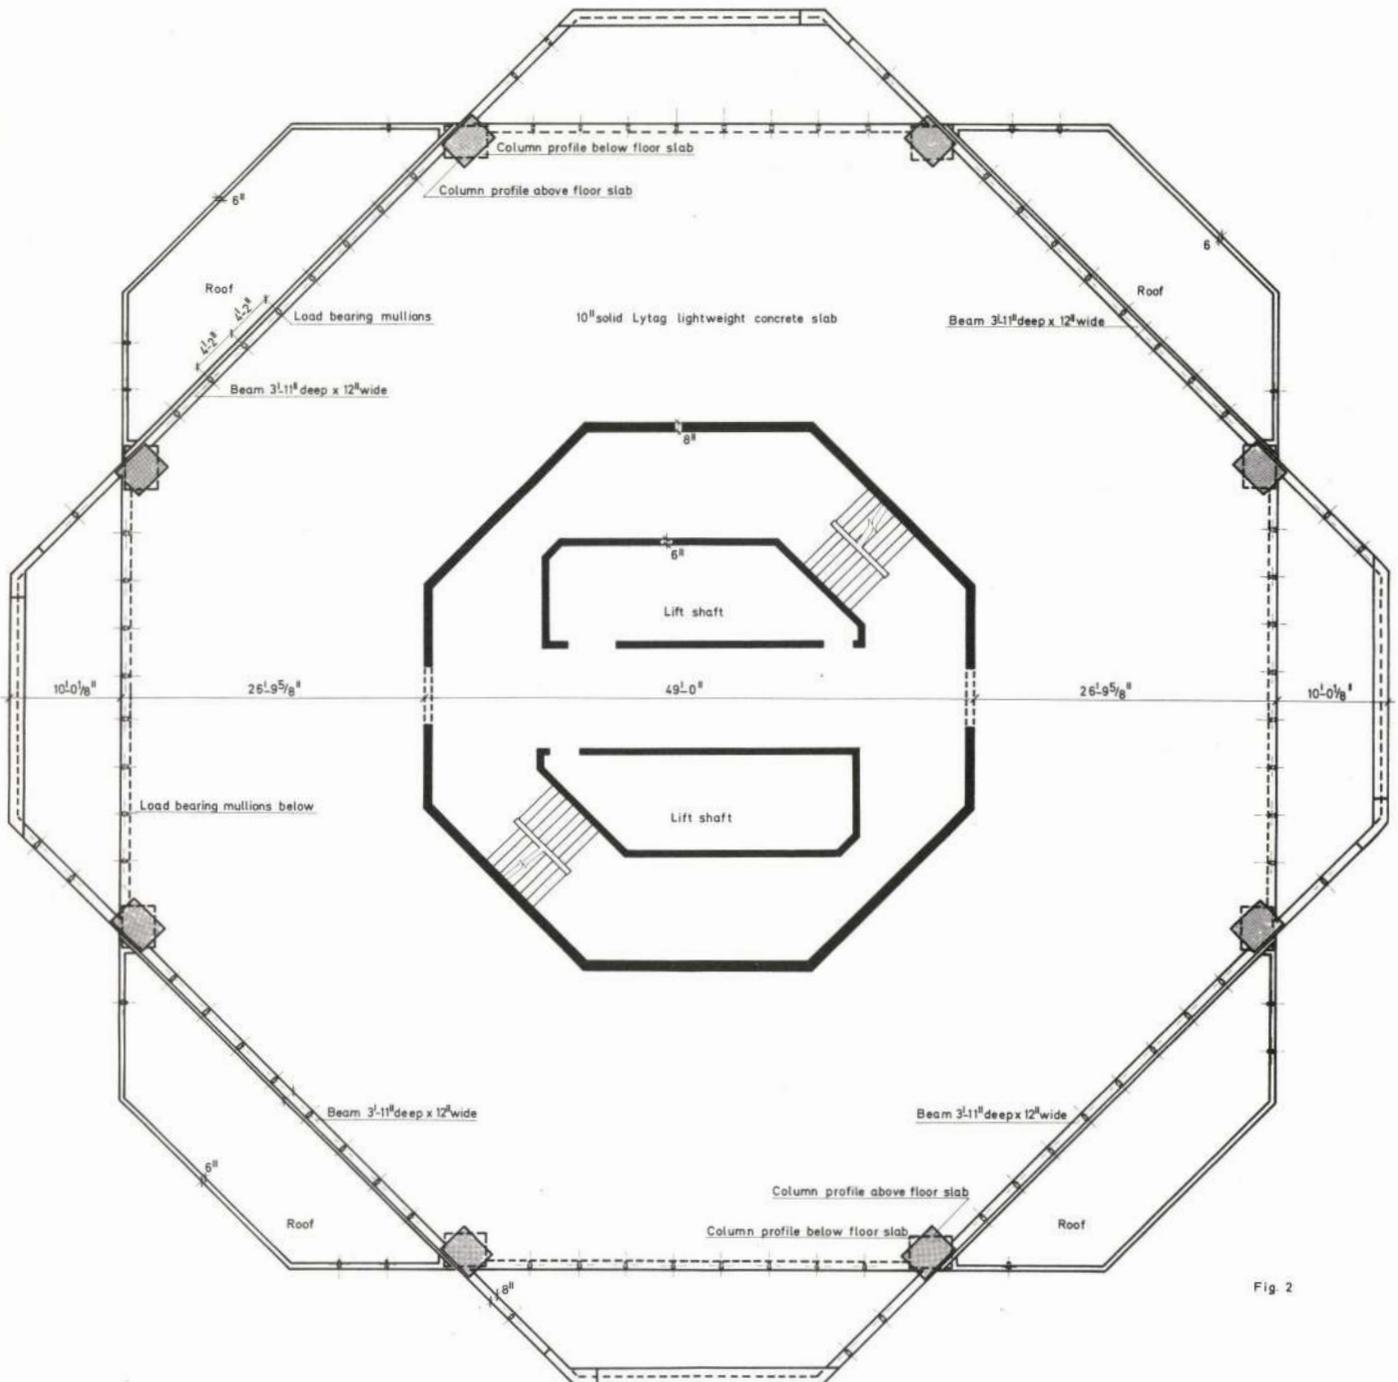
Fig. 2 below
Typical floor plan.

Above ground, the building is unusual in plan (Fig. 2), the perimeter being a twenty-four sided figure formed by superimposing two squares above each other, one square rotated at 45° with respect to the other, and then cutting the corners off each square to form two unequal sided octagons superimposed on each other. (In the initial schemes the corners were not cut off.)

There are 20 typical floors (Fig. 2) and each is a 10 in. (250 mm) solid flat slab disc of lightweight *Lytag* concrete supported at the centre by the service core walls, and at the outer edge by four perimeter beams formed of dense concrete and four rows of load bearing mullions at 4 ft. 2 in. (1.27 m) centre to centre.

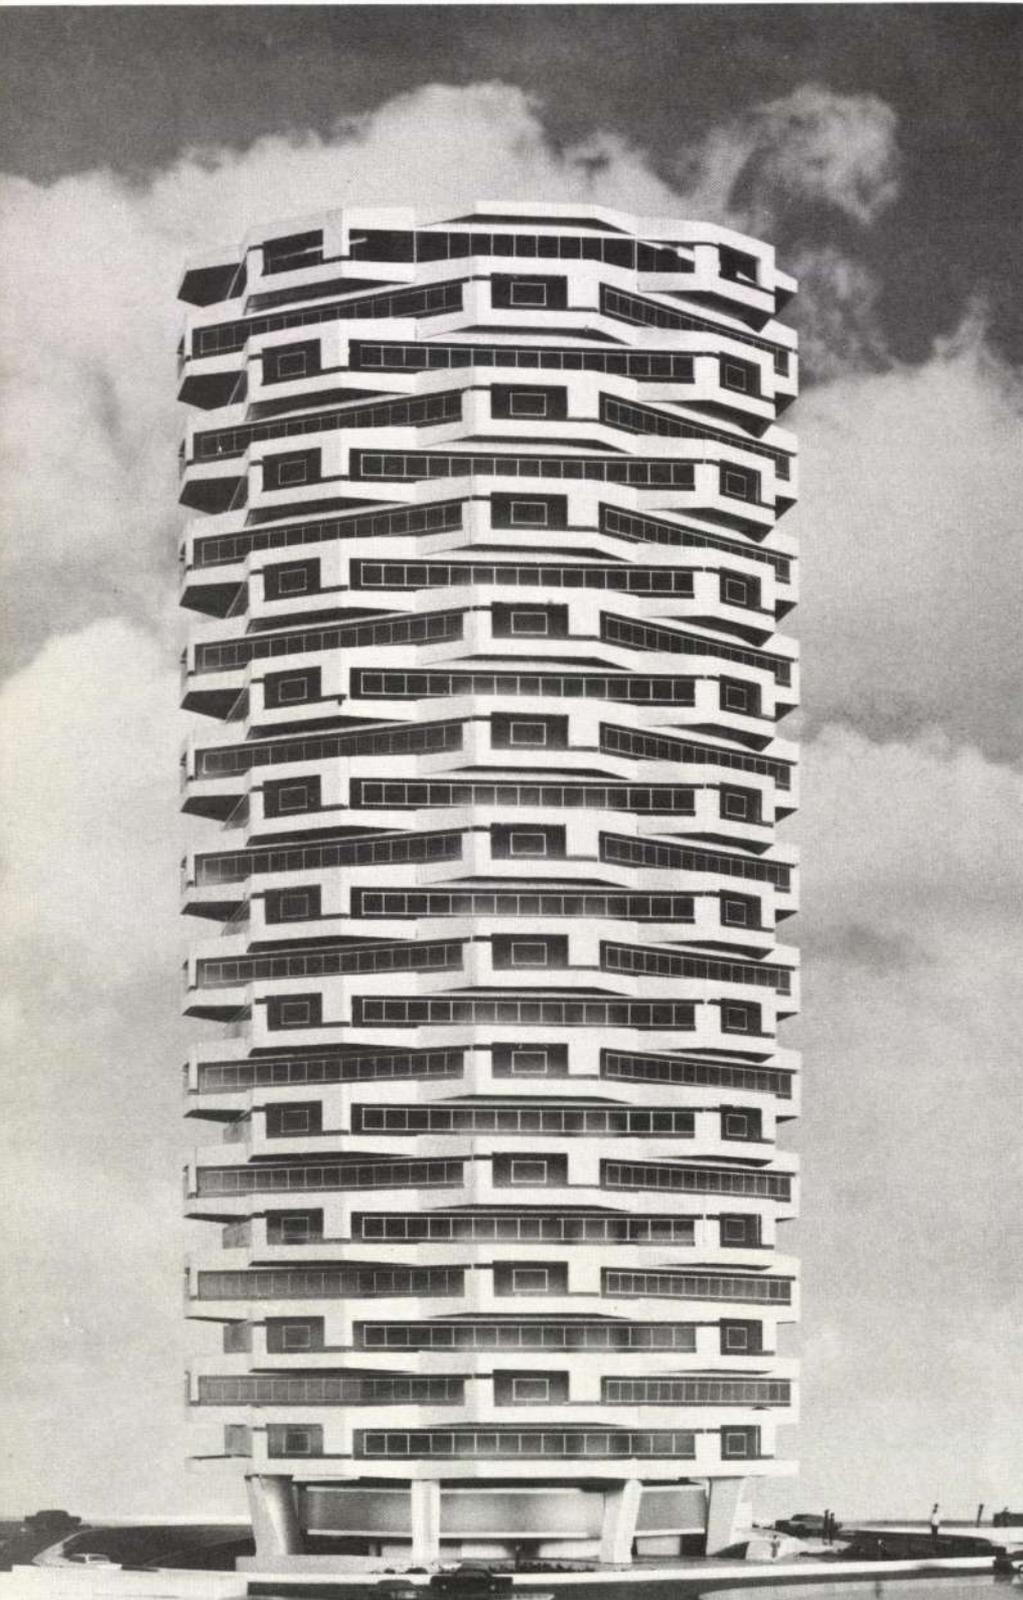
Fig. 3
Architectural model of the development.
(Photo: Fox Photos Ltd.)
Reproduced by permission of R. Seifert and Partners.

The effect of rotating the floors and providing balconies is to produce a building which externally gives the impression of being circular with bold projecting facets, rather like a very knobbly pineapple (Fig. 3), but which has the great advantage of having office floor plans which are almost square. The balconies provide the further advantage of shielding the windows by an 11 ft. (3.4 m) overhang and also serve to collect rainwater at each level and thus eliminate the problem of progressively larger quantities of rainwater passing down the face of the building to be collected somehow before ground level is reached. This problem is not always dealt with adequately at the design stage.

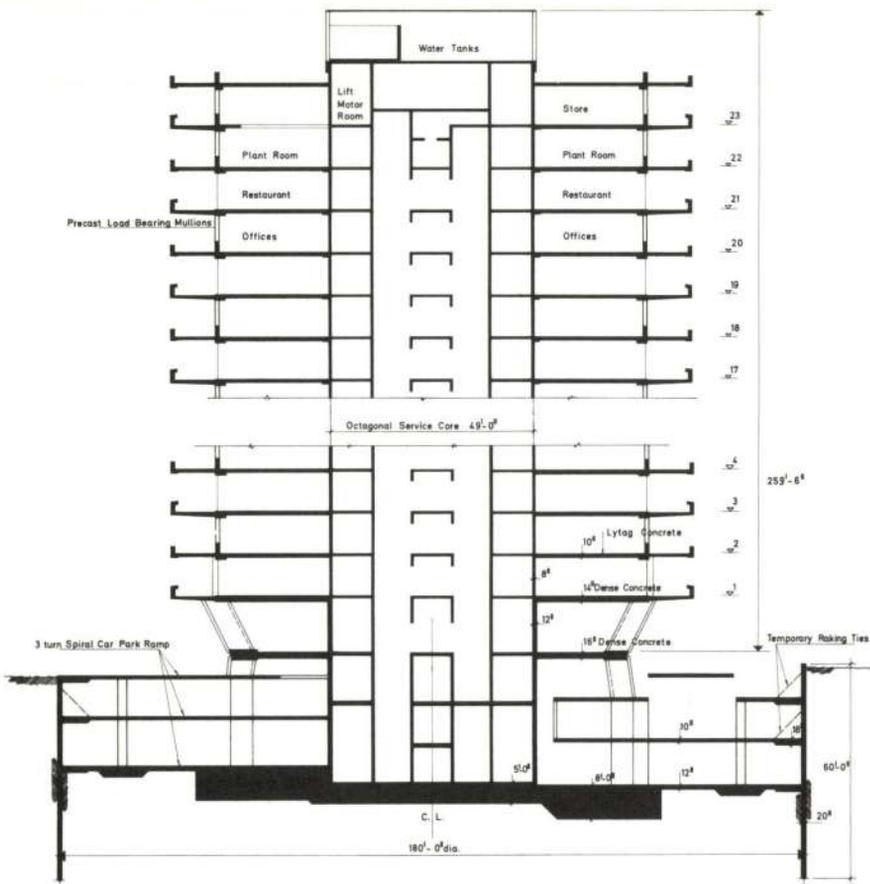
Fig. 4 left
Vertical section through the building.

Between ground and first floors the architects have boldly expressed the vertical structure, a characteristic for which they are well known (Fig. 4). The glazing line is withdrawn inside the line of eight perimeter columns, the plan shape varies, and, in radial elevation, the columns slope slightly towards the centre of the building between lower ground floor and ground floor and then sharply away from the vertical between ground and first floors.

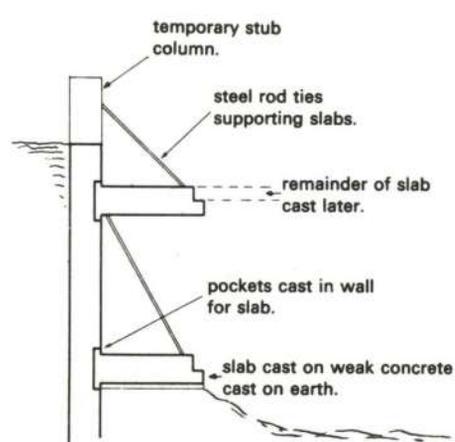
Fig. 5 below
Construction of helical stiffening ring.

201.00 to level 175.00 at a slope of 1:48, and, at any given section, provides three horizontal supports to the wall at 9 ft. (2.74 m) centres vertically (Fig. 5).

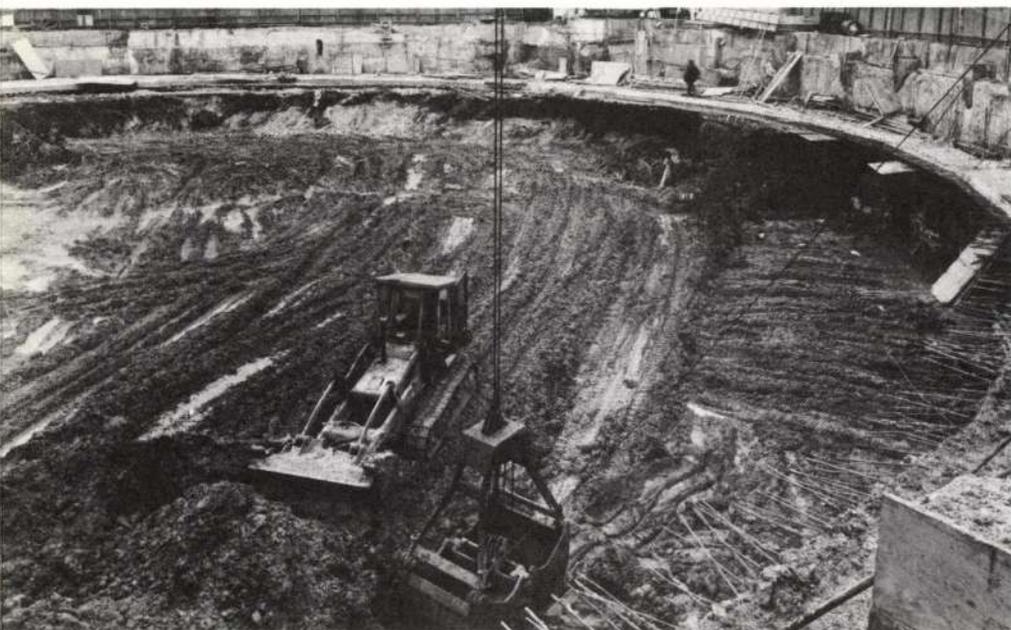
Fig. 6
Excavation of car park showing stiffening ring (cast on ground) supported by raking ties. Excavation was entirely by mechanical equipment with complete elimination of any temporary propping. (Photo: E. J. Studios). Reproduced by courtesy of Taylor Woodrow Construction Ltd., who are the main contractors.

The stiffening ring was cast in situ using the unexcavated ground as propping for plywood sheets laid on the ground (Fig. 6). Concrete was then placed on the plywood and into rebates in the diaphragm wall. These were formed by attaching polystyrene blocks 2 ft. x 3 in. (610 mm x 75 mm) to the reinforcement cages of the diaphragm wall before they were lowered into position through the bentonite.

The horizontal stiffening ring was itself supported by temporary raking ties of 1½ in. (28 mm) diameter mild steel every 15 ft. (4.6 m) approximately. The upper end of each raking tie was hooked through a hole and cast a bond length in a rebate left in the ring immediately above that which was to be cast and adjacent to the diaphragm wall. The holes and rebate were then filled with concrete. The lower end of the tie was set at the inner edge of the stiffening ring, and was cast in with the ring. This method of fixing ties was found to be the simplest and cheapest, and eliminated the need for costly turnbuckle adjusting screws. Alan Tricklebank, who was responsible for the structure up to ground floor level, spent many hours investigating alternative methods before the system used was finally evolved. A rebate was formed at the inner edge of the ring and reinforcement left projecting. This later formed the seating for the 10 in. (250 mm) thick car park slab. This junction acted as a day joint in the suspended slab after the remainder of the car park slab had been cast and the raking ties cut off. The contractor estimated that the elimination of traditional propping had reduced the excavation time, and his costs by £40,000.

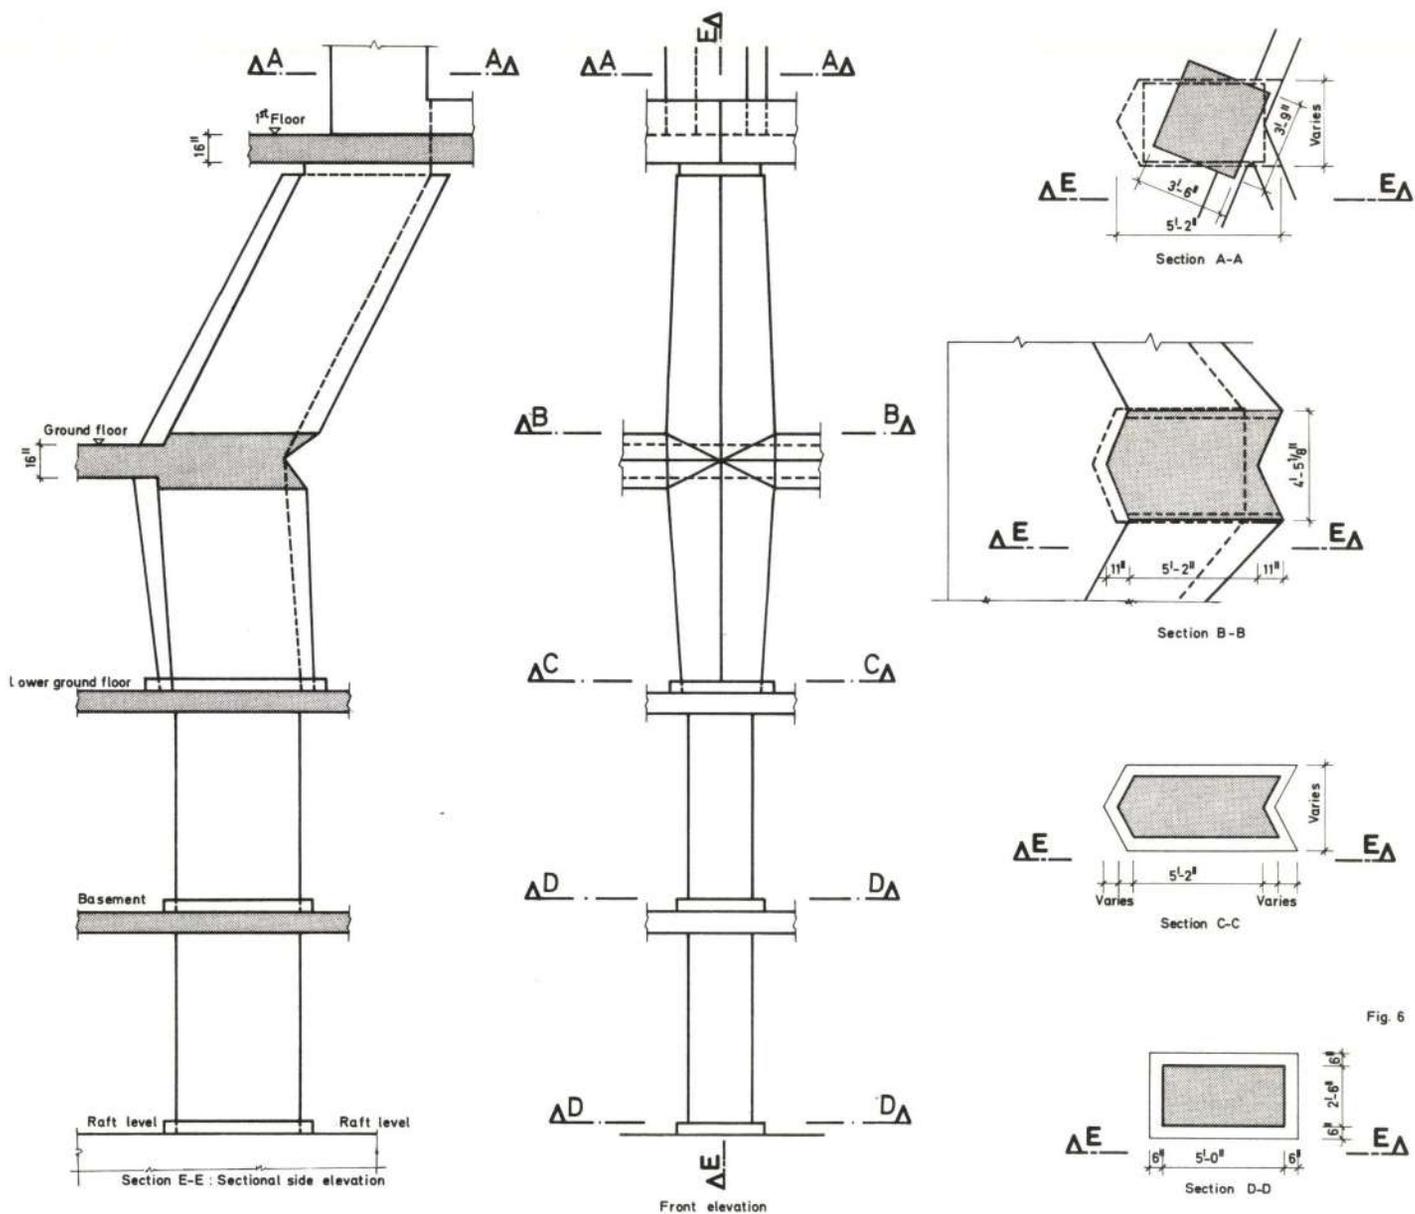
Fig. 7
Elevation and sections of the sloping columns between the raft and first floor.

From raft level upwards, through two floors, the columns are rectangular, vertical, and continuous in section. Between lower ground floor, ground floor and first floor they have a constantly changing chevron shaped section and no longer remain vertical, sloping in towards the centre 9 in. (230 mm) between lower ground and ground floor, and sloping outwards 6 ft. 9 in. (2.1 m) (23° away from the vertical) between ground and first floor (Fig. 7). Above this level they are vertical.

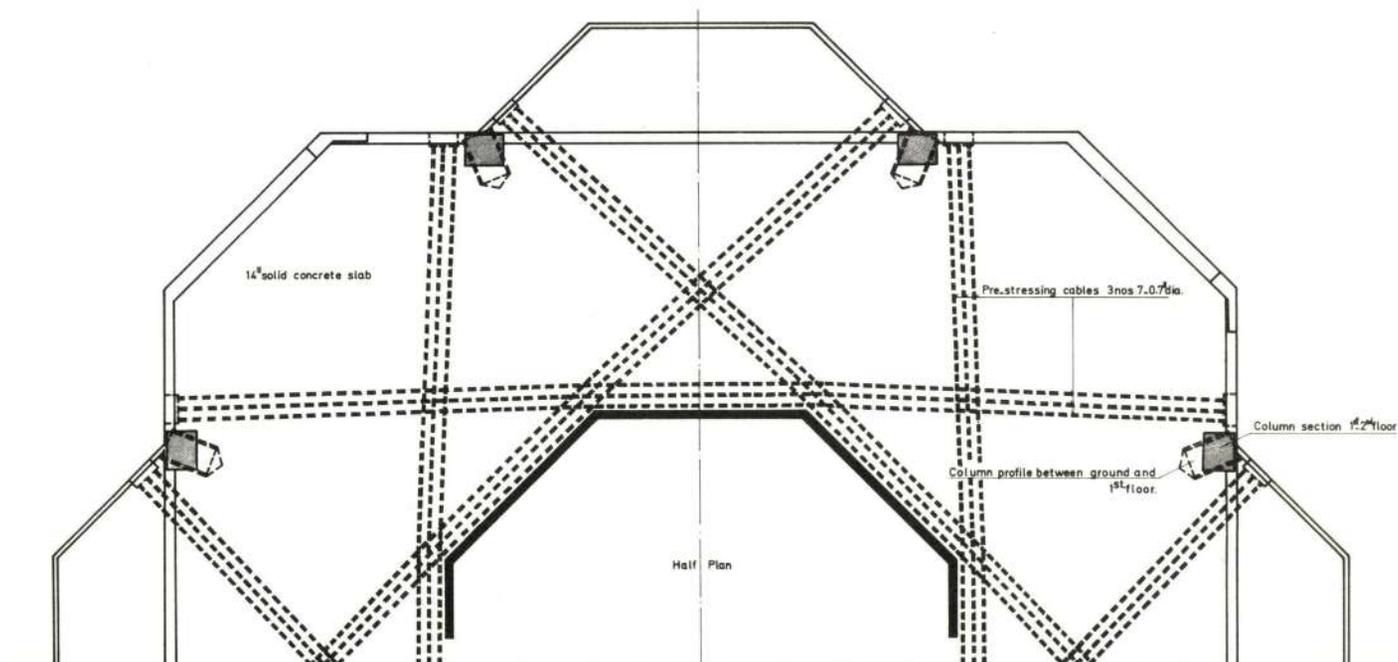
Fig. 8
First floor layout of prestressing cables.

At first floor level the sloping columns are tied into the building by a system of prestressing cables laid at mid depth of the 1ft. 2 in. (360 mm) thick dense concrete floor slab. Six cables restrain each column and exert a total radial tie force of approximately 1800 kips (Fig. 8).

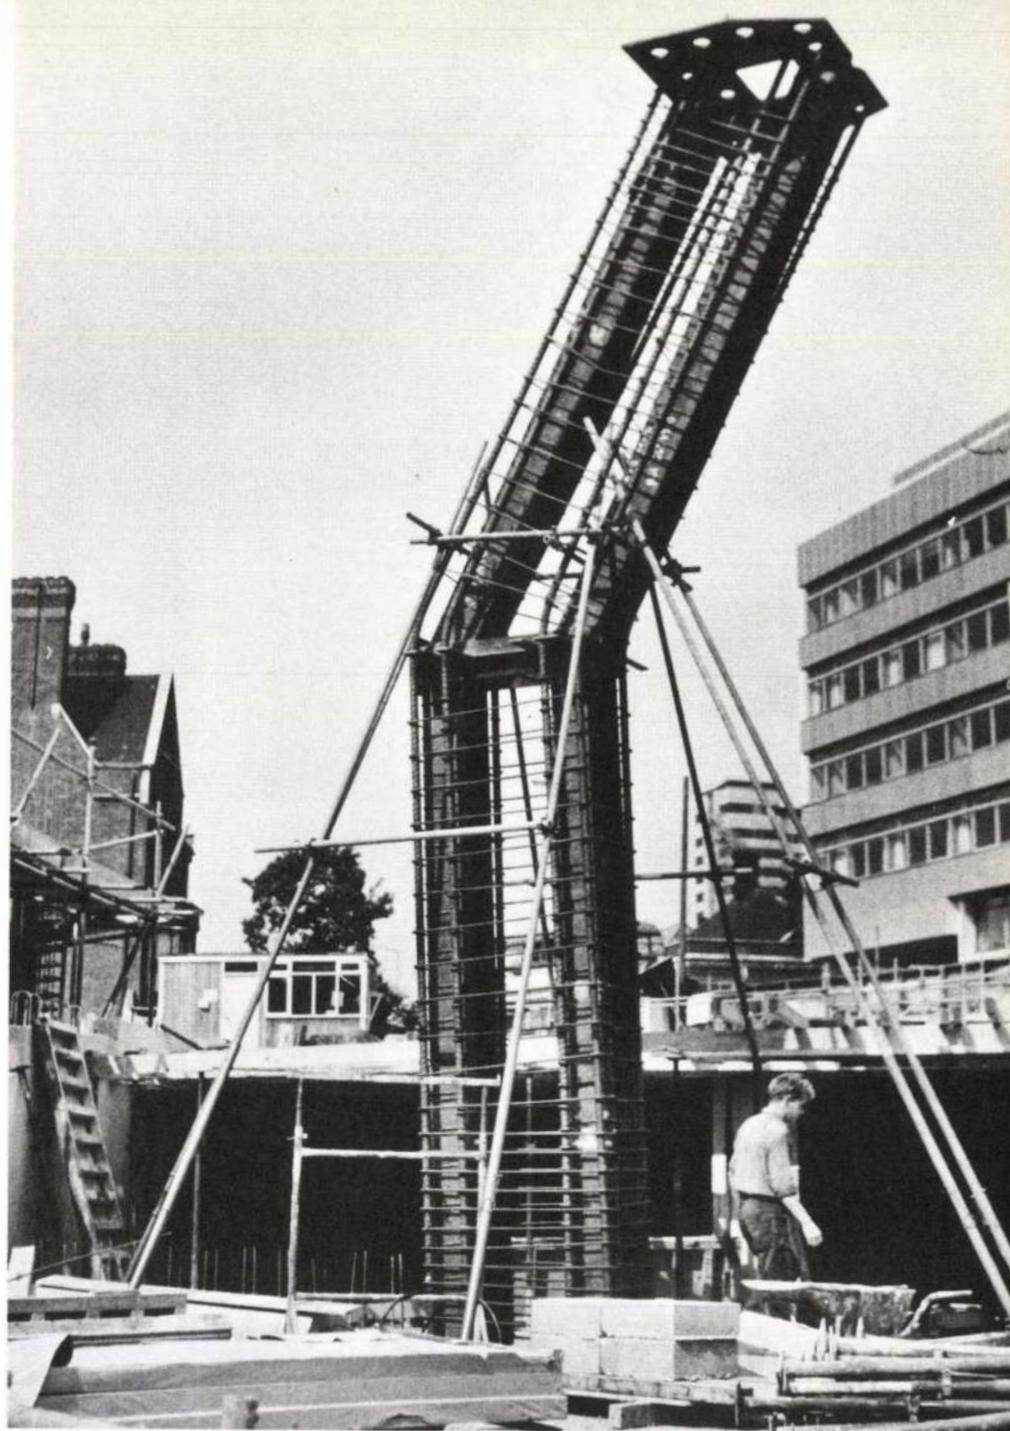
Fig. 9 Cranked column reinforcement formed by two 12 in. x 12 in. universal columns and eight 2¼ in. diameter *Hi-bond* bars. (Photo: Peter Ryalls)

Thus the problem to be solved was that of providing reinforcement which could be accurately placed in all three planes. It was decided that reinforcement to the sloping parts of the column should be two 12 in. x 12 in. (305 mm x 305 mm) universal columns, cranked and welded at the change of slope and strapped together to form the main reinforcement (Fig. 9). The universal columns

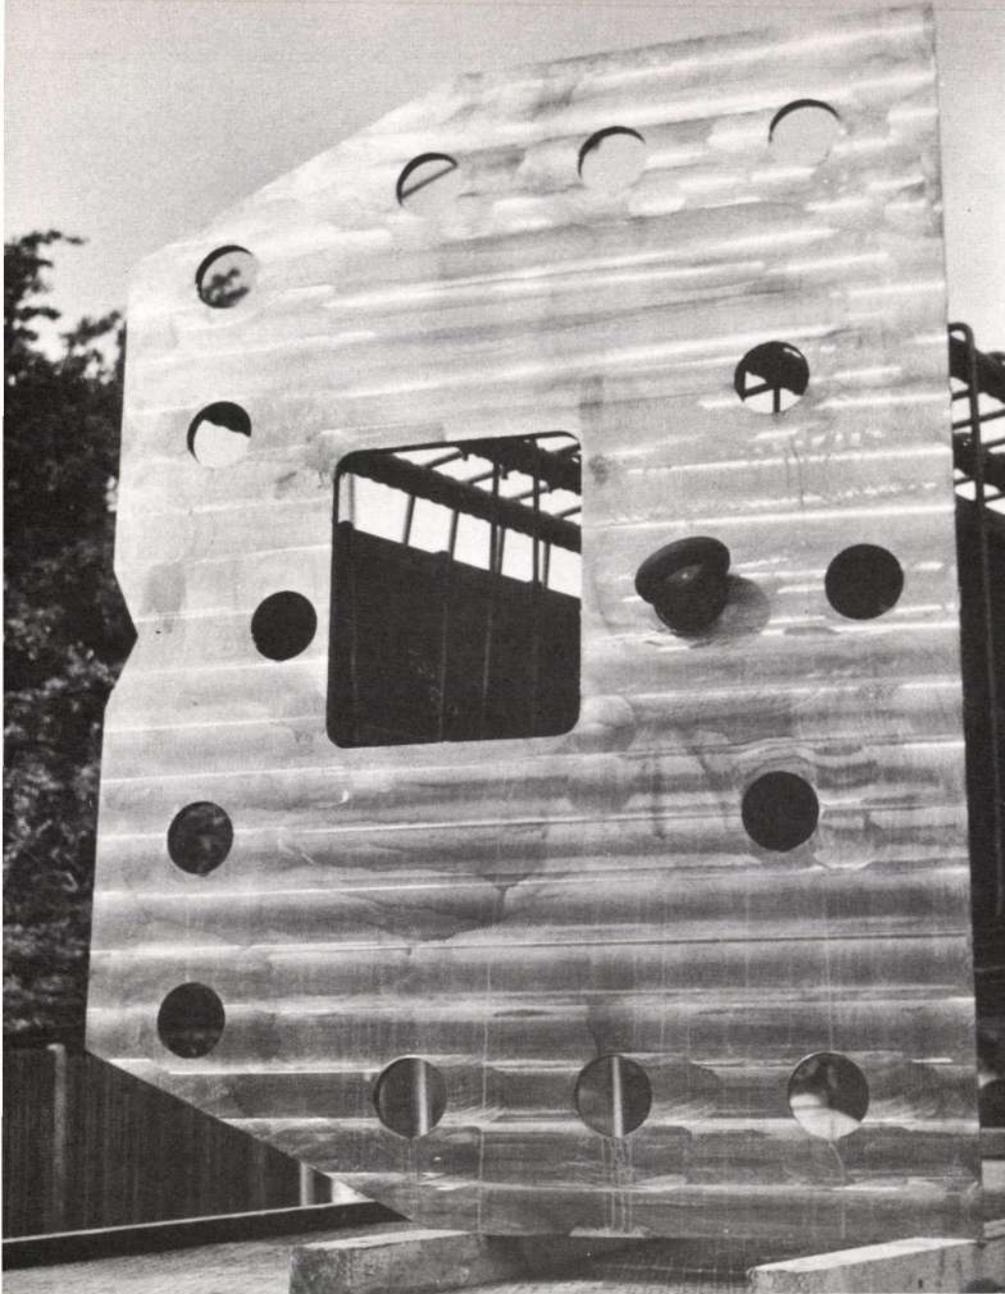
Fig. 10
Upper plate of fabricated column. (To this plate a loose plate containing 22 starter bars is welded at first floor.)
(Photo: Peter Ryalls)

were butt welded to machined base plates top and bottom (Fig. 10). Corner bar reinforcement was provided by four 2¼ in. (57 mm) bars also butt welded to the base plates. Shear connector links were welded to the universal columns and conventional links were attached to the 2¼ in. (57 mm) bars. Because of the welding and the thickness of the sections and the difficulty of normalizing a fabricated element 28 ft. x 4 ft. (8.5 m x 1.2 m), the universal columns were specified as ND (notch ductile) 2b steel and the 2¼ in. (57 mm) bars were McCalls weldable *Unisteel '60'*. This part of the work was put out to tender to steel work fabricators.

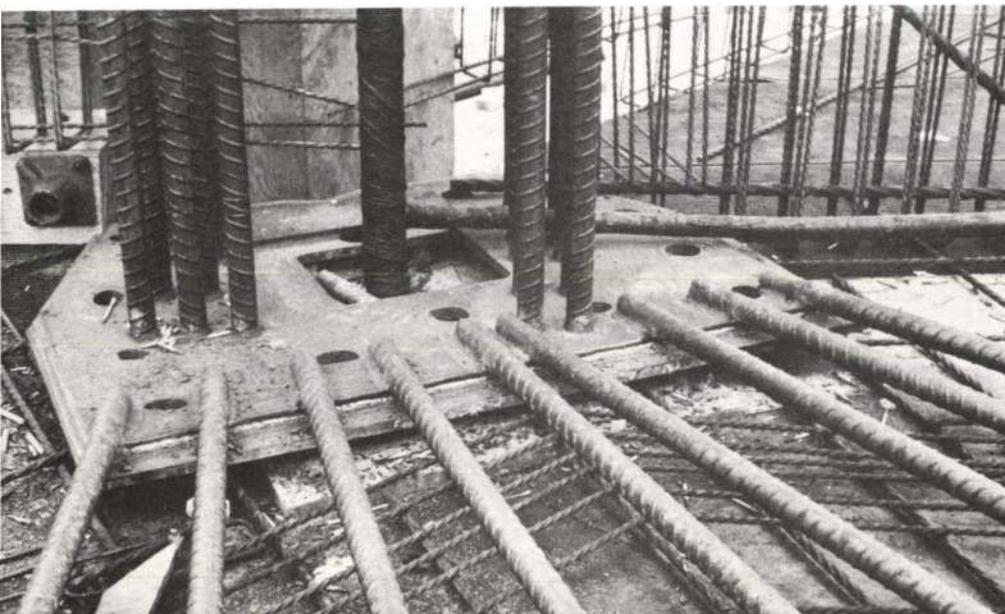
Fig. 11
Column at 1st floor level showing loose plate with 22 2 1/4 in. diameter vertical bond bars and nine horizontal 2 1/4 in. diameter *Hi-bond* bars welded to it, and loose plate welded to upper plate of the fabricated column. The 6 in. diameter rain water pipe is also shown passing vertically through a rectangular hole in centre of plates.
(Photo: Peter Ryalls)

At first floor level a loose plate was welded to the upper end of the steel column. To this loose plate, 22 2 1/4 in. (57 mm) bars were welded to act as starter bars for the column above the first floor (Figs. 11 and 12).

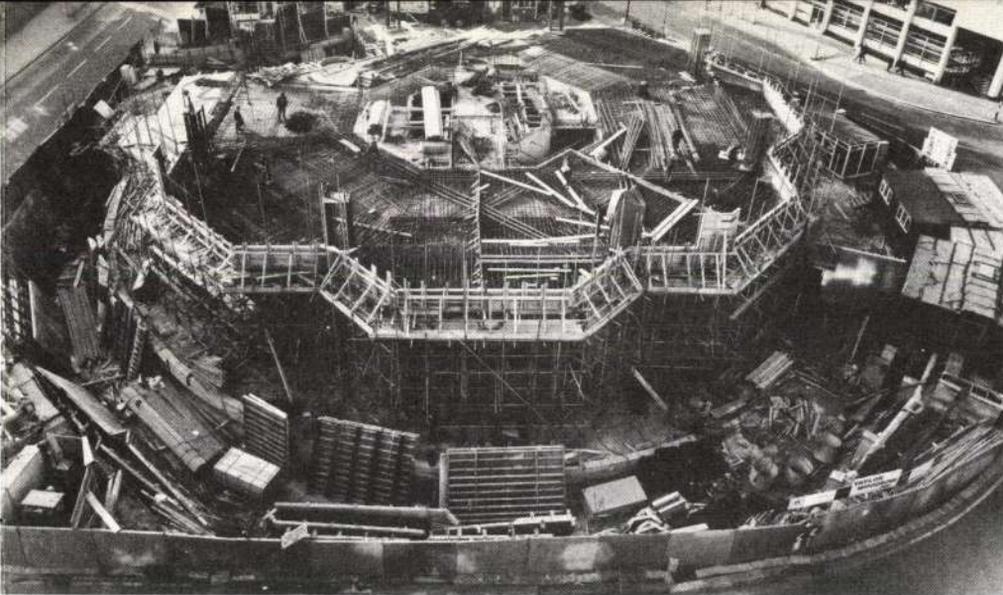
Fig. 12
1st floor level showing column reinforcement erected between 1st and 2nd floors and templates attached to the reinforcement. Some stressing cables are shown in position. (Photo: E. J. Studios). Reproduced by courtesy of Taylor Woodrow Construction Ltd.

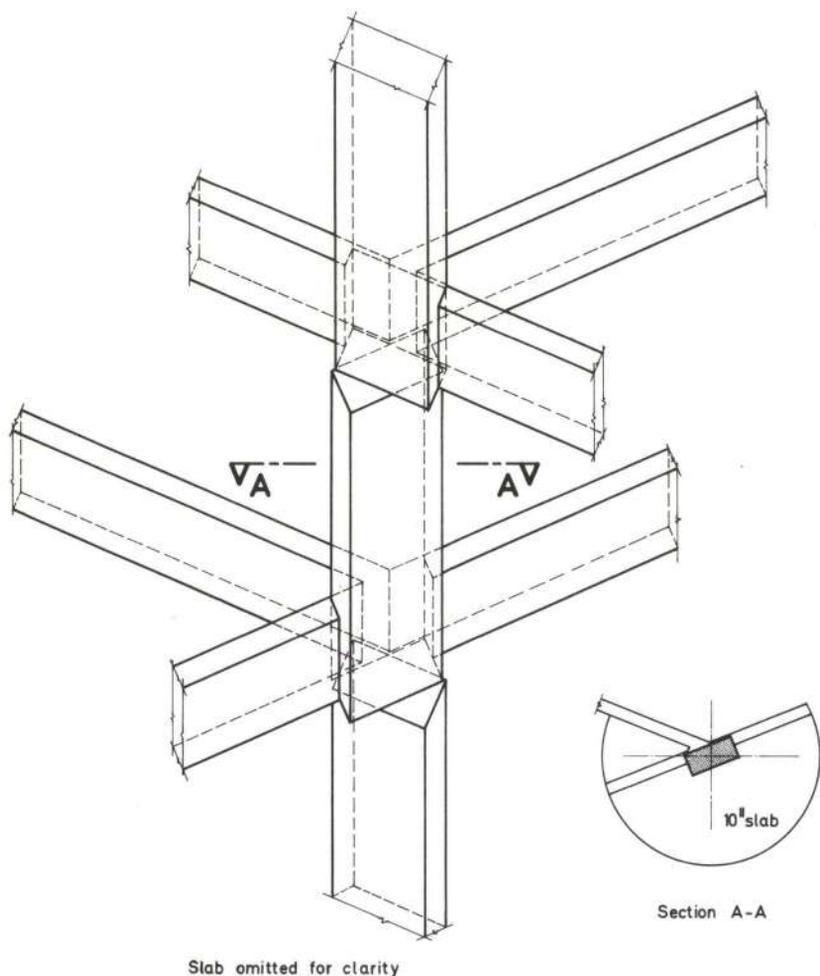
Fig. 13 left
Diagram showing the rotation of columns floor to floor.

Above 1st floor each column is vertical and rectangular in plan (Fig 13). At each floor the plan rotates through 45°, and the section reduces progressively up the building. On each successive floor a main edge beam frames into the column, on the opposite side of and 45° inclined to both that on the floor above and that on the floor below. In four of the eight columns a 6 in. (150 mm) rainwater pipe passes down the middle and collects water from balconies on alternate floors.

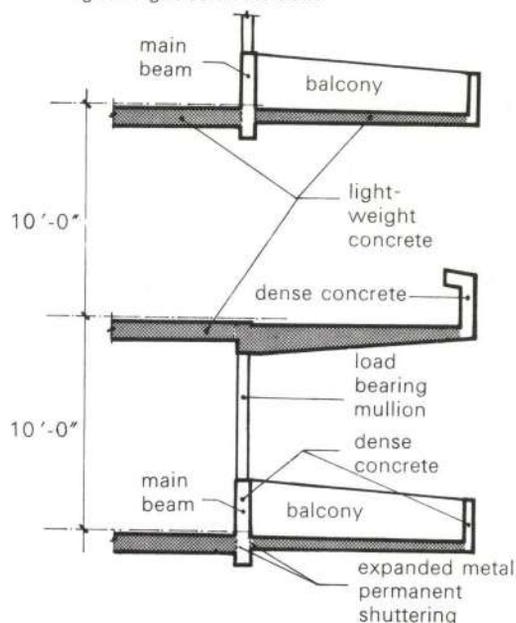
Fig. 14 below
Section through mainbeams showing the dense concrete beam projecting through the lightweight concrete slab.

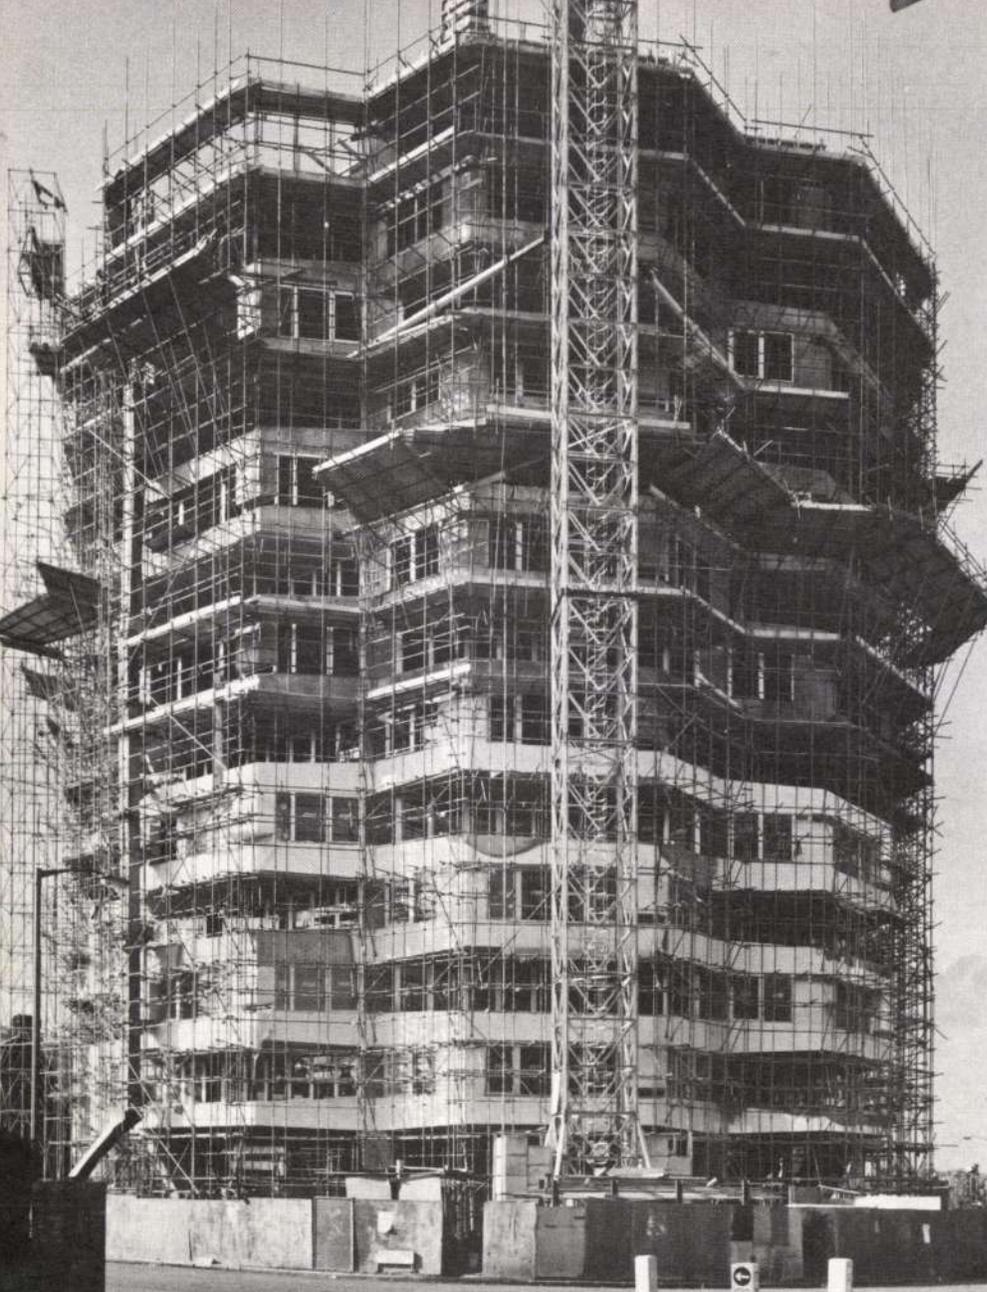
Fig. 15
View of building at end of September 1969,
with construction at 13th floor.
(Photo: E. J. Studios). Reproduced by courtesy of Taylor Woodrow Construction Ltd.

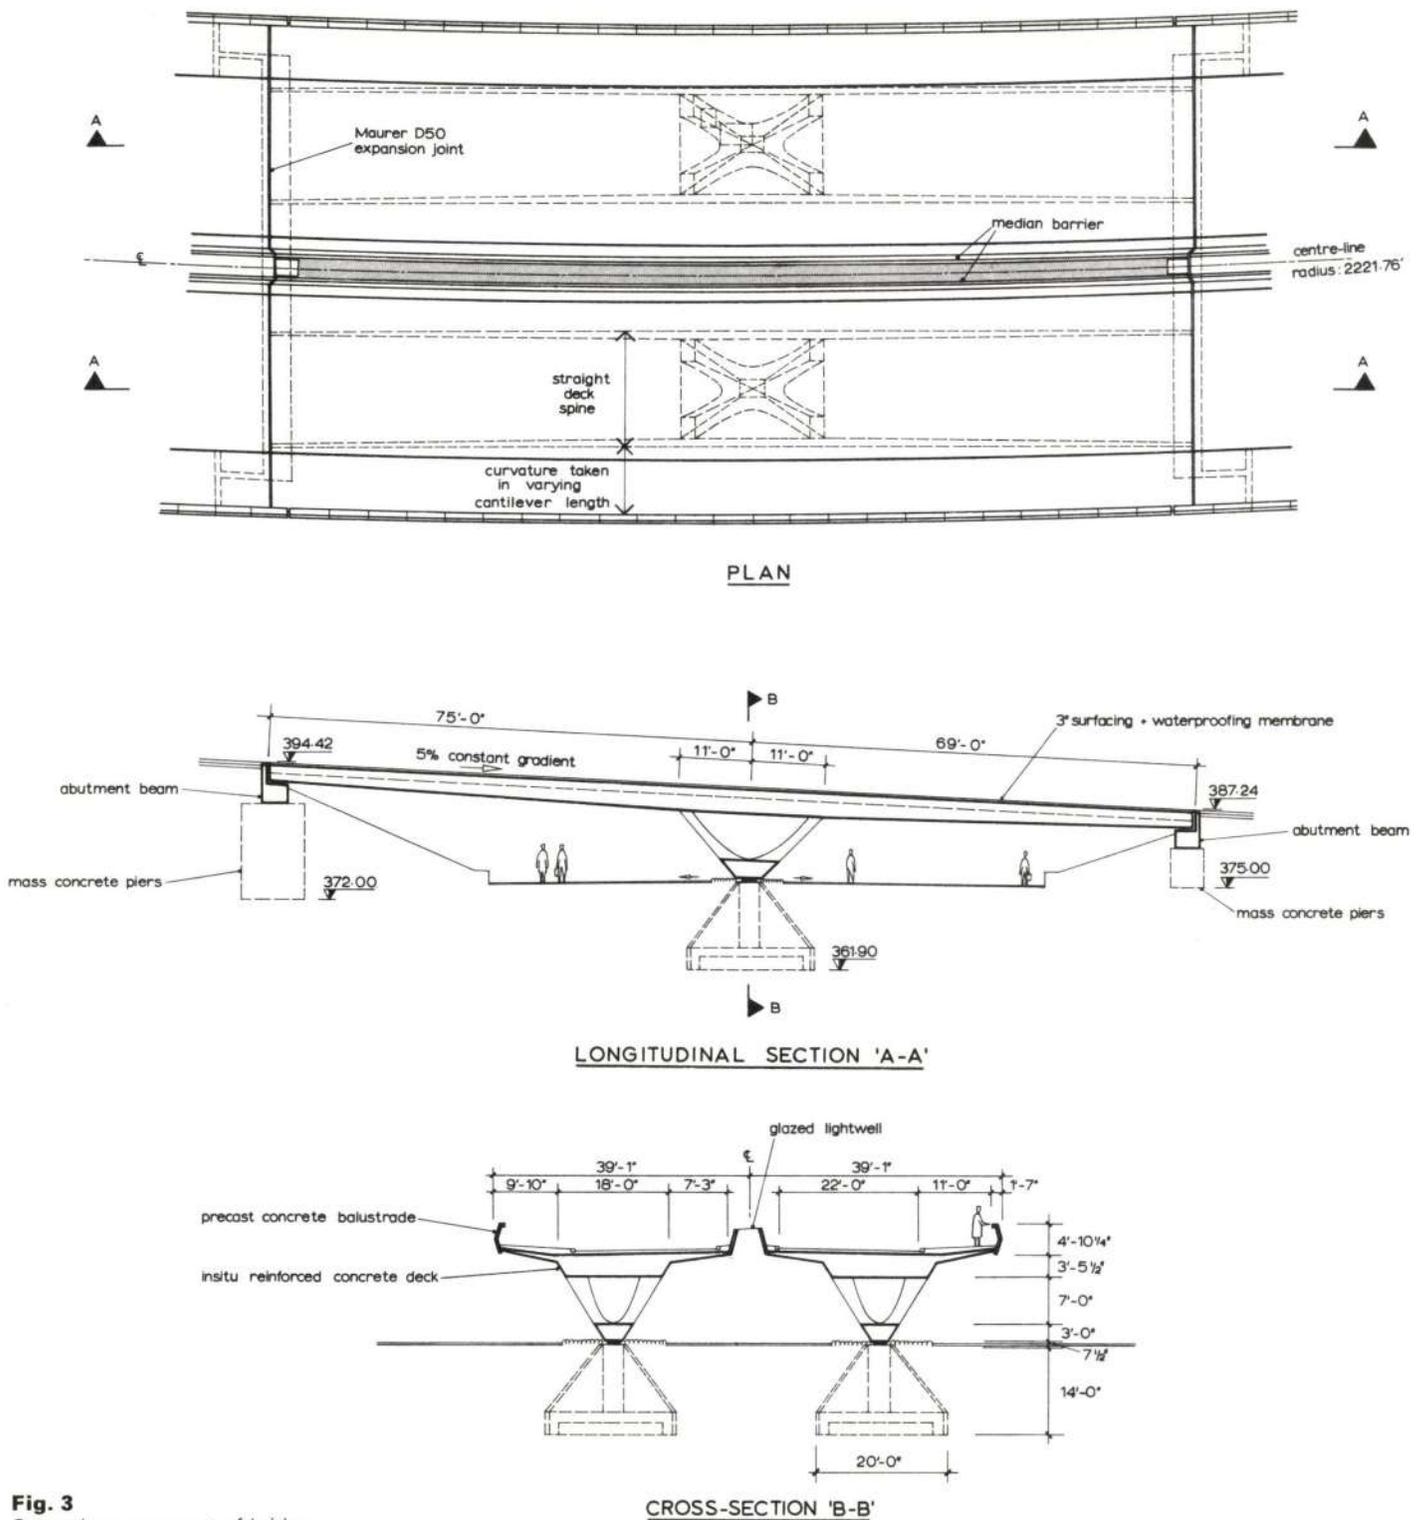
Fig. 3
General arrangement of bridge.

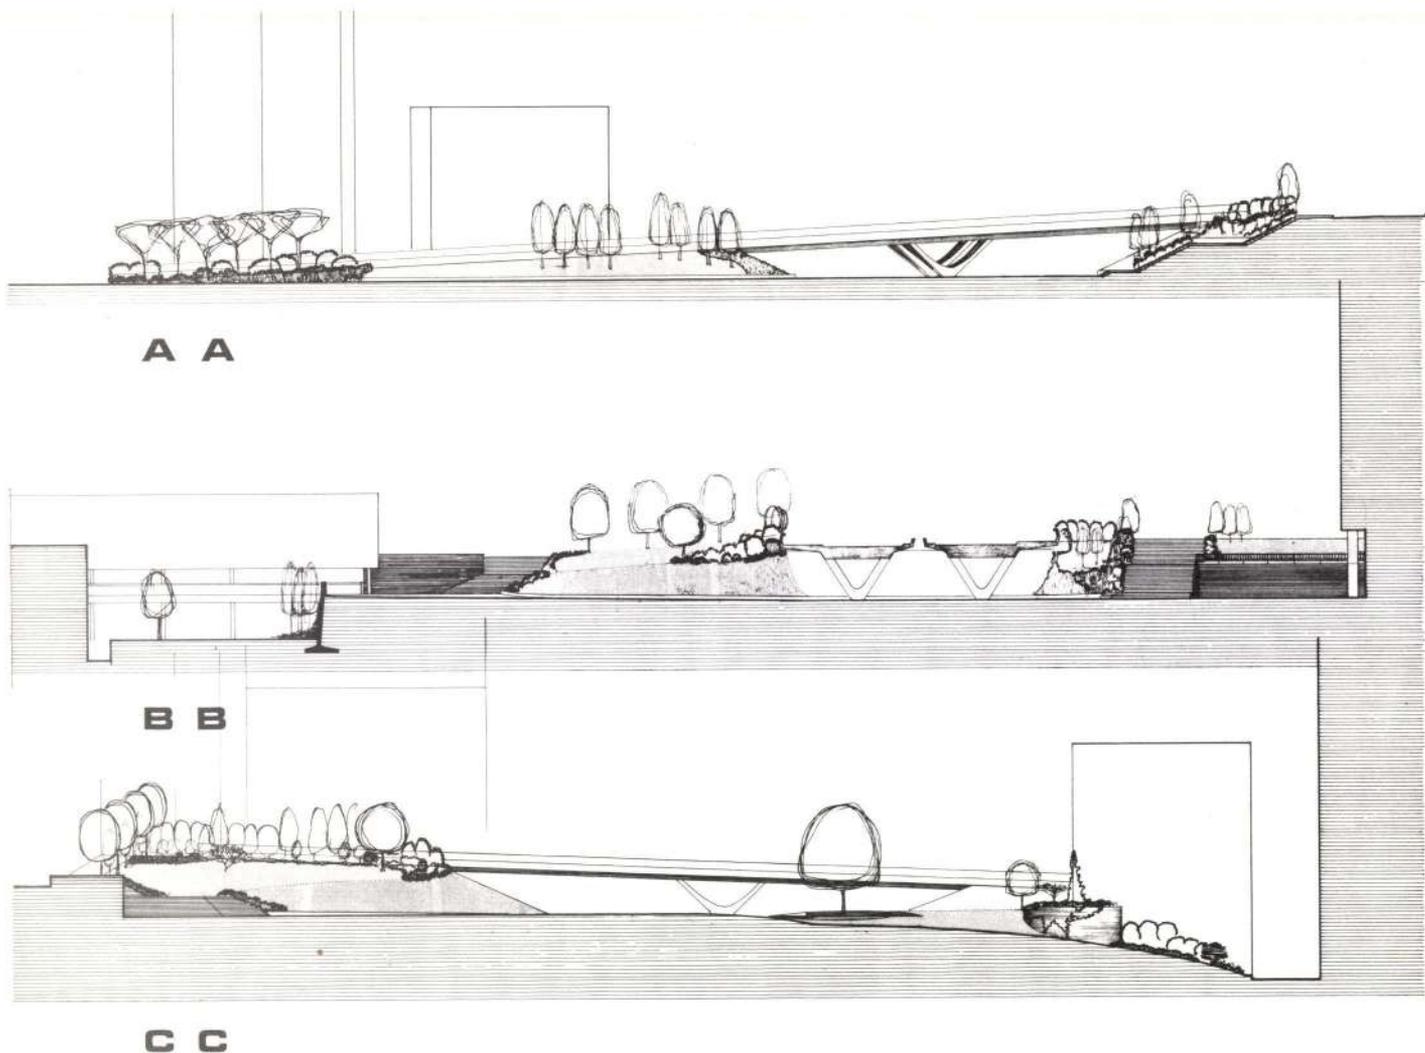
Fig. 7
Sections through concourse.

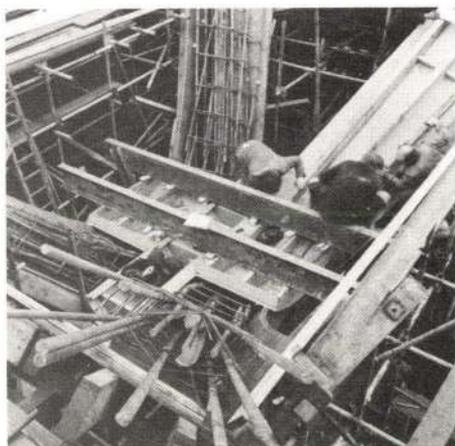
Fig. 8 above
Positioning of top shutter to central support.
(Photo: M. T. Walters and Associates Ltd.)

The central support was to be poured in a single operation and any movement during construction could create considerable difficulties. The outside shutters were therefore supported very firmly and the core top shutter anchored down to the foundations against the several tons of uplift that would occur. Ready-mixed concrete was used throughout the works and this created problems, as the only access was from the open half of the dual carriageway. The carriageway was therefore closed on a Sunday morning. The concrete was first poured through a central 9 in. (230 mm) diameter tube into the base until it rose up into the bottoms of the legs and then down each leg simultaneously. The result achieved, considering the difficulty of the operation, was quite good. Credit should go to the Ready-Mix supplier for his co-operation in producing a mix with the necessary

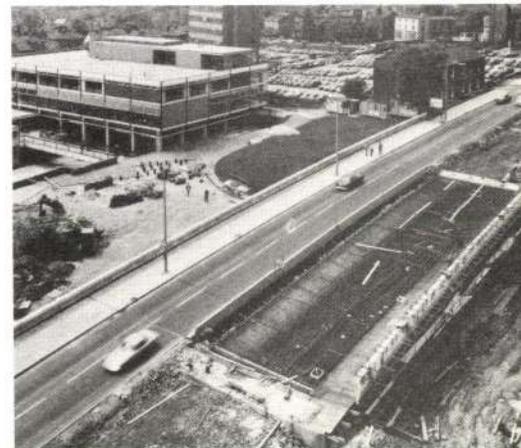
Fig. 12 above
North bridge before concreting.
(Photo: M. T. Walters
and Associates Ltd.)

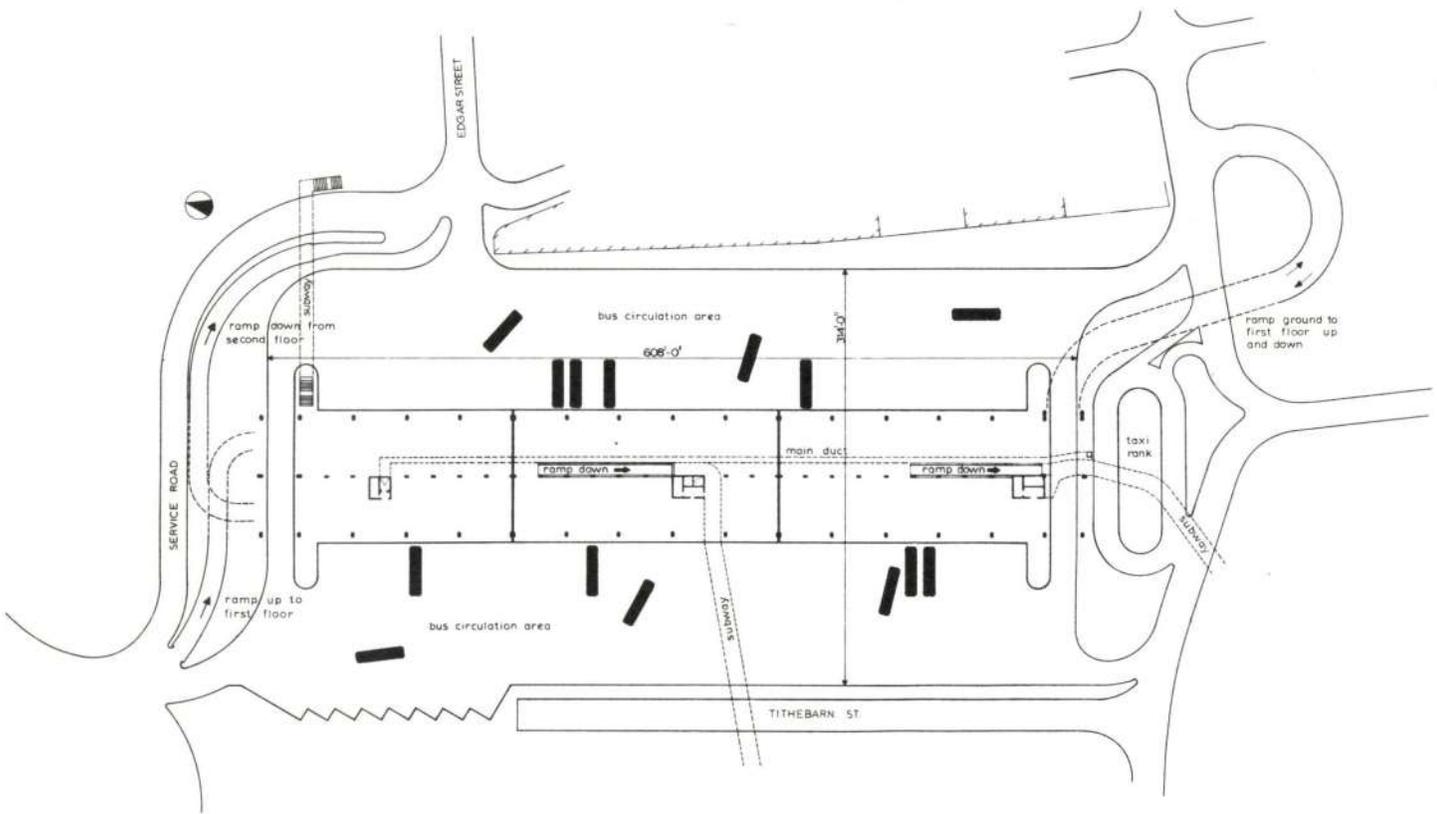
Fig. 1
Ground floor plan showing bus circulation, concourse, subways and ramps.
