THE ARUP JOURNAL

The Island Site, Addiscombe Road, Croydon, Surrey, by T. Henry and P. Ryalls	2
The design and construction of Sheffield University Concourse, by K. Ranawake, R. Gordon and K. Tune	11
Preston Bus Station and Car Park, by R. Stephenson	19
Rooms for students, by T. Sturgis	27

The Island Site, Addiscombe Road, Croydon, Surrey

Tom Henry and
Peter Ryalls

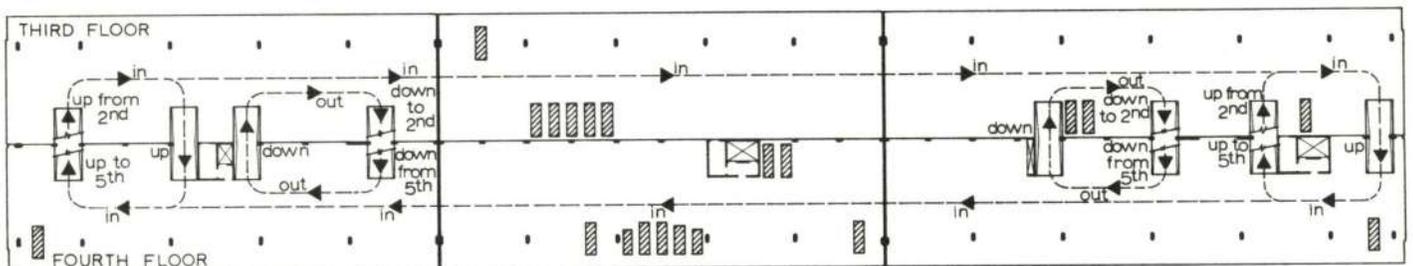
Fig. 2
Upper floor plan showing internal ramps.

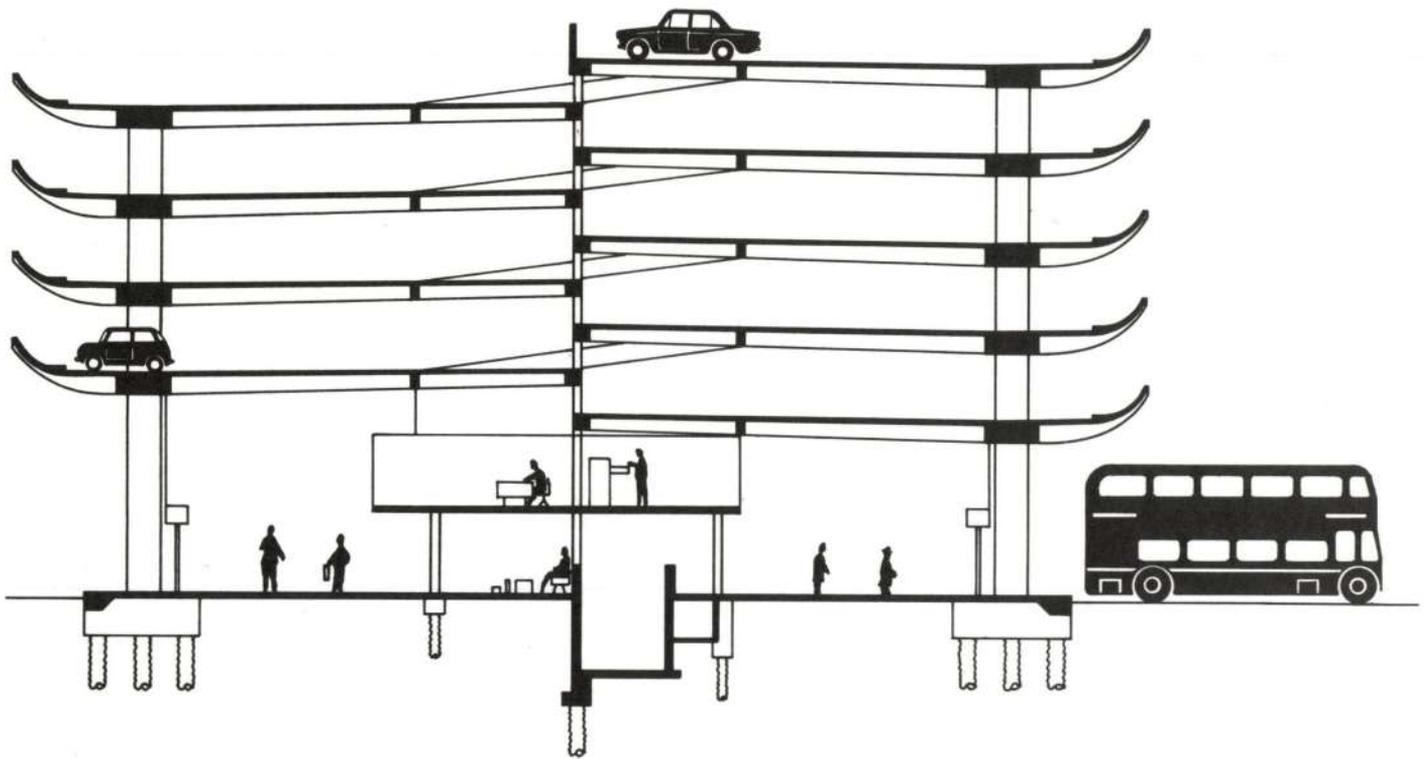
Fig. 3
Section through building.

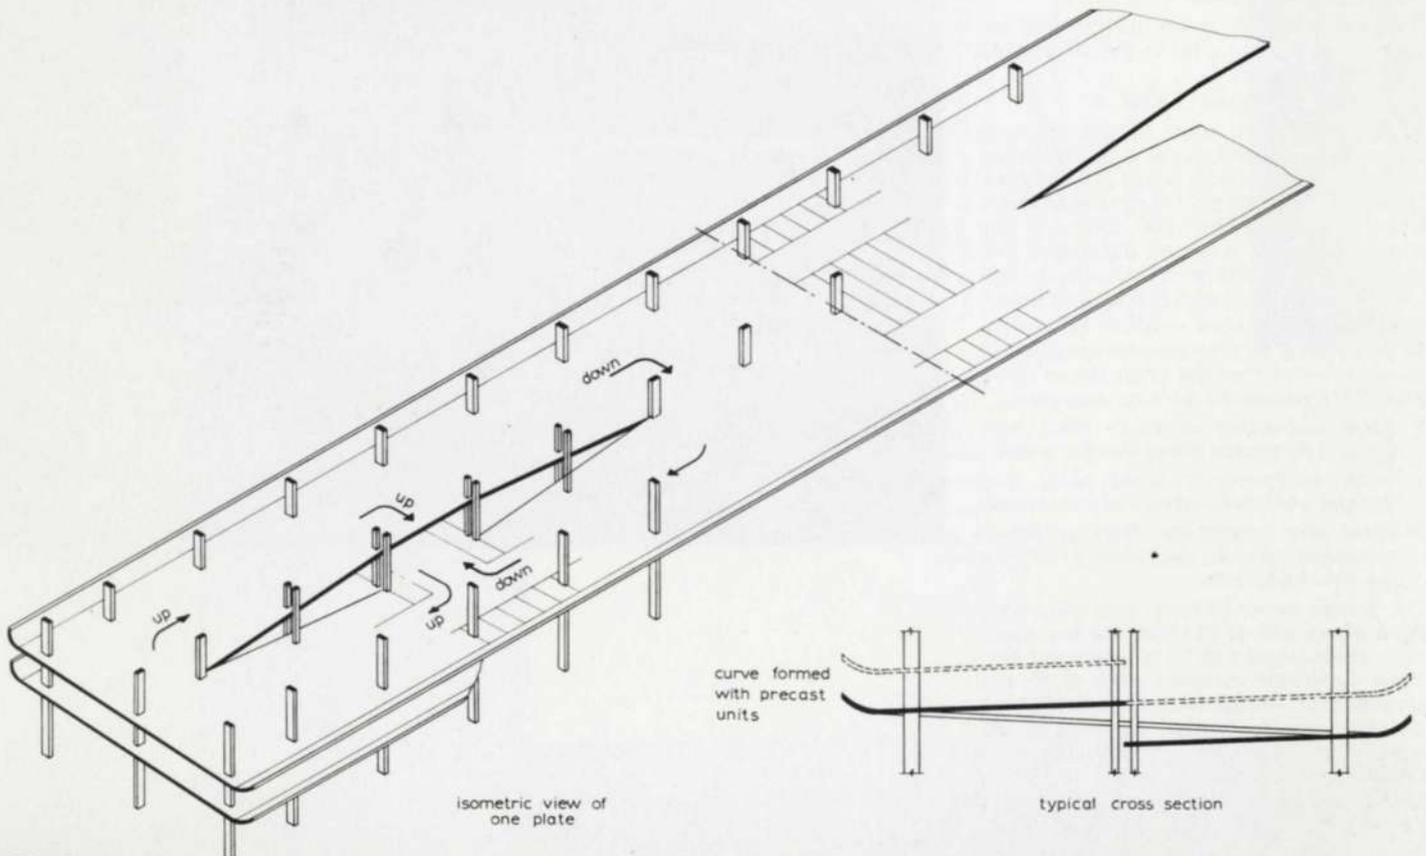
Fig. 6
British Lift Slab warped slab system.

Four alternative designs were put forward. Two were in steel and did not comply with the fire regulations then in force (2), nor were they aesthetically acceptable to the architect. A third was a precast concrete scheme that did not comply with the performance specification. The serious competition came from the fourth scheme. This was submitted by British Lift Slab Ltd. who put forward what they describe as the 'warped slab' system for the car parking floors (Fig. 6).

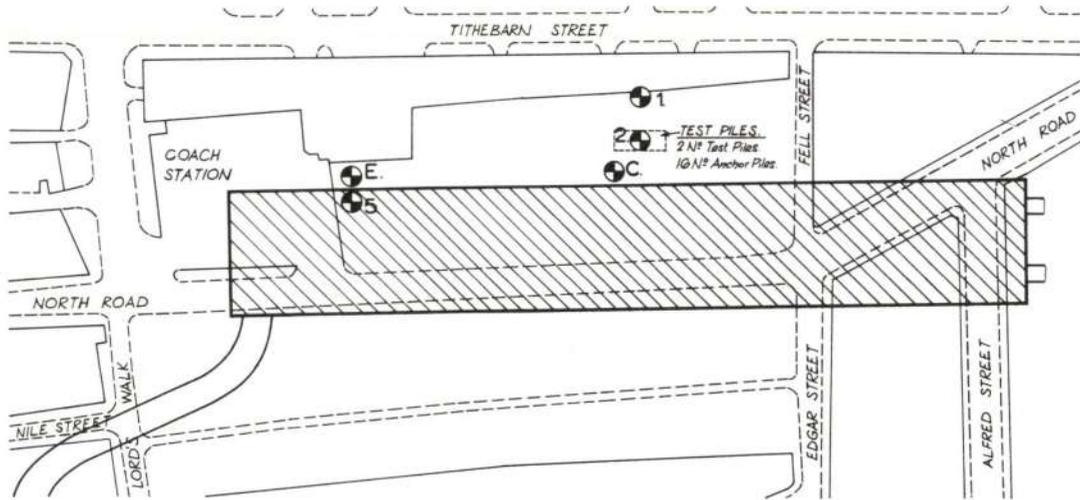
BOREHOLE 'C'			
STRATA	LEGEND	DEPTH	N
Cinder & brick fill	[Cross-hatch pattern]	G.L.	
Light brown fine sand with thin bands of silt & gravel	[Small circles and dots]	4' 0"	
			10
			8
			7
Loose light brown silt	[Small 'x' marks]	26' 6"	
			2
Firm brown clay. Compact light brown sand.	[Horizontal lines]	33' 0"	
		34' 0"	23
Dense fine light brown sand	[Small dots]	37' 6"	
			40
			46' 6"
End of borehole			40

BOREHOLE '1'			
STRATA	LEGEND	DEPTH	N
Made ground—ashes, brick, rubble, sand.	[Cross-hatch pattern]	G.L.	
Loose fine silty sand	[Small circles and dots]	2' 6"	4
Moderately compact reddish brown medium grained sand with occasional fine gravel	[Small circles and dots]	7' 0"	16
			17
			13
			23
Fine silty sand. Moderately compact to compact reddish brown fine sand	[Small 'x' marks]	29' 0"	13
		31' 0"	17
			21
			34
			22
			47' 0"
			80
Very compact fine reddish brown sand	[Small dots]	50' 0"	50
End of borehole

BOREHOLE 'E'			
STRATA	LEGEND	DEPTH	N
Brick clay & cinder fill	[Cross-hatch pattern]	G.L.	
Compact light brown sand	[Small dots]	4' 0"	
			9
			23' 0"
			7
Loose light brown sand with bands of soft brown clay	[Horizontal lines]		2
			3
			2
Dense light brown sand	[Small dots]	38' 0"	41
			42
			51' 6"
End of borehole			46

BOREHOLE '5'			
STRATA	LEGEND	DEPTH	N
Made ground ashes, brick, rubble, sand. Dark grey silty sand. Moderately compact mixed brown sand with occasional gravel	[Cross-hatch pattern]	G.L.	
		1' 6"	
		3' 6"	13
			14
			14
Loose fine brown silty sand	[Small circles and dots]	21' 0"	13
			9
			8
			11
Compact becoming very compact with depth. Fine to medium brown sand	[Small dots]	36' 0"	29
			35
			50
			50' 0"
End of borehole			63

Boreholes 'C' & 'E' by Geo-Research Ltd. 1966.
Boreholes '1', '2' & '5' by G.K.N. Foundations Ltd. after test piles installed.

Before commencing the installation of the working piles, GKN did five boreholes of their own for their own use. Two of these, no. 1 and no. 2, were adjacent to the test pile set up, no. 1 being about 20 ft. (6.1 m) away from it and no. 2 being between the test piles. GKN borehole no. 5 was close to Geo Research borehole E. The logs of these holes, and SPT (Standard Penetration Test) values obtained from them, are shown in Fig. 7.

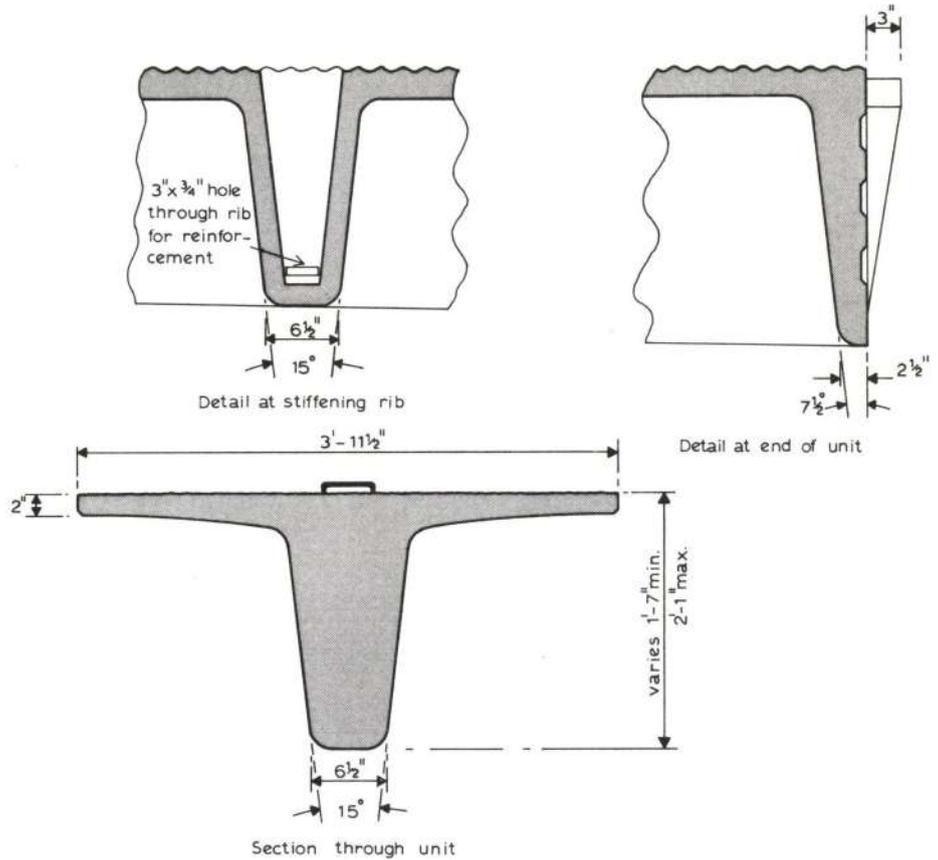
Fig. 8 right
Details of precast units.

There are five precast unit types, A, B, C, D and E, and details of these are shown in Fig. 8 and Table 3. Each type has variations to accommodate services, fixings and reinforcements, but none of the variations affect the basic moulds.

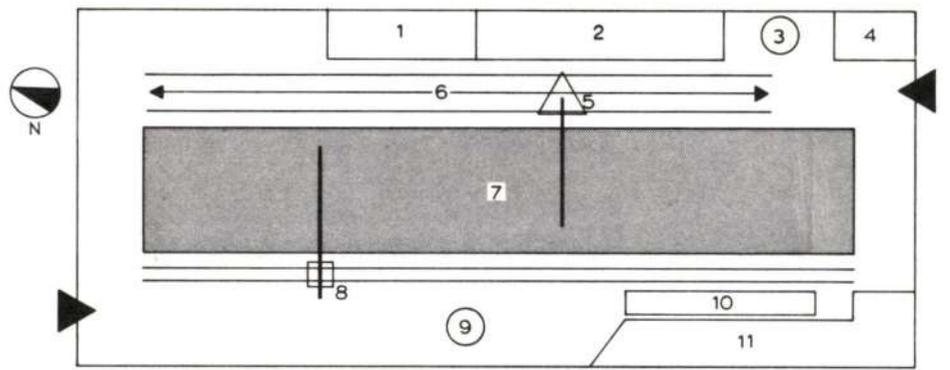
| 5 Travelling derrick crane for precast concrete | 11 Existing bus station |

Fig. 9
Layout of contractor's plant.

The timber formers for the moulds were made in Blackpool by Messrs. Glasdon Signs Ltd. and the fibre glass moulds were made in Nelson by Bennett Plastics Ltd. Thirty moulds were made in all, 12 of type A, 1 each of nos. B, C and D and 15 of type E, and these were then set up in the site casting yard by the contractor (Fig. 9).

The finish to the top of the flange is produced by wire brushing the green concrete in the direction of the flange width to produce a surface suitable for keying the in situ topping. In addition to this key there are depressions in the flange edges and projecting links from the web (Fig. 9).

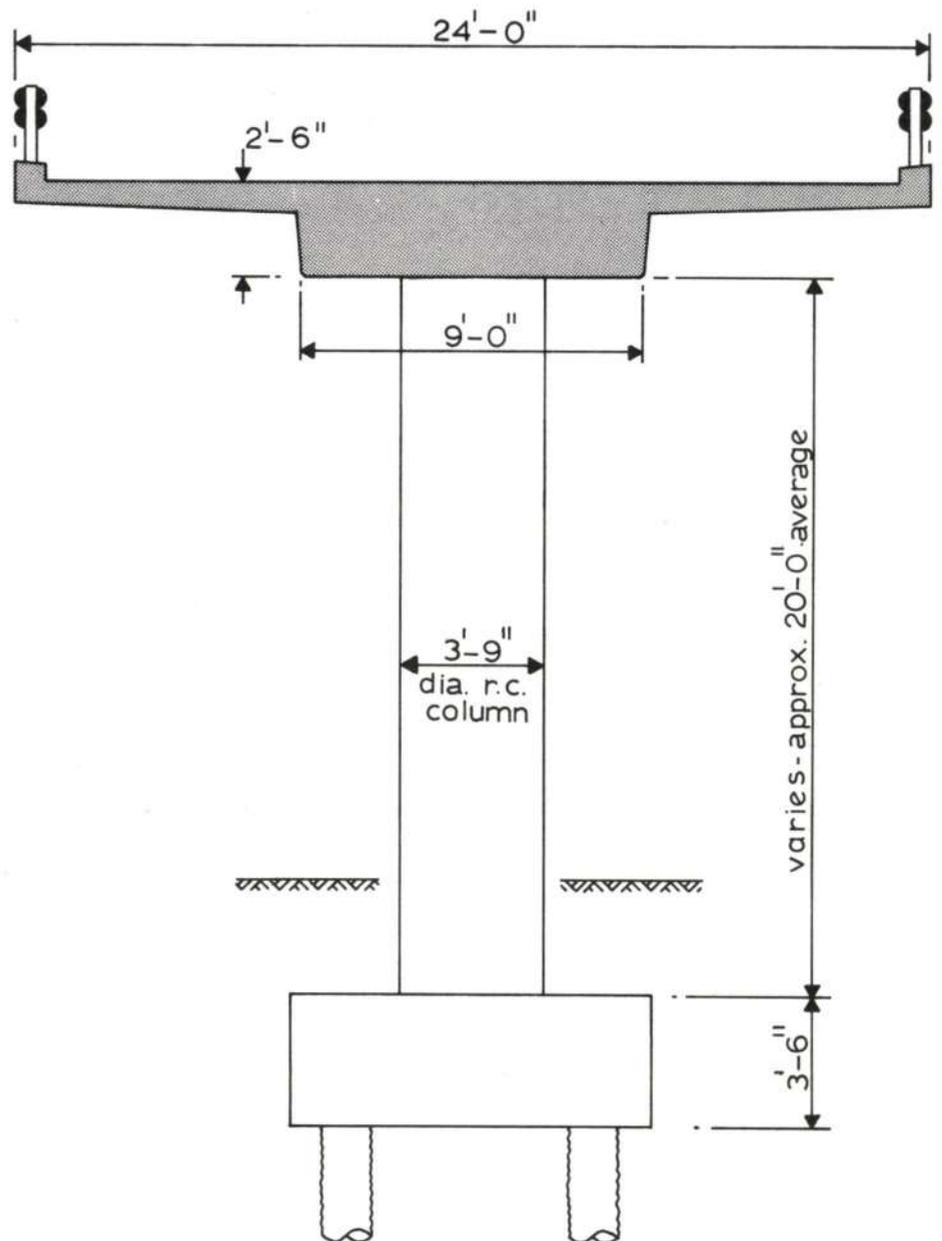
Fig. 10
Section through ramp.

The ramps are of in situ construction with decks supported on single rows of circular columns. The finish to the decks is fair faced concrete but the columns are grit blasted. At the southern end of the car park the ramp is 24 ft. (7.3 m) wide, allowing two way traffic. At this end, the deck spans are up to 44 ft. 6 in. (13.5 m) across 3 ft. 9 in. (1.1 m) diameter columns and the spine beam is 2 ft. 6 in. (760 mm) deep overall by 9 ft. (2.7 m) wide, with the deck slab cantilevering either side and tapering in thickness from 10 in. (250 mm) to the edge (see Fig. 10). The edge thickness is 1 ft. 1 in. (330 mm) of which 7 in. (180 mm) is taken up by the deck slab, the remaining 6 in. (150 mm) being a kerb. At the northern end the ramps are 12 ft. (3.7 m) wide with spans up to 35 ft. (10.7 m). These are of lighter construction than the northern ramp but of similar shape.

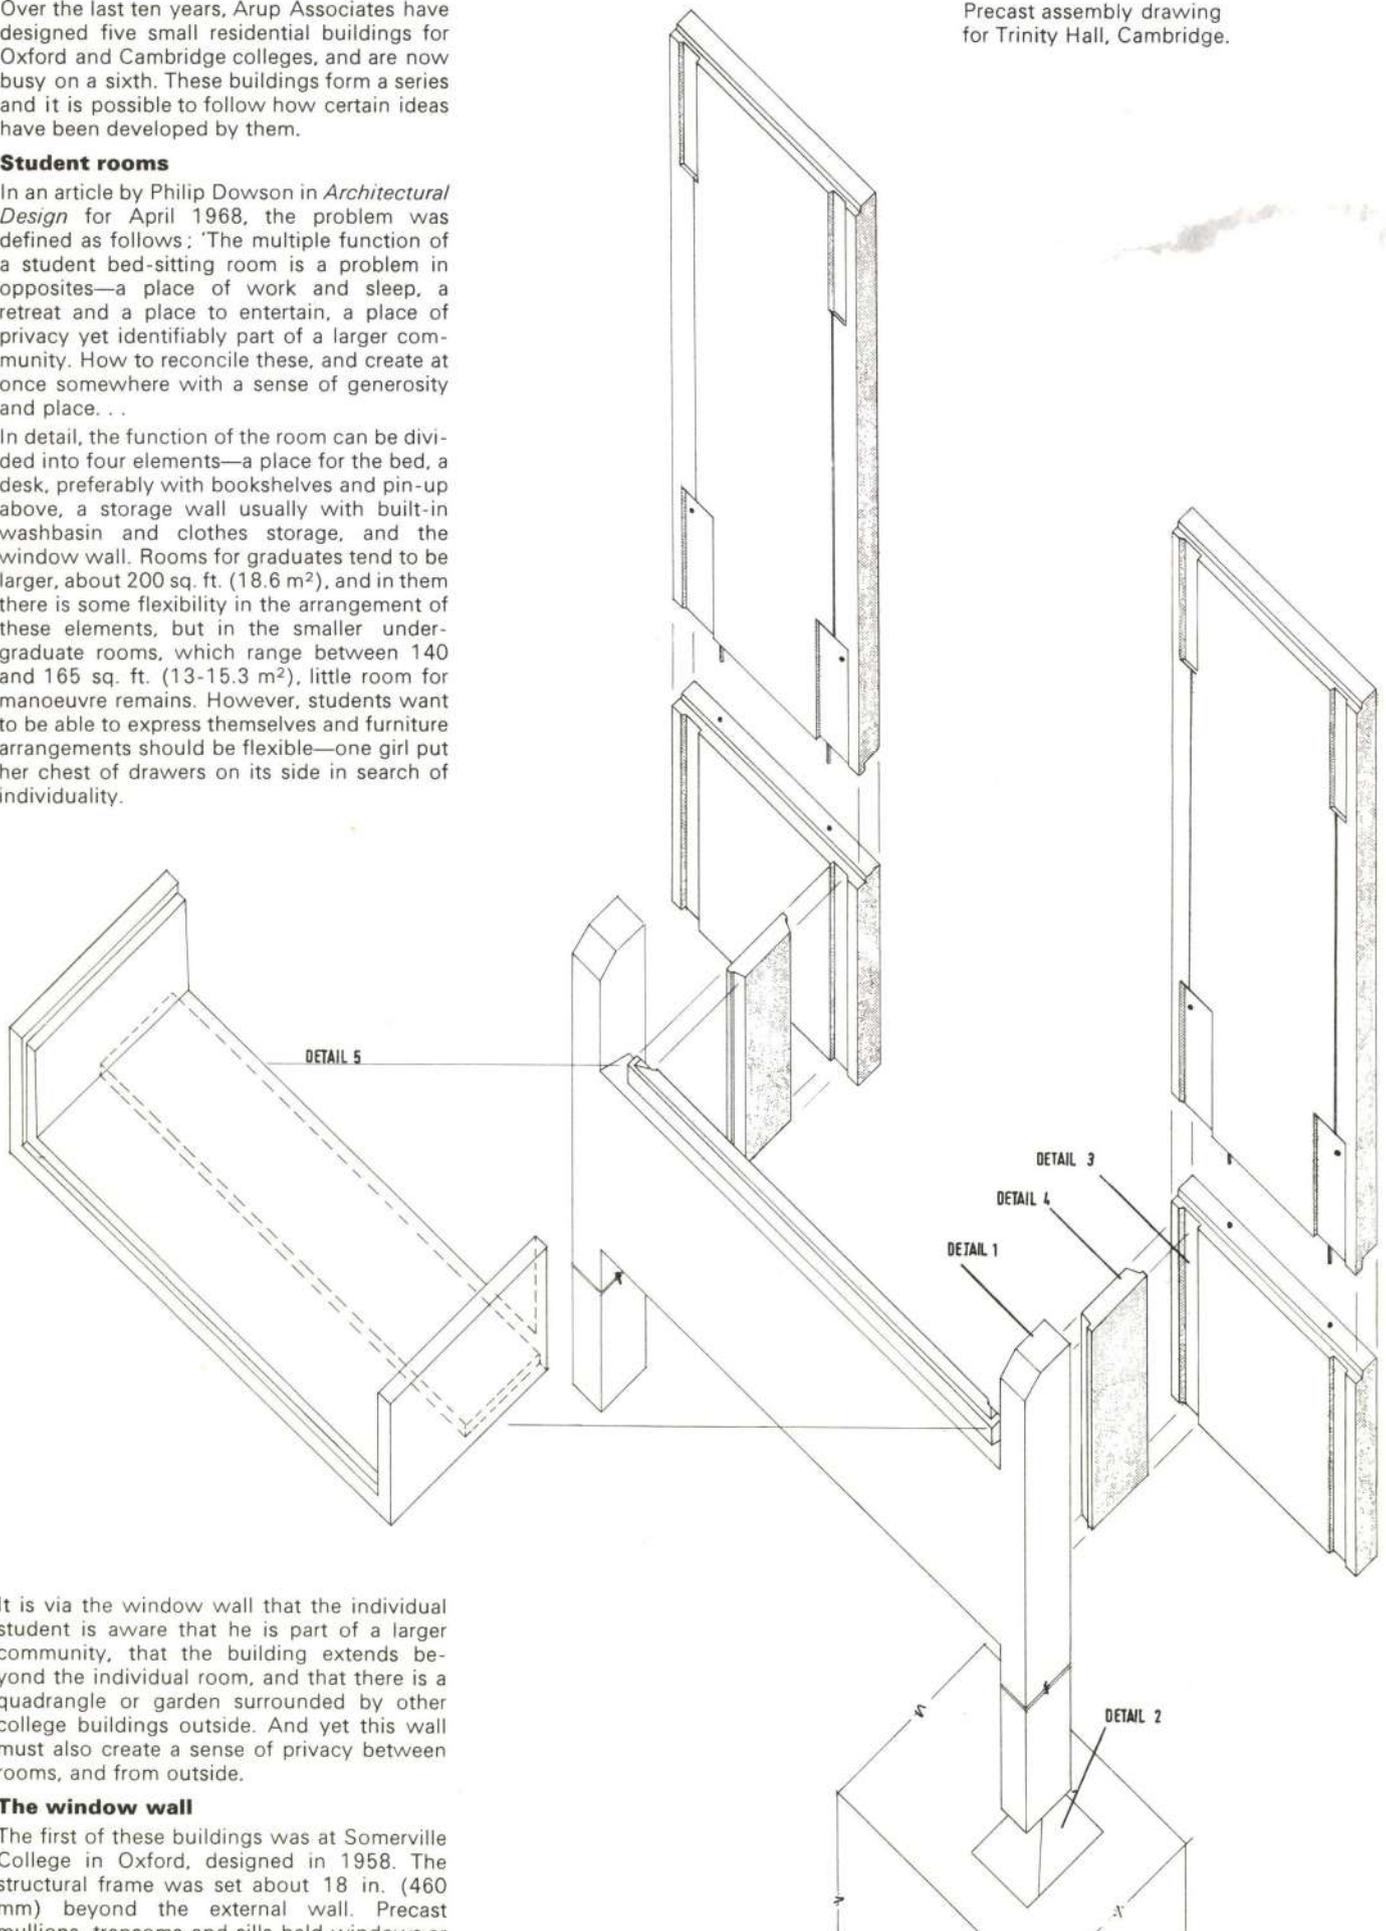
Fig. 1

Precast assembly drawing for Trinity Hall, Cambridge.

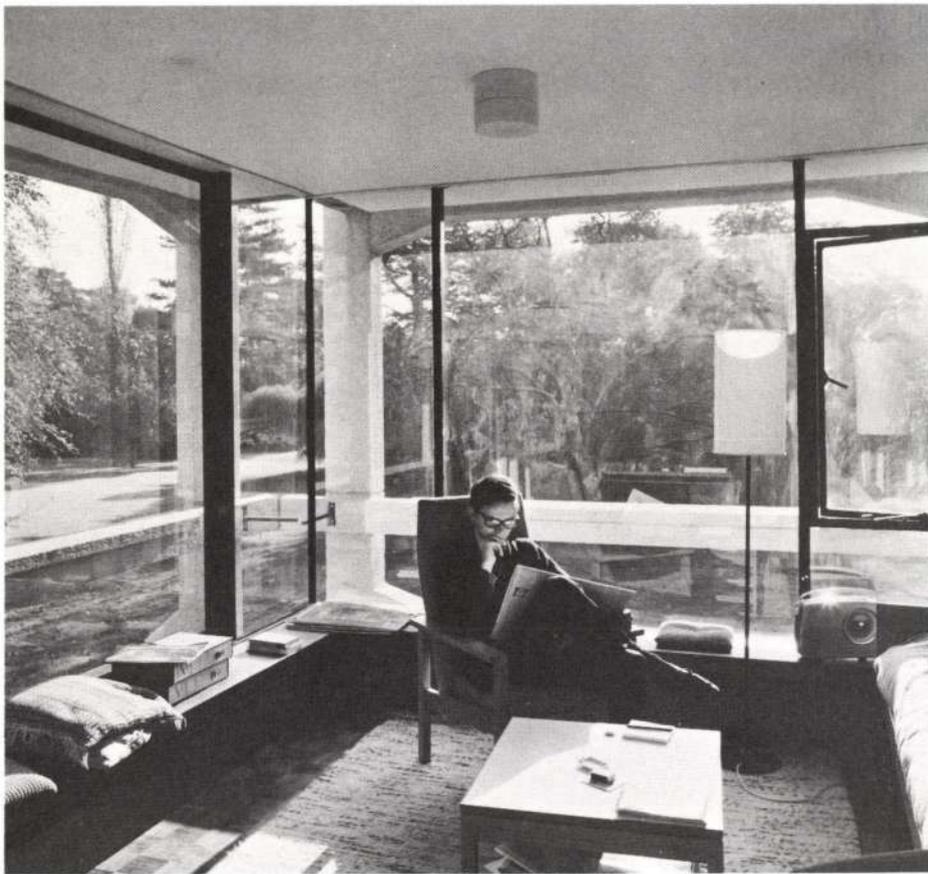
Figs. 2, 3, 4 & 5 Corpus Christi, Cambridge, Leckhampton House.

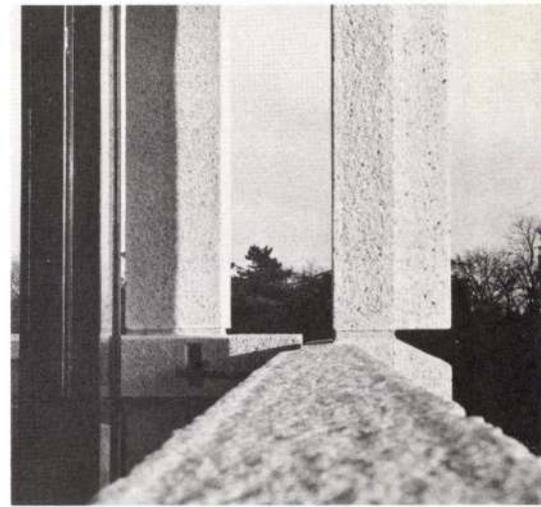
5 An example of the tooled white concrete. (Photo: Harry Sowden)

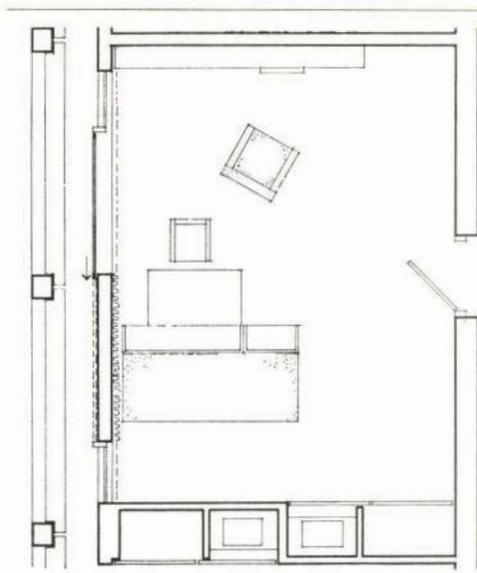
Fig. 14 Somerville College, Oxford, stages I and II.

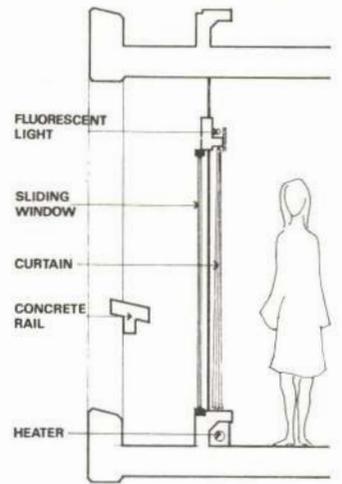
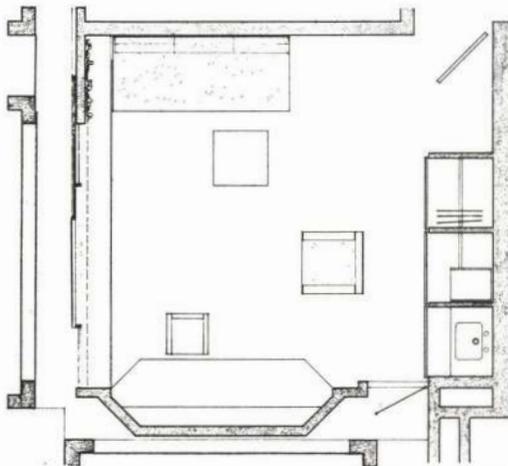
Fig. 15 Corpus Christi, Cambridge, Leckhampton House.

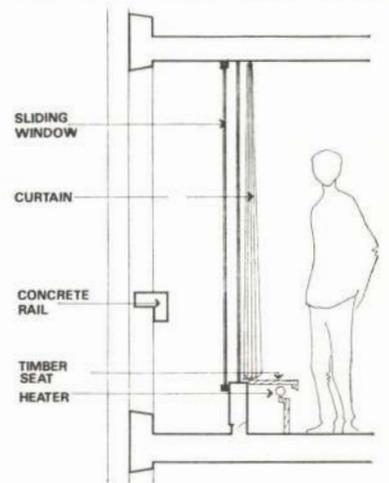
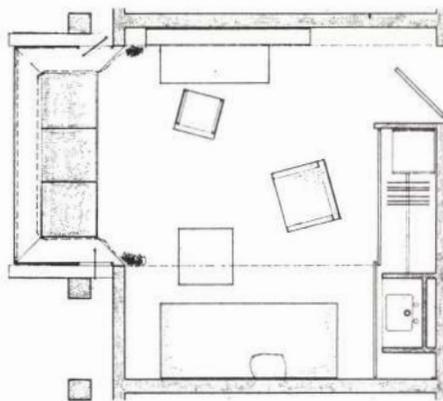
Fig. 16 Somerville College, Oxford, stage III, Wolfson Building.

This idea of modulating the external wall in relation to the external frame was carried further in the next building, which was the Wolfson Building, back at Somerville College (1964). In both the previous buildings, with the external wall running parallel behind the frame, the fenestration pattern was apparently arbitrary. However the same sense of the building extending beyond the individual room could be achieved if the windows were pushed out beyond the frame, instead of pulled back behind it. Also there were obvious gains to the room in having a large window seat, which was an admired tradition in the older buildings of the university. Although all the previous buildings had had common rooms at ground level, here for the first time was the need for a column-free multi-purpose hall, and consequently a clear span. This was achieved by the introduction of precast post-tensioned concrete beams spanning across the building, with the bay windows fixed between them.

Only the sides of the bay open, so as to retain a sense of security when one sits amongst the columns and beams beyond the building. This also has the effect of turning the focus of the window seat back into the room. The introduction of beams added almost 2 ft. (610 mm) to the height of the room, which provided an opportunity to create a bed alcove with the ceiling over it dropped to the soffit of the beam. It did, however, let much more light into the rooms than we had anticipated, with a consequent loss of privacy, unless the blinds were down.

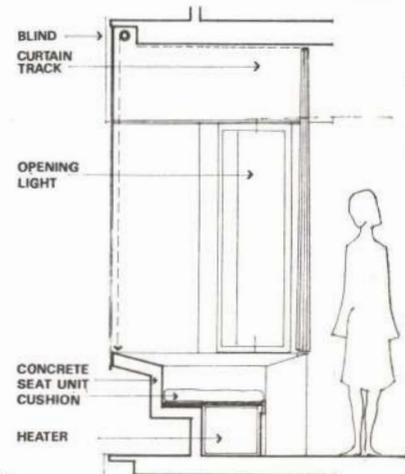
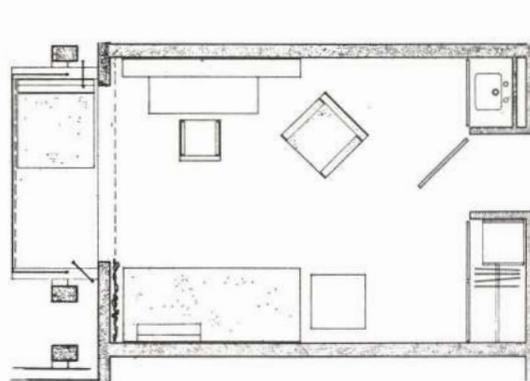
Fig. 17 Trinity Hall, Cambridge, Wychfield House.

Trinity Hall (1966), we have tried to simplify the details. The common room at ground level could accept internal columns, so the structure reverts to a flat slab spanning over the internal columns and out to the beams of the external frame. The tops of the bay windows were made of sloping glass, with the sun blind pulling down this slope over a relieving roller, and then down the vertical face. With the ventilation coming from the sides of the bay, it is possible to have both sun shading and ventilation at the same time. The fan convectors have been positioned under the clothes cupboard on the back wall of the room. A rail across the window acts as both a back rest and a small electric heater (250w). The latter is incorporated to cope with down draughts and condensation.

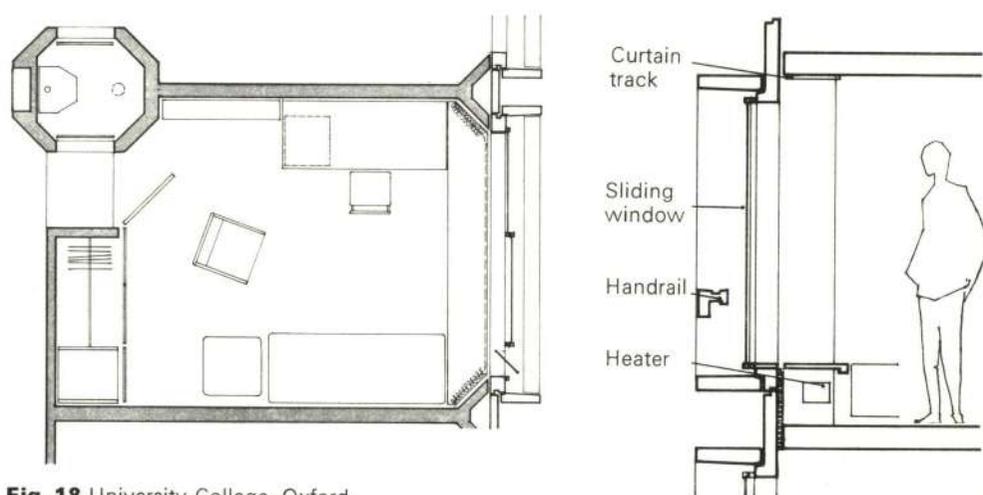
Fig. 18 University College, Oxford.

We are now working on a sixth building for University College, Oxford (1969). Here there is no common room, and so the justification for a framed structure is removed. Sound insulation between rooms is vital, so that there is much in favour of a cross-wall solution which combines the needs of structure and sound insulation. Naturally the structural change greatly reduces the number of elements of the external wall, by the omission of structural members. Two elements remain; panels and window units. The latter are designed to provide many of the solutions arrived at in the earlier buildings, privacy by their projecting sides, an enhanced quality of daylight by their projecting head and sill, outlook down into the garden combined with the security provided by an external handrail, a housing for the heating element which is back under the window and grooves to carry windows, glazing, curtain tracks, etc.
