# THE ARUP JOURNAL

SEPTEMBER 1971

Hyde Park Cavalry Barracks, by E. Happold	2
Archaeology and the engineer, by N. Ross	8
Projects in Saudi Arabia: an introduction	11
Mecca: Saudi Arabia, by M. Dharamsi	12
Mecca Hotel and Conference Centre, by M. Courtney	12
Trial structure at Tours, by L. Grut	14
The Riyadh project, by I. Liddell	16
Services, lifts and lighting in car parks, by D. Ball and H. Nordentoft	19
An alternative approach to calculation of soil movements in deep excavations, by A. Day	21

## Hyde Park Cavalry Barracks

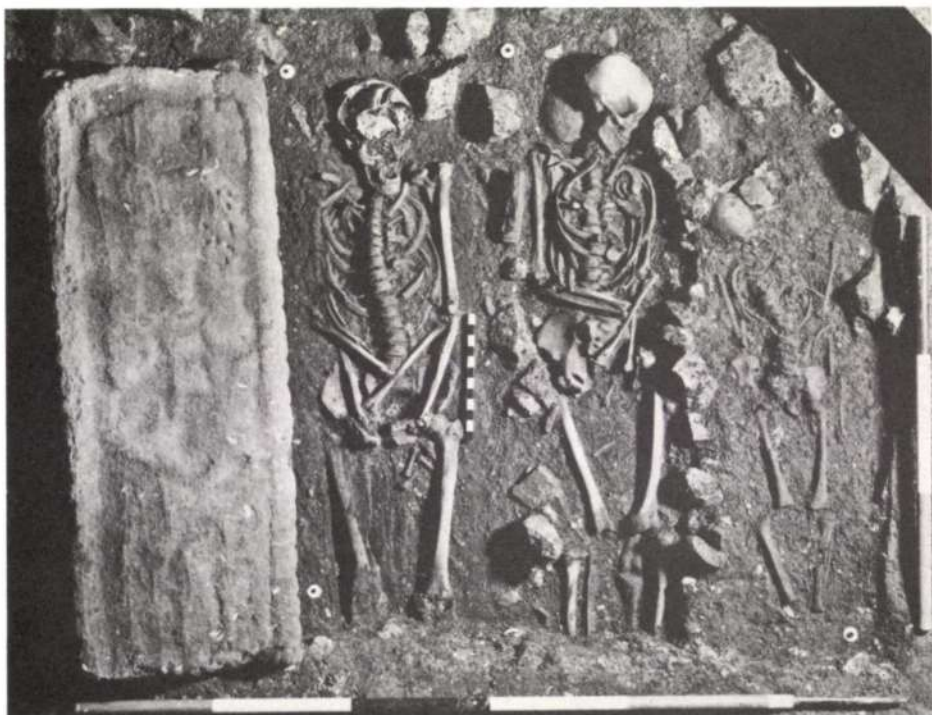
**Fig. 5**

York Minster: Saxon grave slab and skeletons from South transept central area excavations (Photo: Royal Commission on Historical Monuments (England). Crown copyright)

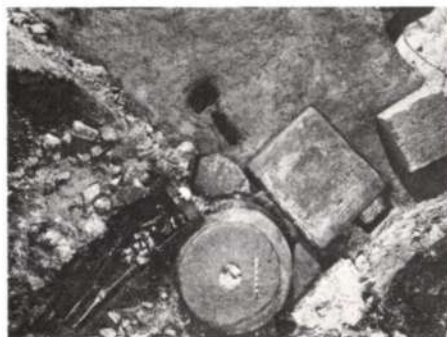
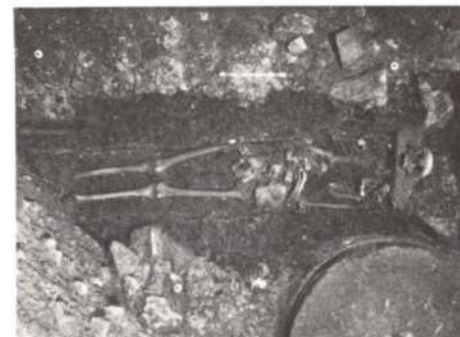
**Figs. 6 & 7**

York Minster: Remains of a Roman column base and podium with Saxon grave. (Photos: Royal Commission on Historical Monuments (England). Crown copyright)

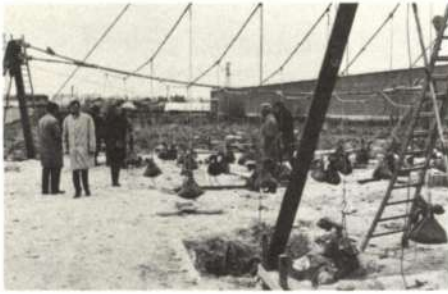
**Fig. 2**  
The cable net with sandbags

stiffness, the cables would be loaded with sacks of sand and the transverse members placed one by one. He believed that it was cheaper and that the other problems could be tackled on site, although the prospect of working on the cables before any transverse members were attached did worry him.

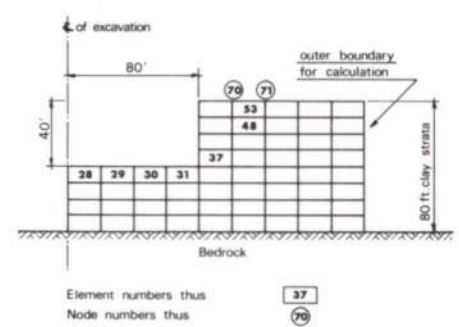
**Fig. 6**  
Trial excavation

were carried out on 3 in. cubes in triaxial equipment, modified for plane strain and the data obtained from them were the average stress, strain and pore pressure for the samples.
