# THE ARUP JOURNAL

DECEMBER 1982

## The Hongkong and Shanghai Bank

This paper is a broad description and interim progress report of the structure for The Hongkong and Shanghai Bank. The specialist studies and investigations that we have initiated and developed will be written up separately and reported on later.

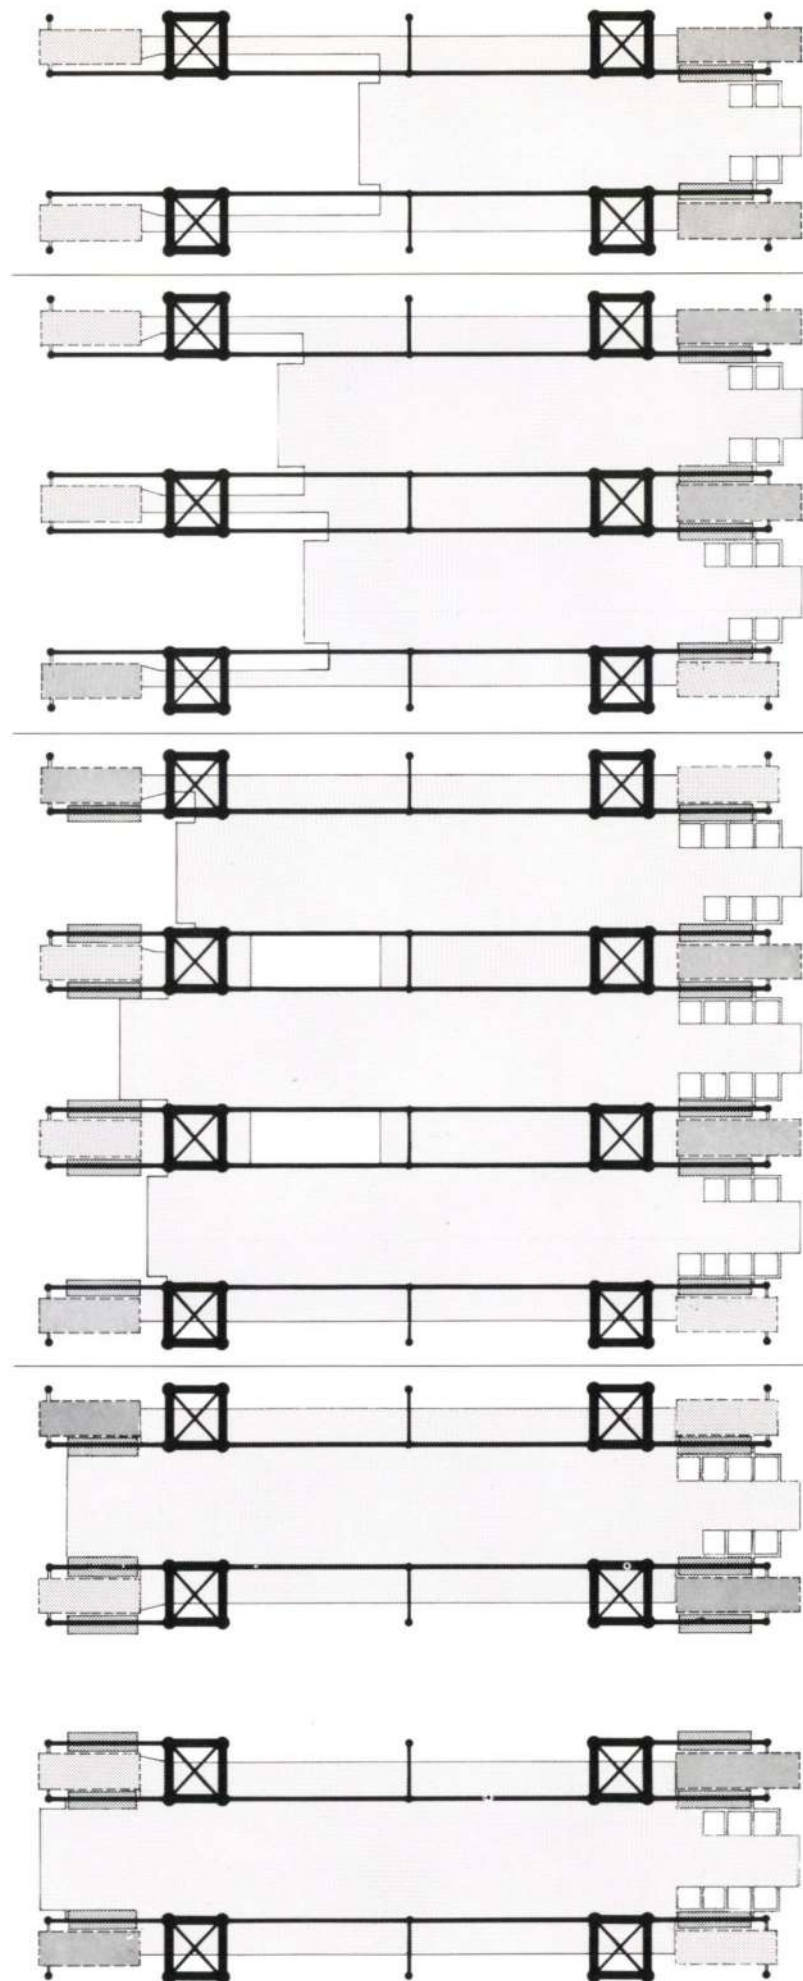
a) North sectional elevation

b) West sectional elevation

c) Typical one-bay office (Levels 37-41)

d) Typical two-bay offices (Levels 30-35)

The gravity load support system is divided into five distinct zones vertically up the building by the suspension trusses. At the top of each zone the series of suspension structures span between and cantilever beyond the masts in the east-west direction, two per mast. Three vertical hangers are suspended from each truss which support primary floor elements spanning between the hangers and the masts. The masts transmit the loading direct to the foundations. The system is illustrated in Fig. 4.

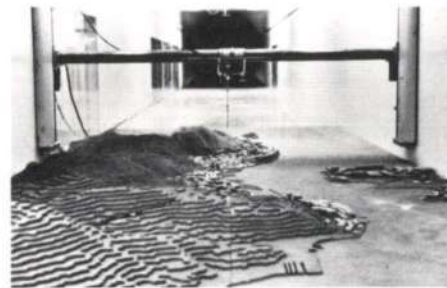
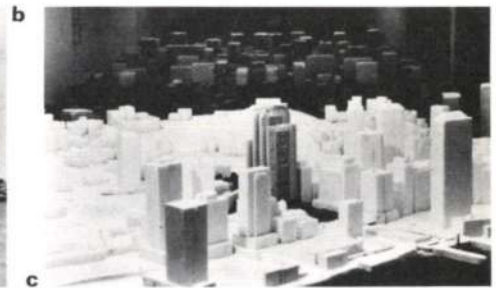
**Figs. 10a-c**  
Wind tunnel study

a) Layout of topographical model for wind tunnel tests  
b) Section of topographical model in wind tunnel  
c) 1:500 scale proximity model including proposed building

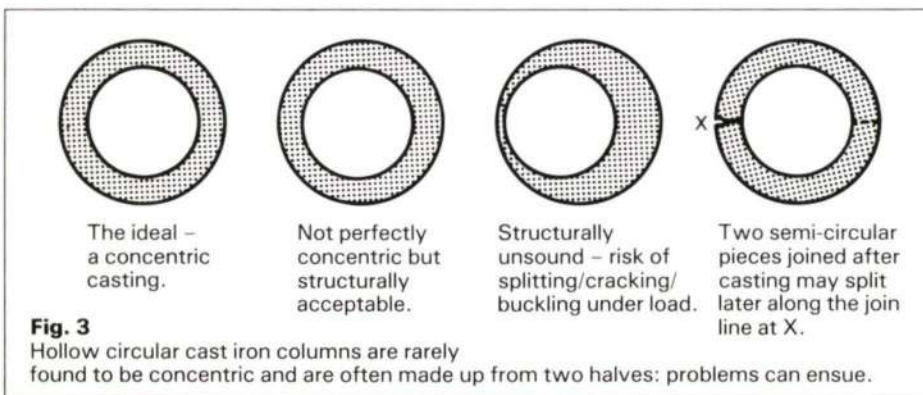
**Fig. 3** Hollow circular cast iron columns are rarely found to be concentric and are often made up from two halves: problems can ensue.

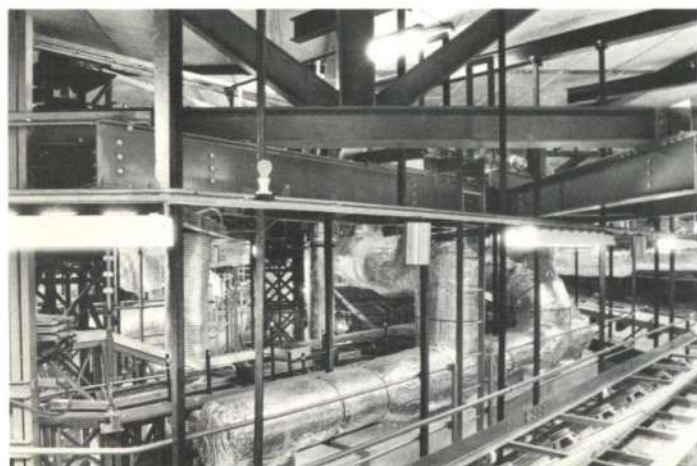
**Fig. 9**  
Ceiling structure and services installations
