Dhajji Dewari

Affordable seismically resistant and sustainable housing

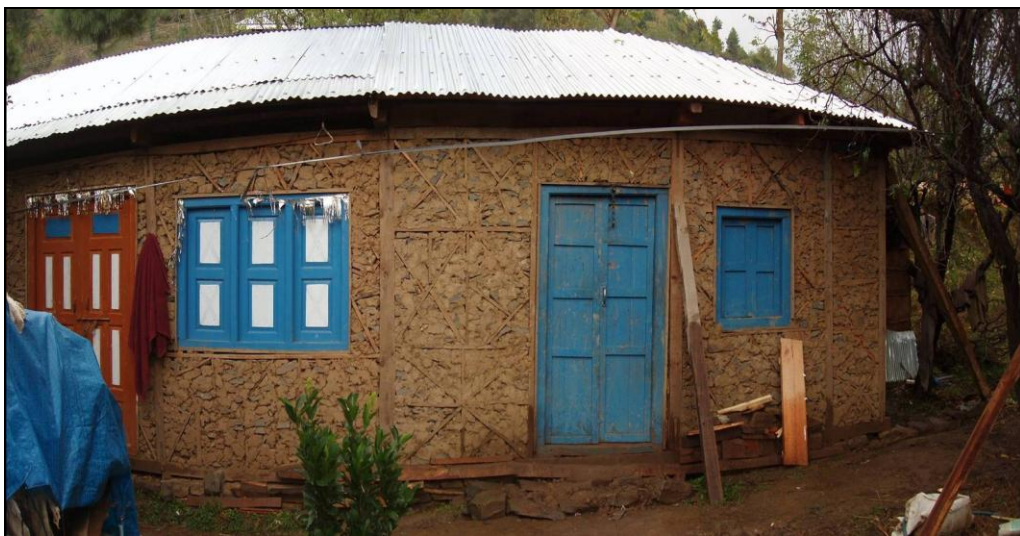
Figure 2-1 Typical dhajji dewari building

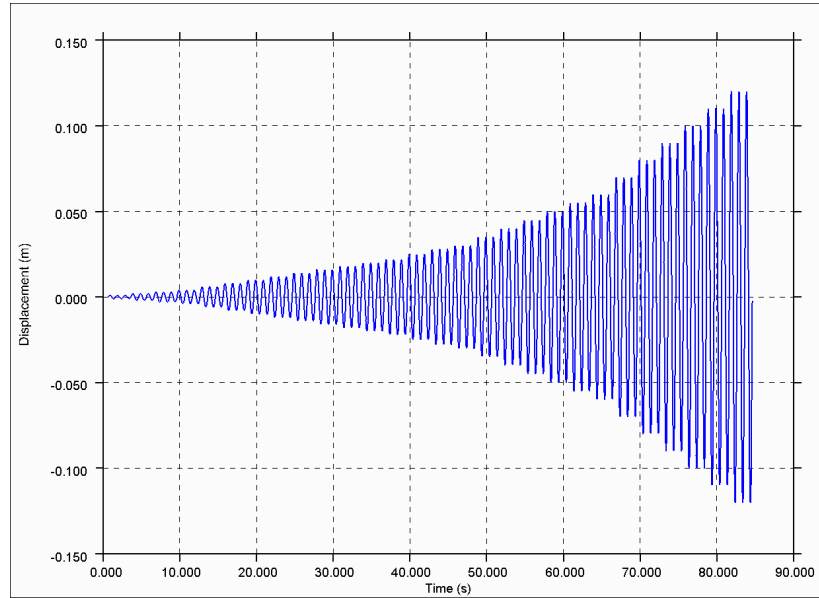
Figure 3-9 Cyclic push over analysis loading regime as used in the UET Peshawar tests.

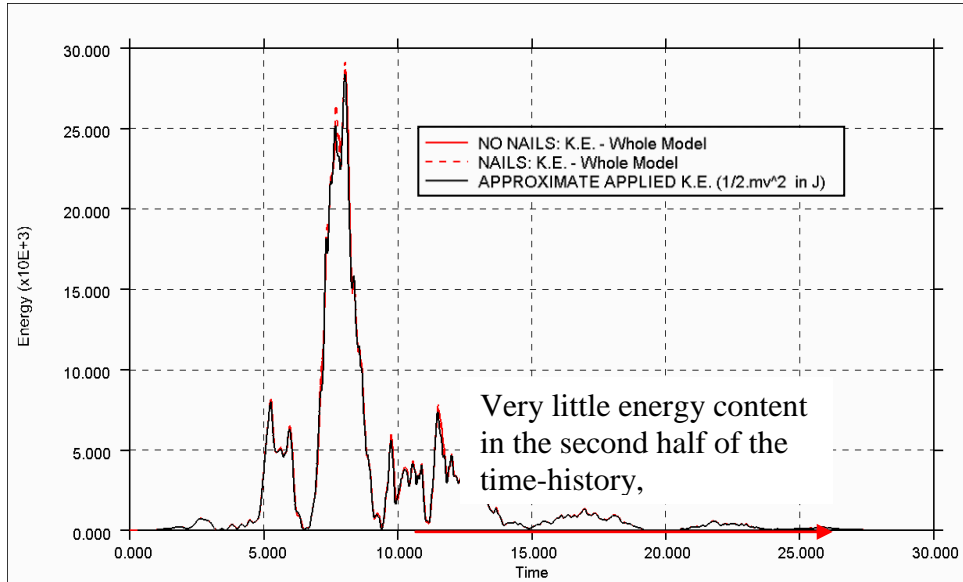
Figure 4-15 Comparison of kinetic energies

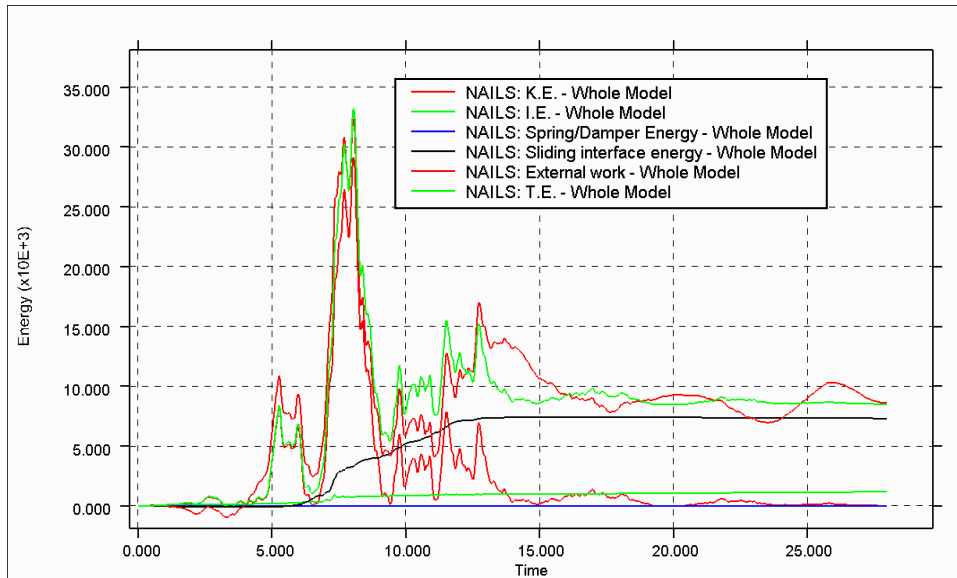
Figure 4-17 Energy plot for time history analysis (PEER1161) with nailed joints

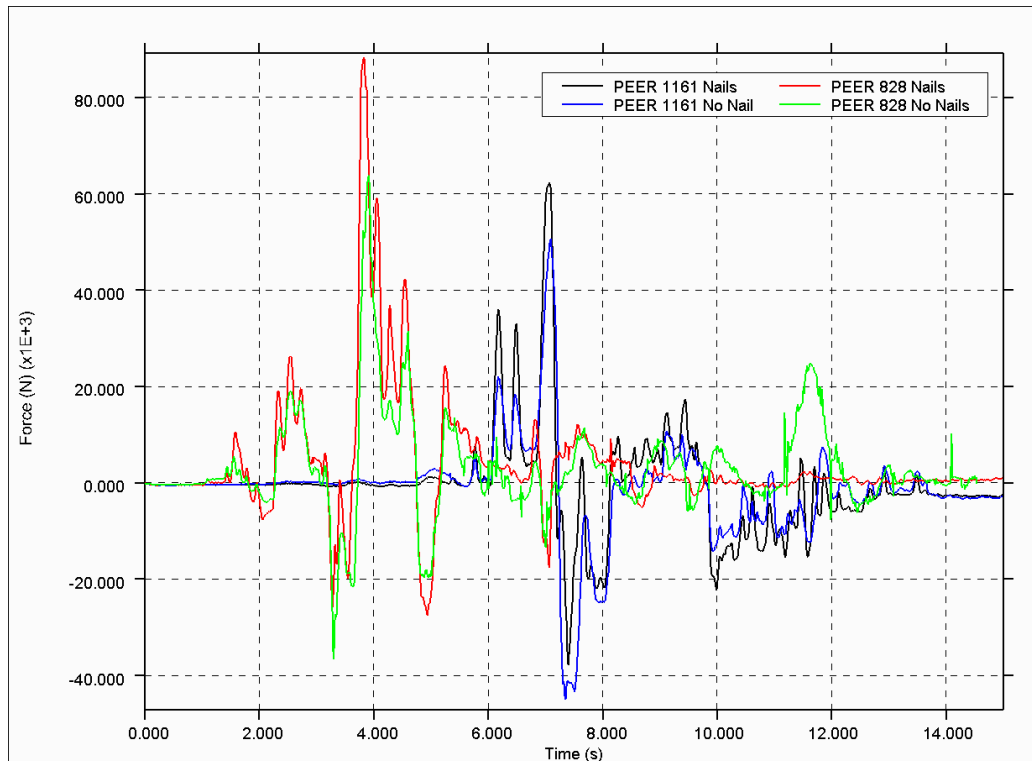
Figure 4-19. Resultant forces at the base of the model

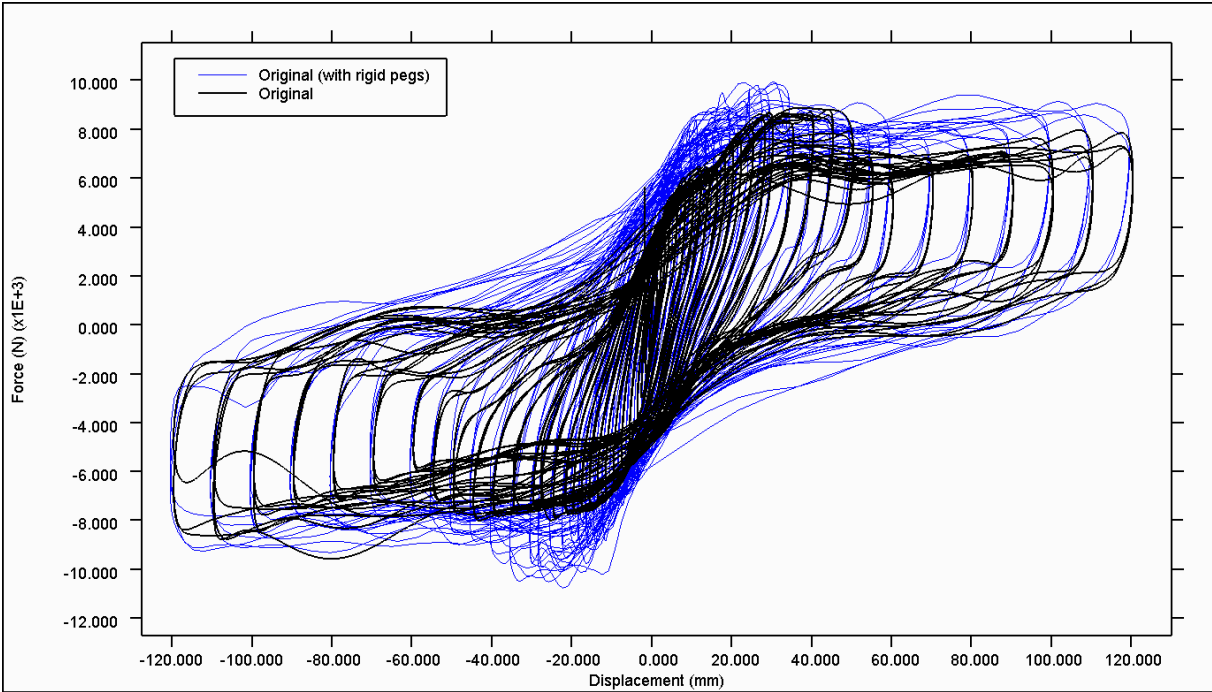
Figure 4-28 Comparison of the benchmark model with modified model that has unbreakable corner timber connections.

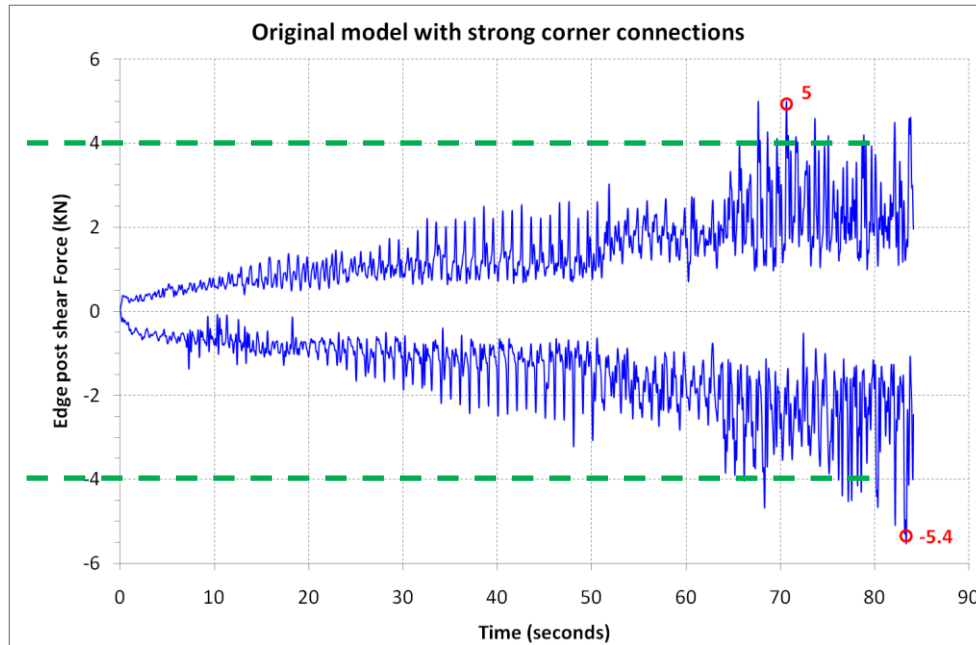
Figure 4-43 Edge post horizontal shear force time history at the left and right hand frame side

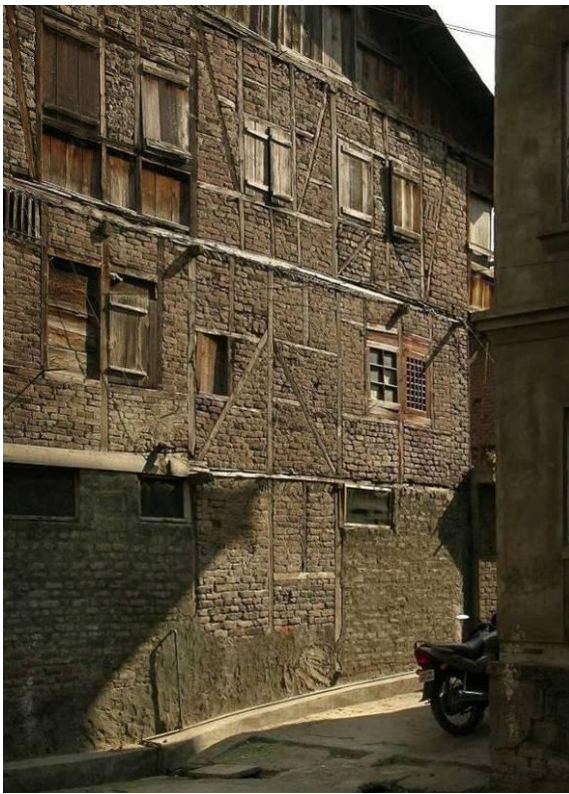
Figure A1-2 . Multi-storey Dhajji building in Shrinagar, India. Photo source © Randolph Langenbach.

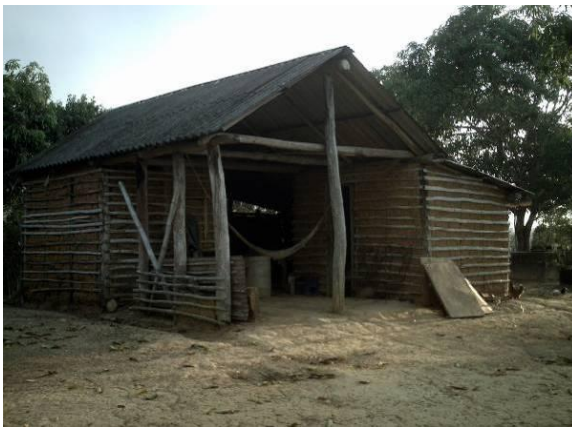
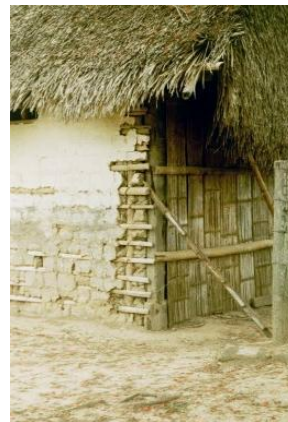
Taquezal / Bahareque (source Wilfredo R. Rodríguez H.)
Taquezal is the term used in Nicaragua, and Bahareque in El Salvador)

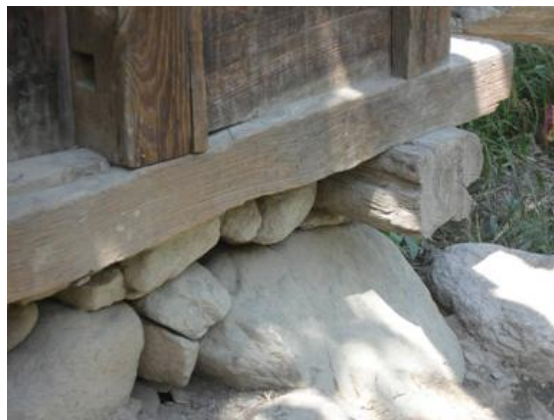
FigureA2-3 Foundation below plinth beam, note no connection between plinth wall and timber beam (existing building)

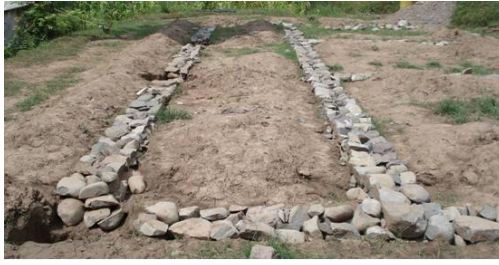
FigureA2-4 Stone strip footing under construction to raise the timber frame off the ground (new building)

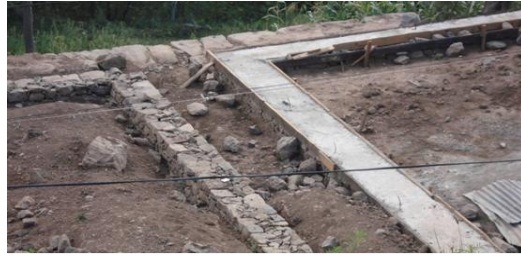
FigureA2-5 Strip footing made from stone with concrete capping and embedded steel reinforcement

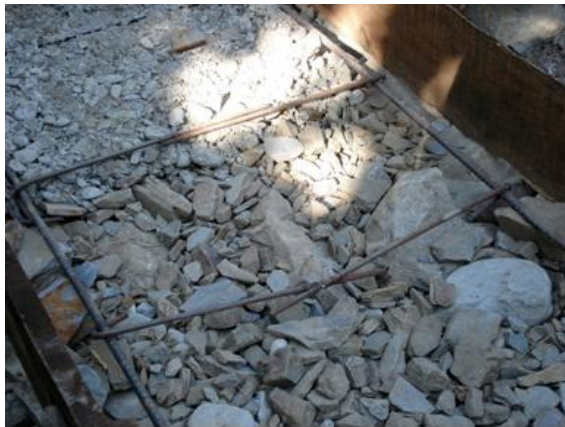
FigureA2-6 RC plinth band under construction (note poor splicing of stirrups)

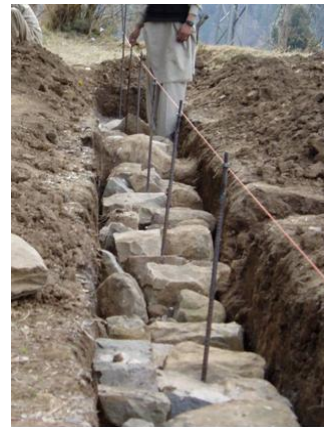
FigureA2-7 Bolts in the foundation to tie-up plinth timber

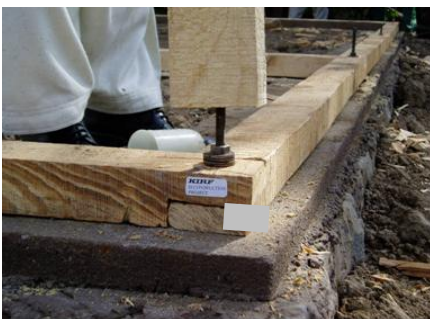
FigureA2-8 Bolting of plinth band with foundation. Note that a damp proof course has not been used

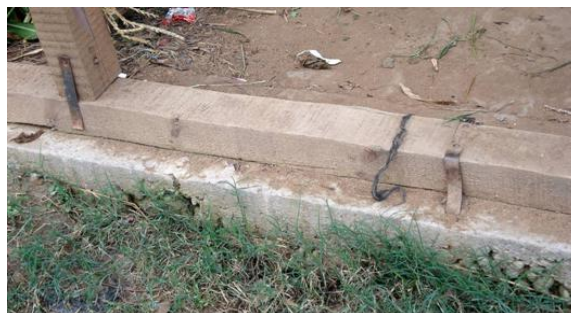
FigureA2-9 Timber ground beam (or sill beam) raised above the ground to protect the timber frame from rotting. Note attempted connection of the timber beam with the foundation. Damp proof course not provided.

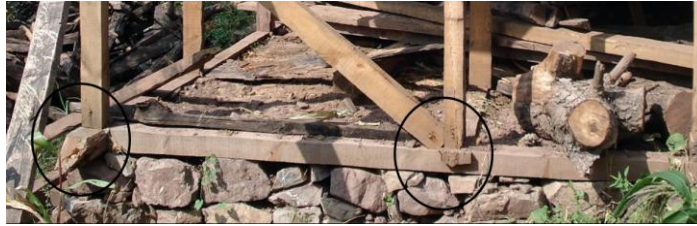
FigureA2-11 Post and plinth beam connection details. Note that the timber frame is founded directly on stone which will help keep the timber dry.

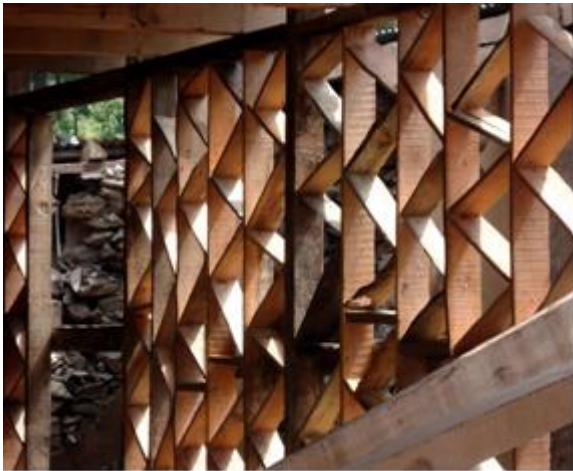
FigureA2-12 Timber frame ready to receive stone infill. Bracing has a zigzag pattern and bracing does not coincide/node-out.

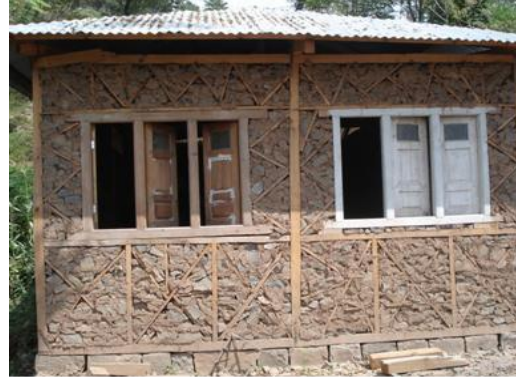
FigureA2-17 A completed wall. Note that the entire building has been raised above the ground level by a stone masonry foundation.

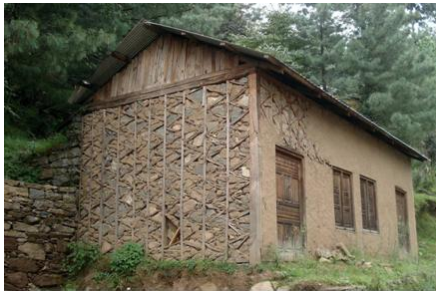
FigureA2-18 A Dhajji building with gable wall with planks

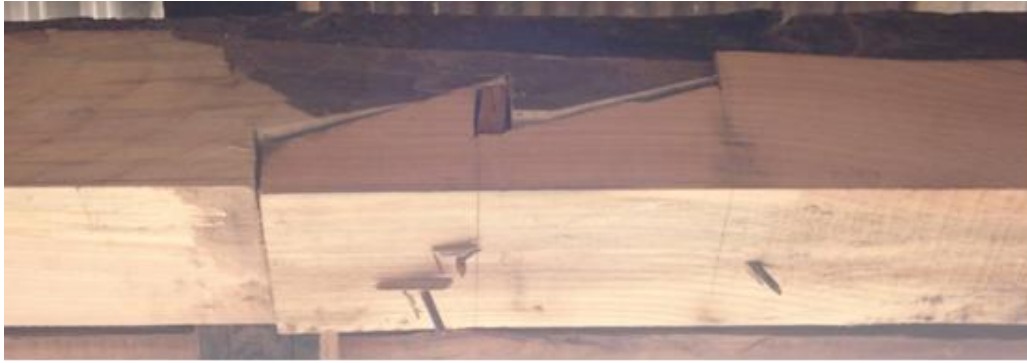
FigureA2-29 Poorly built scarf connection. The joint is a poor fit and the wooden peg that should pre-stress the joint appears loose. Note that the joint has been crudely reinforced with nails.

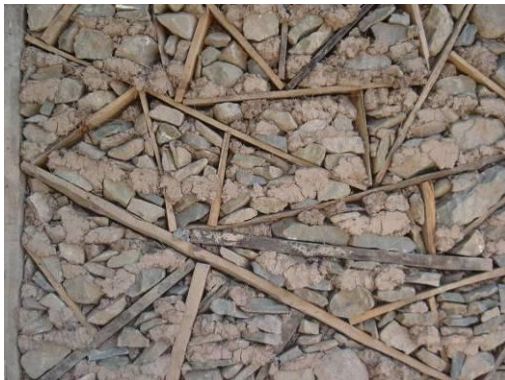
FigureA2-30 Common random bracing in small panels

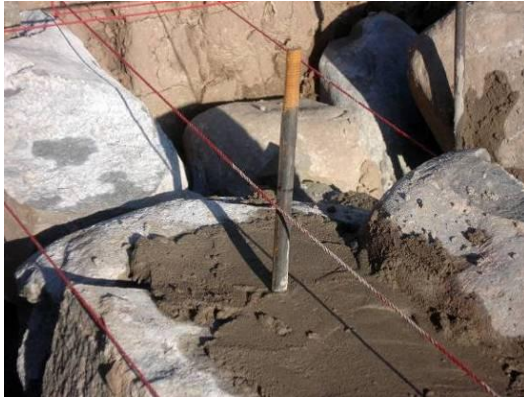
Figure A2-42 Anchor bolt in stone masonry wall laid in sand and cement mortar. Note that the bolt is already rusting and is unlikely to receive any rust treatment prior to connecting to the frame base plate

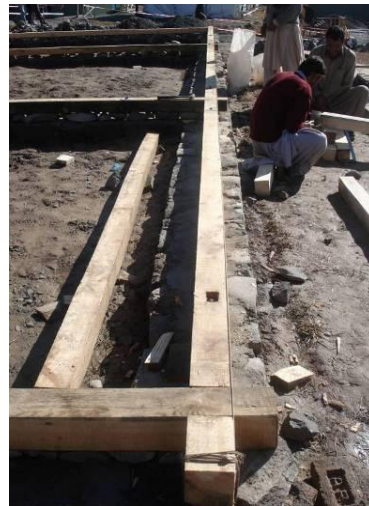
Figure A2-43 base plate corner detail and bolt anchorage holes. Note that orthogonal walls are already planed and interconnected with the perimeter timber ring beam.

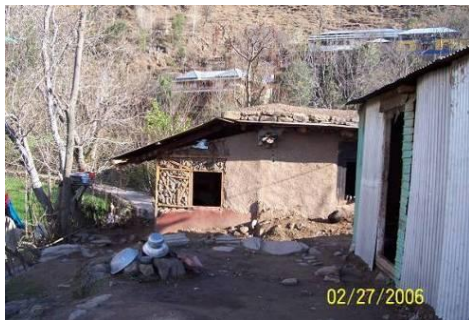
FigureA2-52 Single storey house with Dhajji walls. It was not clear if the roof damage was due to the 2005 earthquake or if this was post earthquake construction.

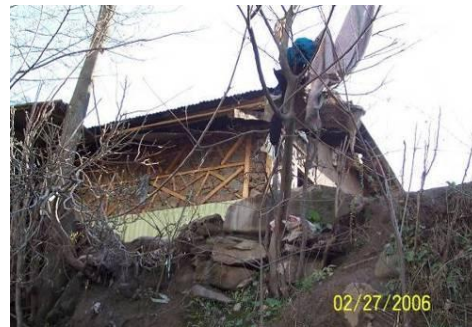
A2.10 Construction Materials

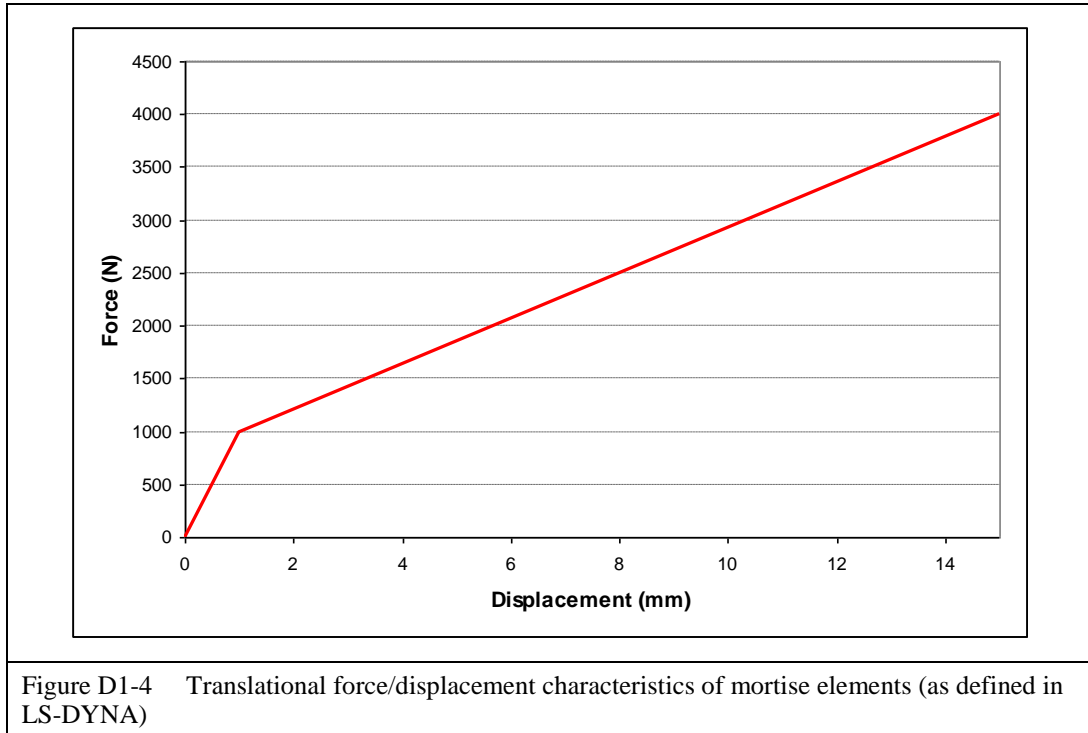
Table D1-3 Mortise characteristics for *MAT_NONLINEAR_PLASTIC_DISCRETE_BEAM.		
Translational stiffness	1×10^6	N/m
Rotational stiffness	1×10^6	Nm/rad
Failure displacement	1.5×10^{-2}	m
Initial yield force	1000	N
Ultimate capacity	4000	N
